**Report on stabilisation of mineworkings.**

## **Mining Investigation Report**

### **Pendil, Llangollen Road, Acrefair**

0209  
18 September 2002

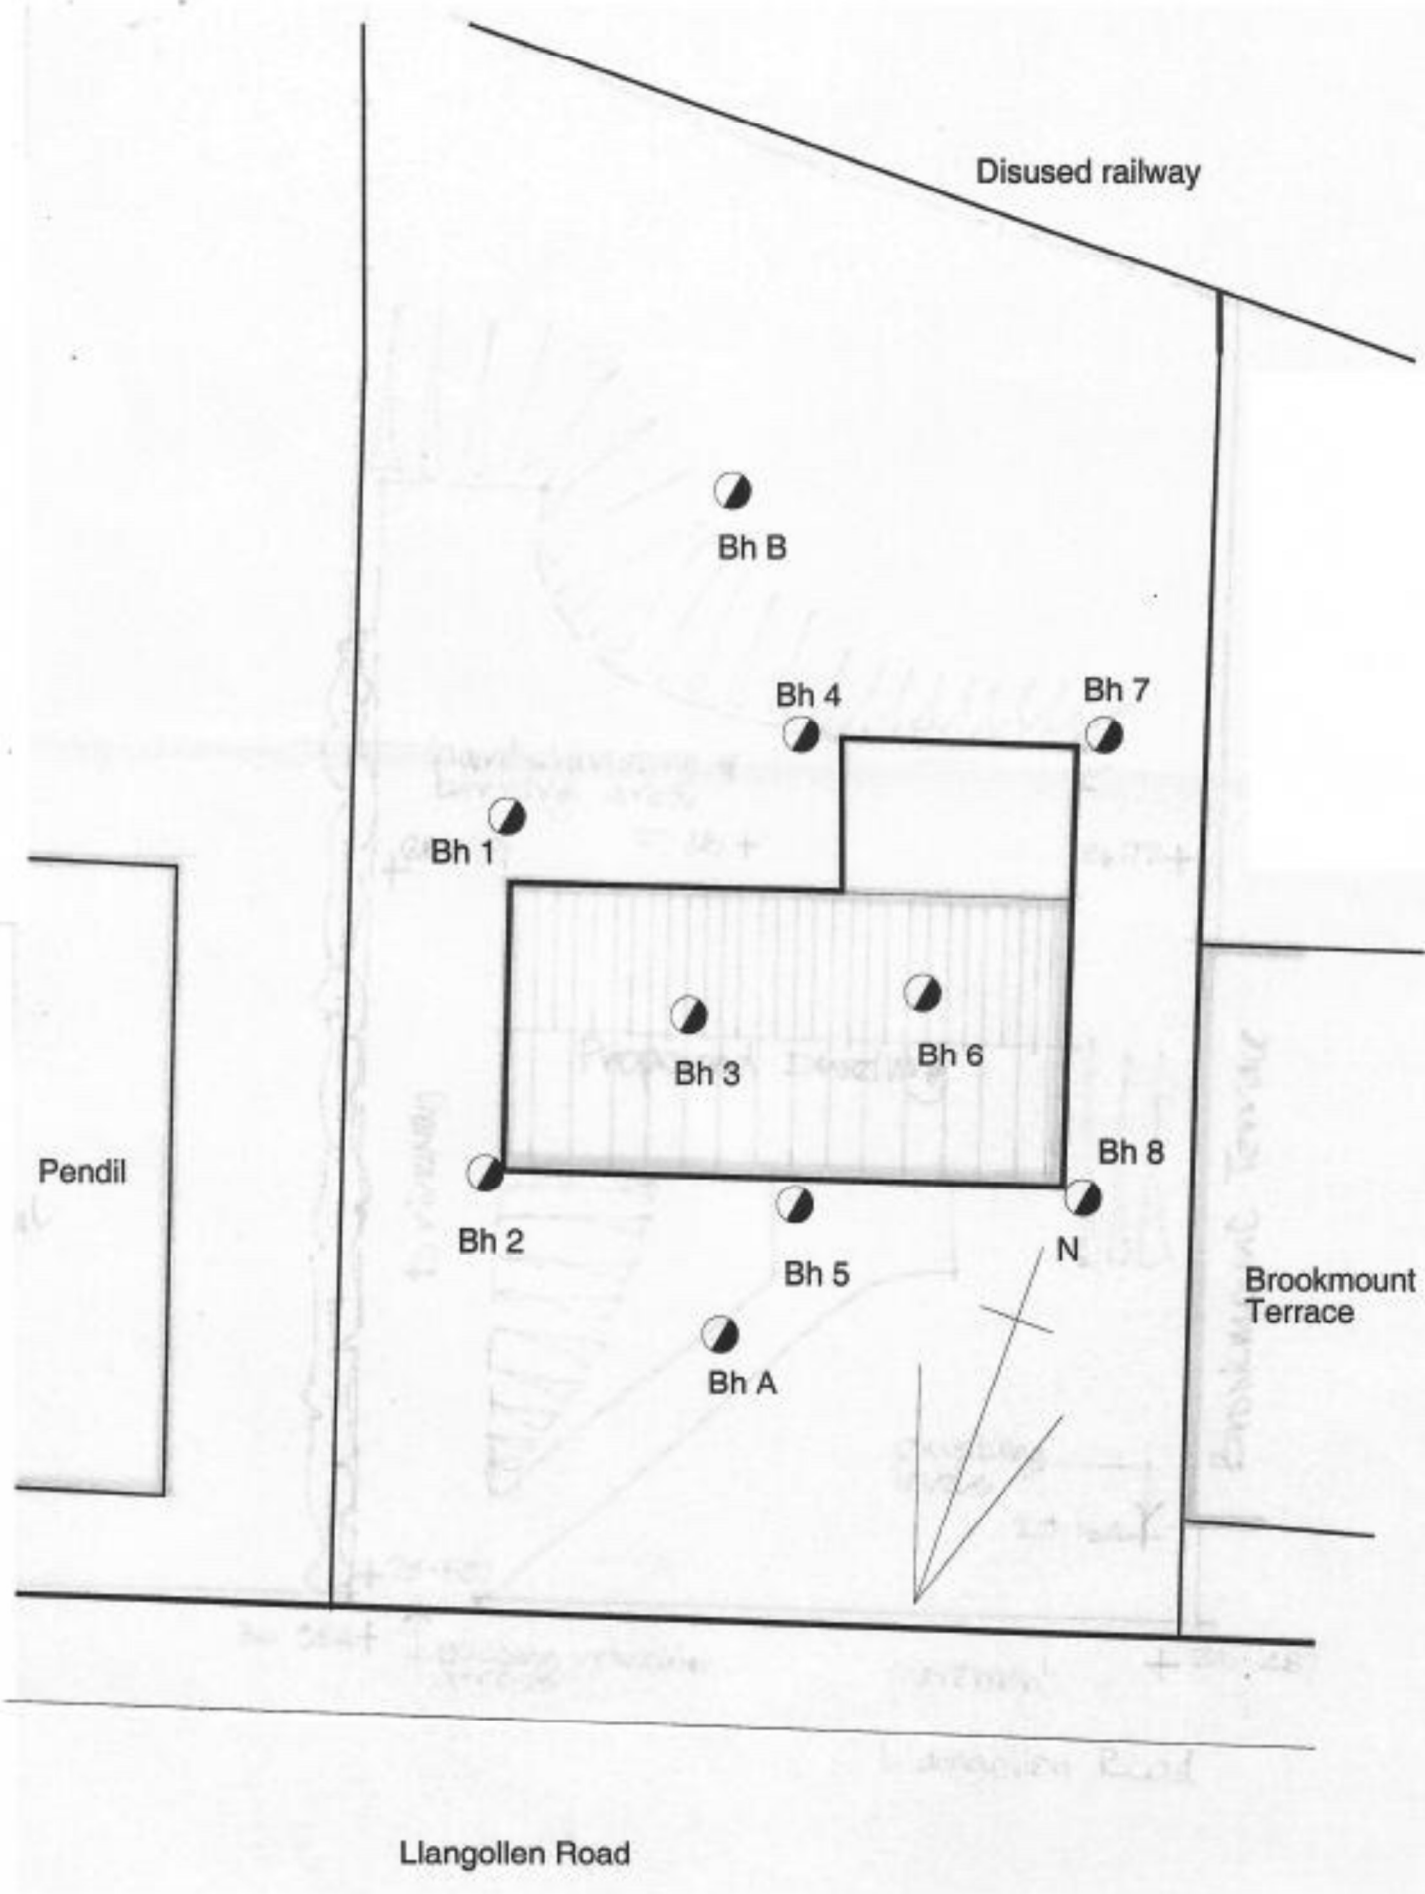
### **Results of remedial work**

Grout mix 4:1 rockdust/PFA/cement and measured in dry tonnes

Injection pressure <150kN/m<sup>2</sup>

Total grout take dry tonnes 12.9

Status codes sd solid cd collapsed cn cavitation vd void

A total of 8 holes were drilled into the Yard Coal workings, and subsequently grouted. See results of remedial work.
