| Project:<br>As Built drawings at,<br>Whalebone Cottage,<br>Plassey Cottage, Willington,<br>Malpas, SY14 7LS | |
| Title:<br>As Built | Scale: (A1)<br>1 : 100 |
| Drawing No:<br>C150/001 | Sheet:<br>1 of 1 |

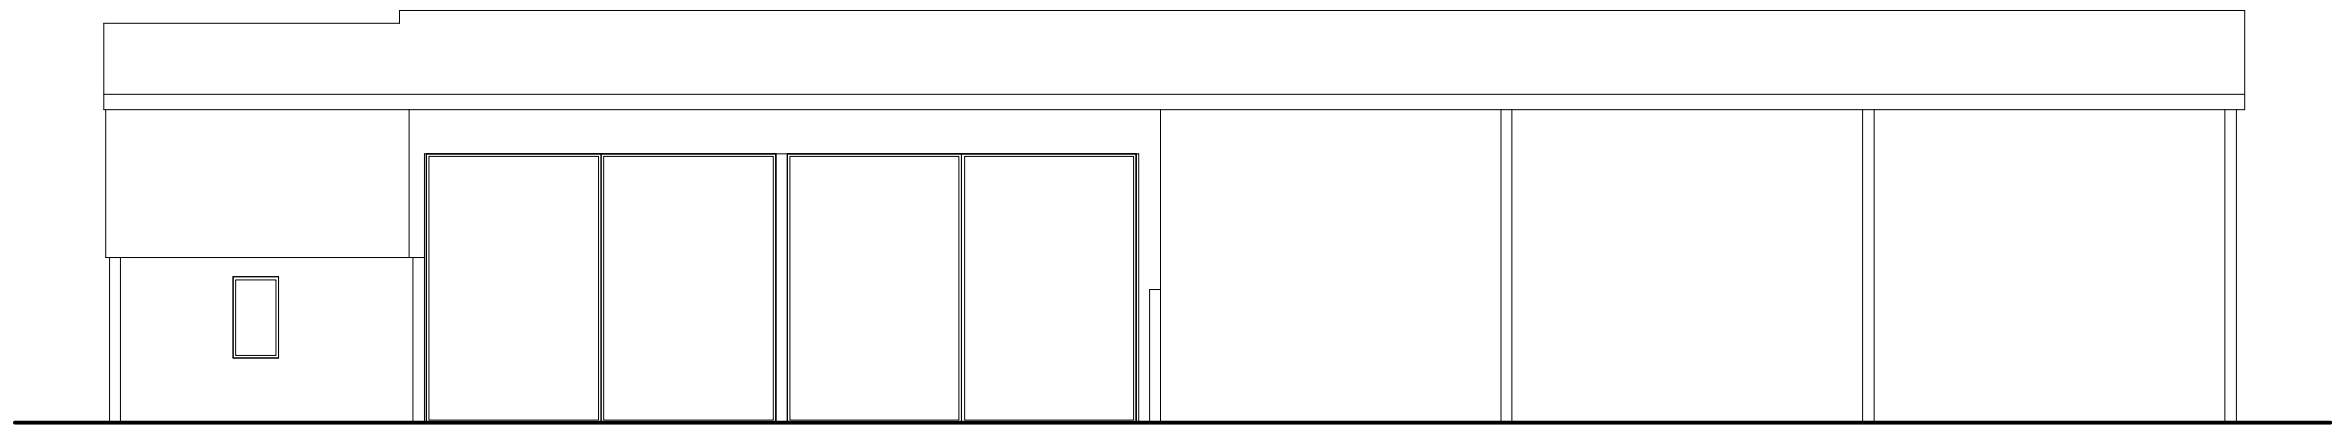
Front Elevation

External Facing Materials  
External walls comprise steel sheet cladding and blockwork.

Roofing Materials  
Roof coverings comprise corrugated roof sheets.

Windows comprise sealed double glazed units set in uPVC frames.

Rainwater collected in uPVC guttering and uPVC downpipes, to discharge to soakaways.
