## HERITAGE IMPACT ASSESSMENT -

**The conservation-led redevelopment of the Patternmakers & Carpenters Workshop, including reinstatement of the roof structure, extensive fabric repairs and new visitor interpretation facilities.**

# Sketch Design Proposals - Pattern Shop Existing Photographic Record and Reconstruction Notes

## Brymbo Heritage Trust - Proposed Regeneration Project

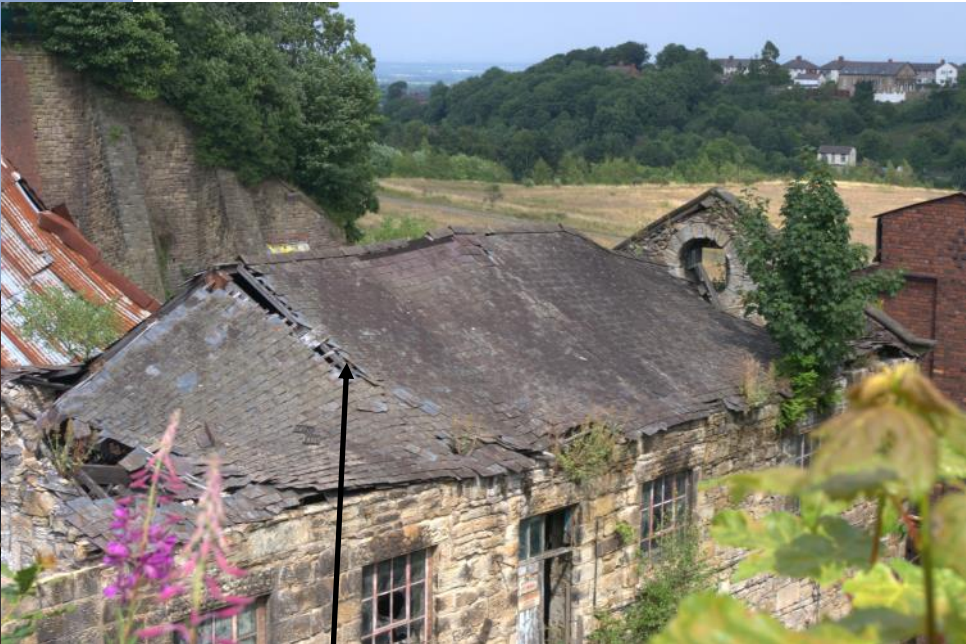
Timber windows to be carefully removed and like for like repairs undertaken, piecing in new timber when necessary

Note truss position

Metal windows to be deglazed, removed and overhauled before being refixed on a like for like basis

Between 4-5 additional courses of stonework need to be rebuilt over the head of the existing windows to realign with the gable and the rest of the elevation

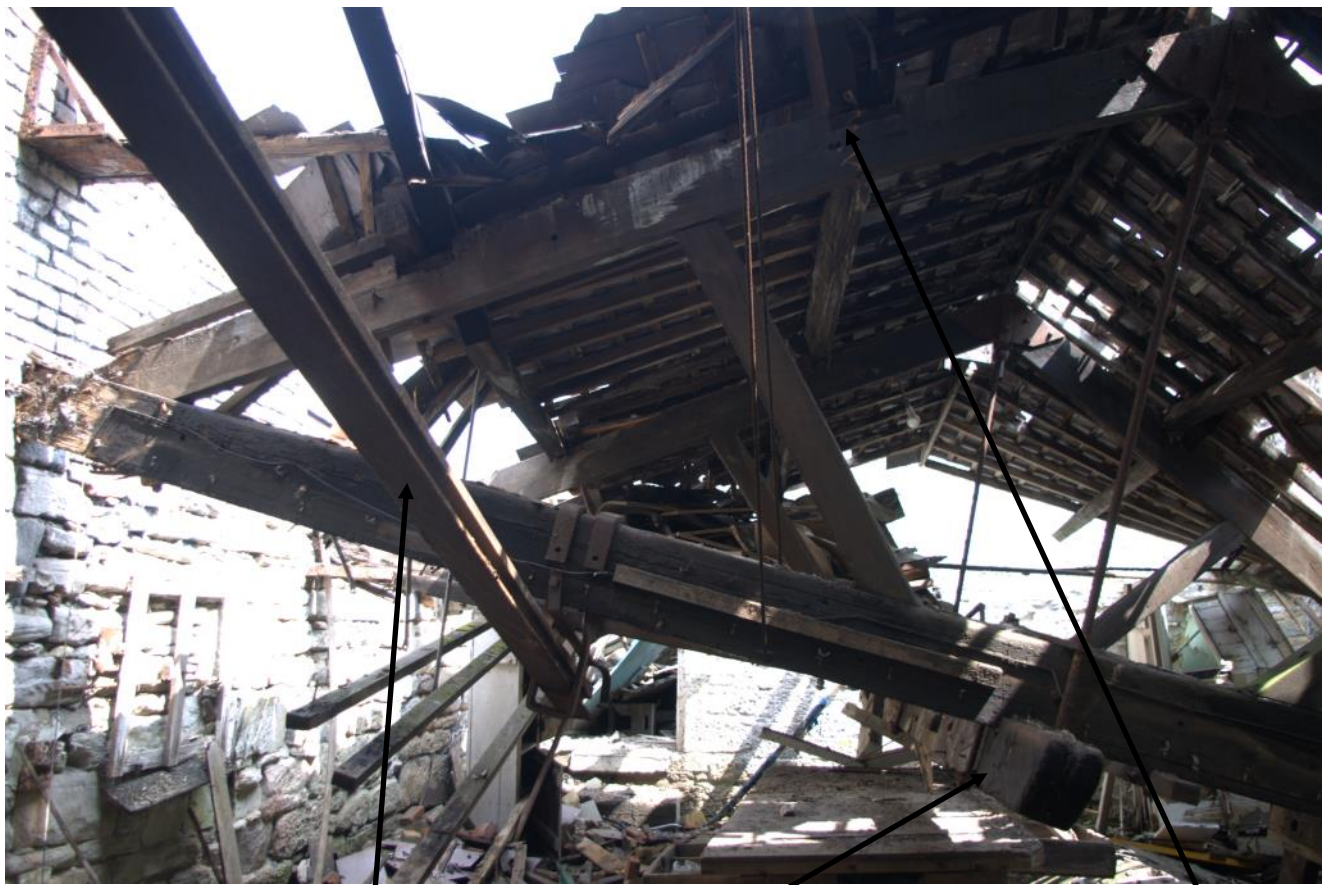
Note lifting beam and fixing details of elements that should be reintroduced under the SMC as the evidential information is available to do so.

Note side by side positioning of the purlins at this end of the building

Strategy to be developed for the recording, lifting and air drying of the existing timber block floor. Floor to be lifter and palletised before cleaning and air drying. Floor to be re-laid on like for like basis on completion of the structural repair works.

As the roof structure was removed from the building some years ago, the timber block floor finish to the workshop at the west end of the building has expanded, distorted and deteriorated considerably. A programme of repair is proposed where it is hoped that the position of the existing blocks can be recorded, carefully lifted and gradually dried under controlled conditions. It is likely that some replacement blocks will be required (percentage not currently known) and will need to be refinished, before being reinstated on a prepared base construction. Despite early enquiries having been made, further investigations are required before a detailed methodology can be finalised and agreed with key stakeholders.

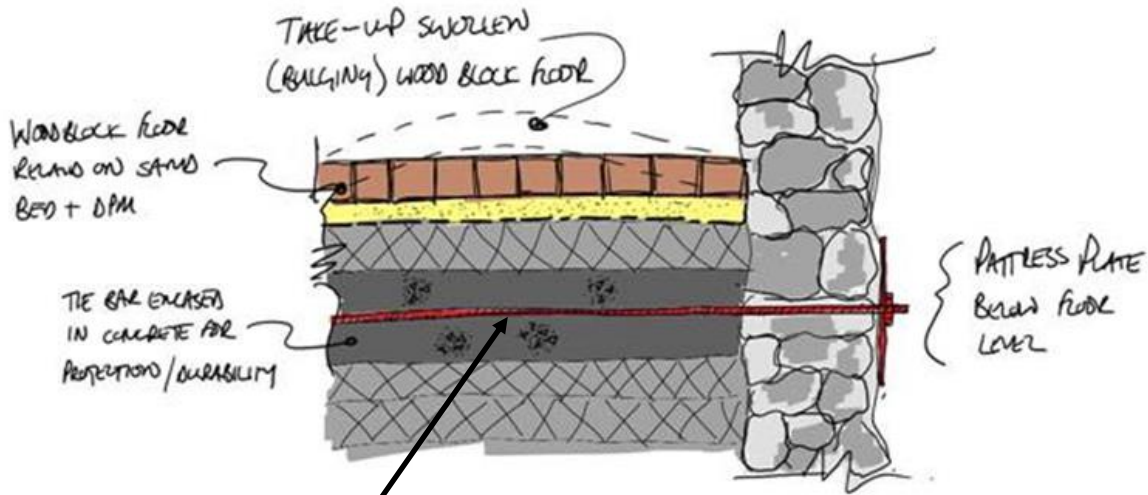
See floor plan for the insertion of ties beneath the existing floor construction. See above WSP details
