**Brother Industries, Vauxhall Industrial Estate, Ruabon,  
Wrexham, LL14 6HA**

**Erection of storage and distribution warehouse (Class  
B8)**

**Report in relation to the discharge of Conditions 8 and 9  
of permission RHO P/2022/0979**

**July 2023**

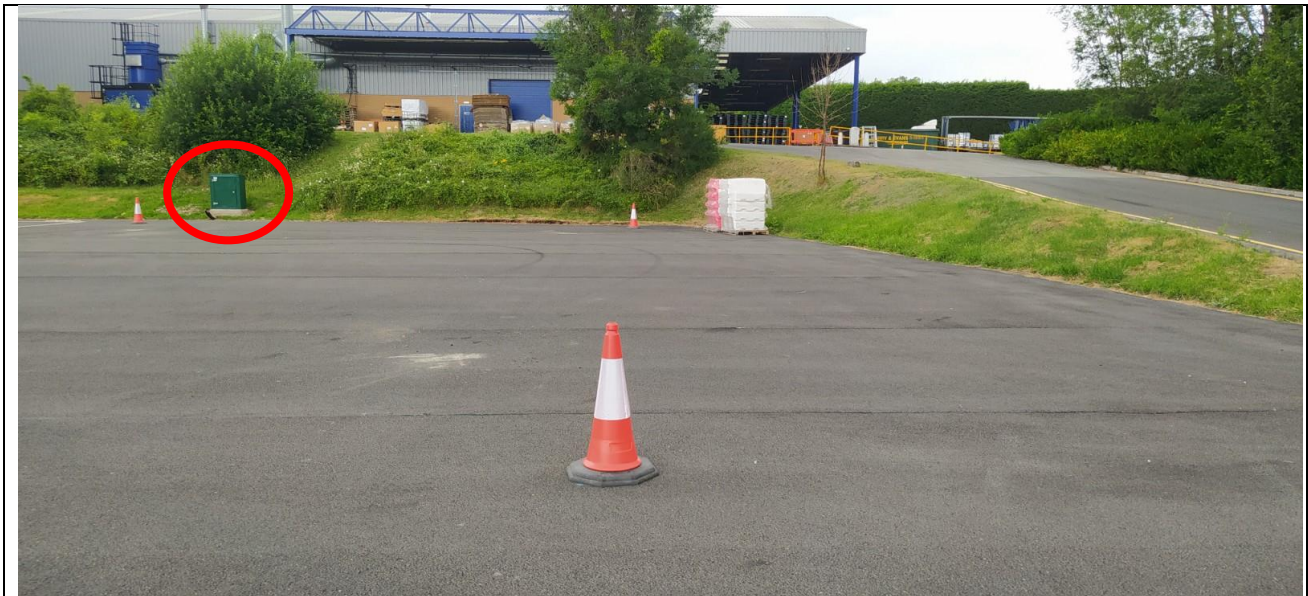
Photo 1 – Location of warehouse on car park, as marked by traffic cones. The electricity supply box is ringed in red

It should be noted that the permitted area is all tarmacked car park and the proposed warehouse is effectively a ‘no-dig’ construction comprising a metal frame bolted and sealed to the ground, with composite wall panels and a PVC roof. The electricity supply box is nearby (with a few metres – see photo 1) and any trenching needed for connection is understood to be do-able as cut and fill within 1 working day. It is understood that no other utilities are required. This context affects the content of the required method statement, audit and biodiversity risk assessment. See photos 1 to 3.

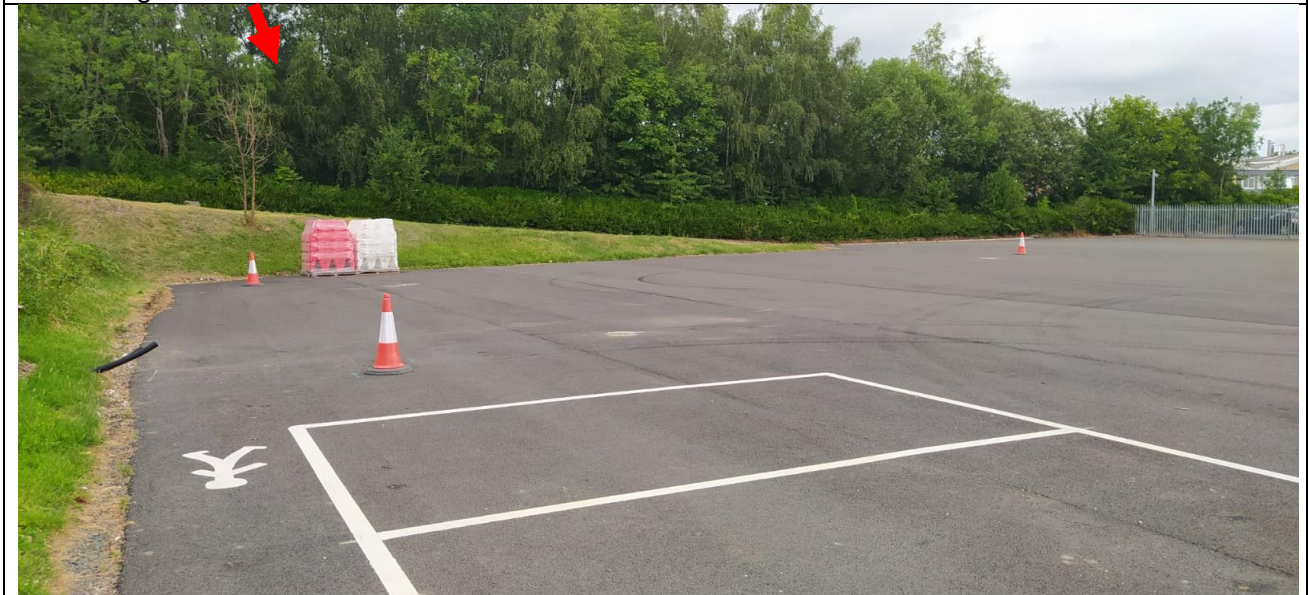
Photo 2 – Location of warehouse on car park, as marked by traffic cones. The location of the nearest breeding pond is arrowed (beyond the tall wooded bund)

Since the proposals are at least 30m from the nearest known breeding pond (to the N and over a 10m tall bund – see Photo 2), there is considered to be negligible risk of introducing invasive non-native aquatic plants or chytrid fungus to that pond.

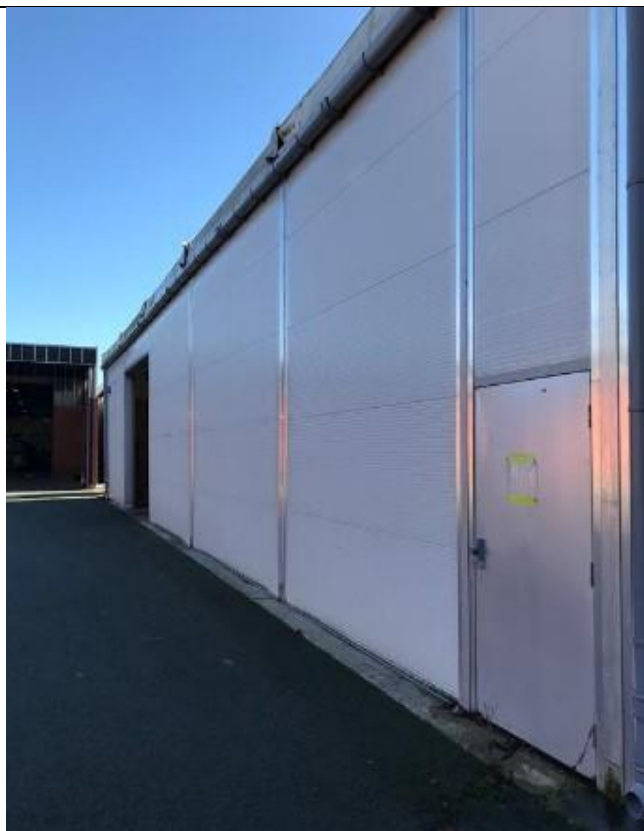
Photo 3 – showing an example of a completed warehouse with a metal frame flush with the ground and PVC walls and roof

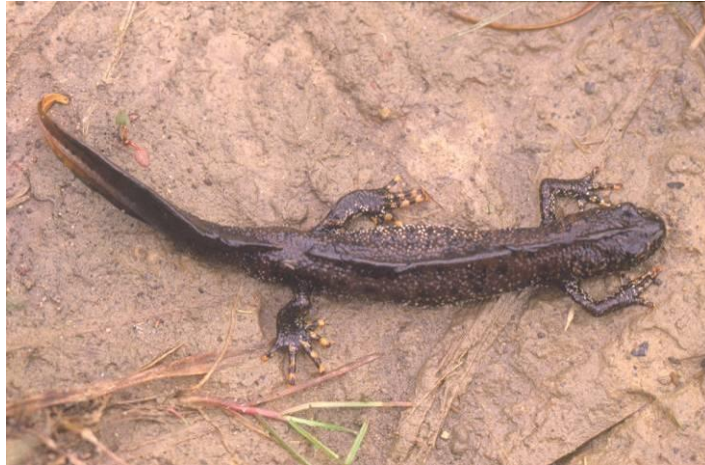
An adult male looks like this (picture approx. half life-size). Adult males have rough dark (black) skin and are up to 15cm long (nearly the length of a typical hand). Note the white stripe on the tail.

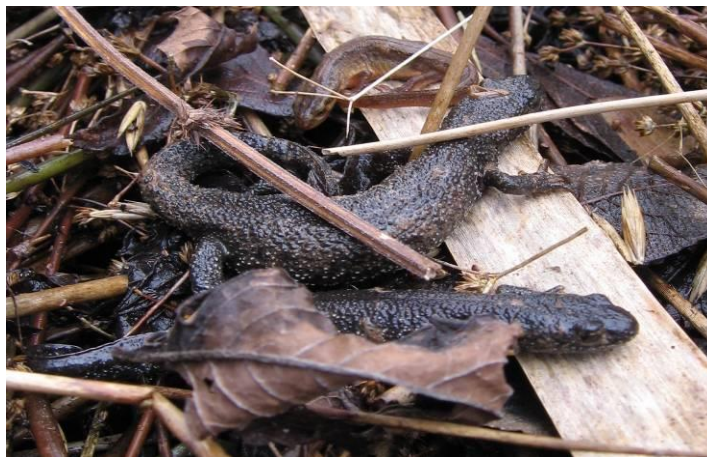
An adult female is similar (picture approx. half life-size). It is typically slightly bigger than males (note there is no white stripe on the tail).

Note that there are two other species of newt that might be found and which can look like a small version of a great crested newt (there is a smooth newt in the photo above). Therefore, if any newt is found it is best to telephone as detailed below.
