WREXHAM MUSEUM ACCESS AUDIT REPORT

Wrexham County Borough Museum and Archives,  
Regent Street,  
Wrexham,  
LL11 1RB

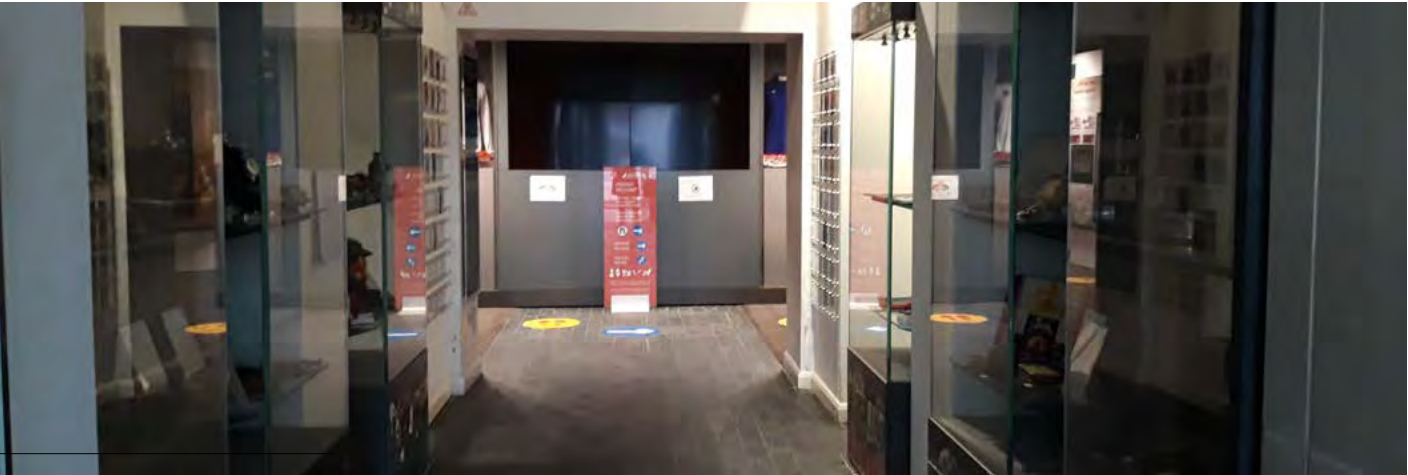
Route through galleries to lift and WCs

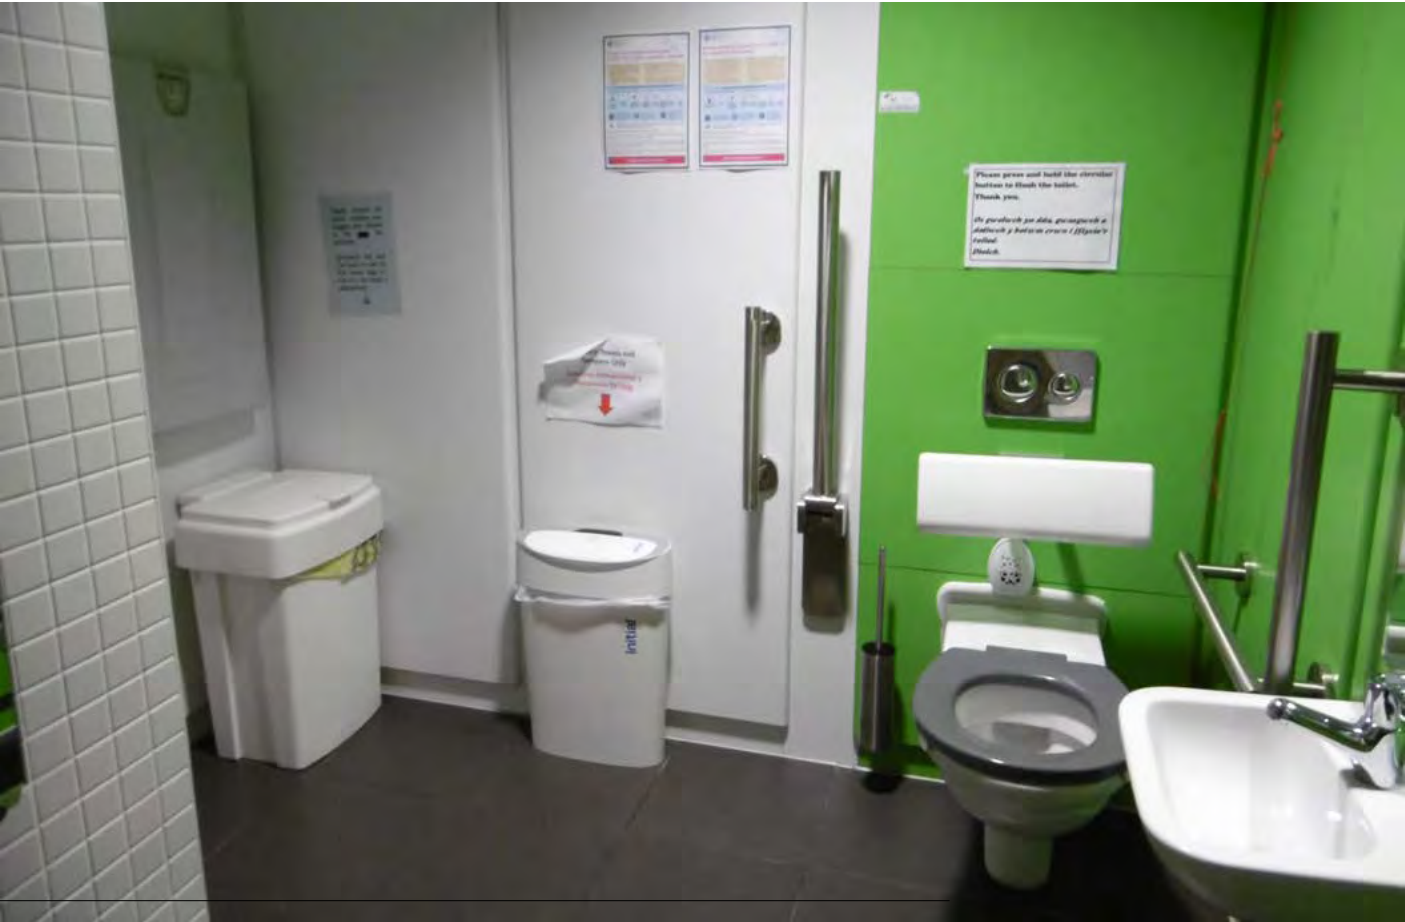
The combined use of accessible toilets for baby-changing is not recommended. It can limit the availability of a toilet for disabled people, who have the same and often more urgent needs to use a toilet as non disabled people. Litter can also compromise the health and safety of disabled users and the large waste disposal bin restricts wheelchair manoeuvrability within the cubicle.

Wheelchair accessible WC with baby change facilities

| EXISTING ARRANGEMENT | | ILLUSTRATION | PROPOSALS | GUIDANCE AD M,AD K, DFA, BS8300:2018-2 | FURTHER ACTION/ STATEMENTS WHERE DIVERGENCE FROM |
|---|---|---|---|---|---|
| 4.6.2 | Accessible WC R0.29 Includes the Family Room provision which should be accessible.<br>Family Room facilities should be separate.<br>The combined use of accessible toilets for baby-changing is not recommended. It can limit the availability of a toilet for disabled people, who have the same and often more urgent needs to use a toilet as nondisabled people. Litter can also compromise the health and safety of disabled users and the large waste disposal bin restricts wheelchair manoeuvrability within the cubicle. | | NA | AD M for Wales, 5.5, p64 | Review requirements in developing proposals |

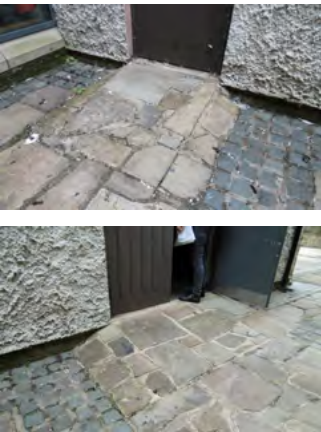
| 4.1.6 | Ramps into Satellite Building R0.52 & R0.53:<br>External ramp has a gradient of 1:6.7 and is non-compliant in terms of gradient and the door swinging over the ramp. | | NA | Approach to entrance<br>AD M for Wales, I.13, p25 | Review requirements in developing proposals |

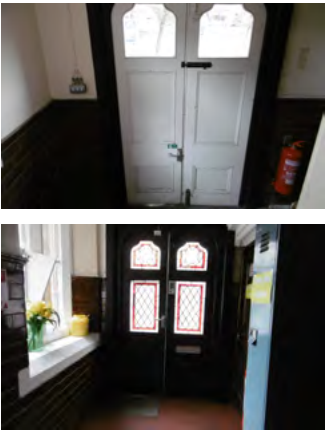
| EXISTING ARRANGEMENT | | ILLUSTRATION | PROPOSALS | GUIDANCE AD M,AD K, DFA, BS8300:2018-2 | FURTHER ACTION/ STATEMENTS WHERE DIVERGENCE FROM |
|---|---|---|---|---|---|
| 4.3.1 | External doors <750mm wide<br>Stair 2 R0.46<br>Stair 3 R0.05 Not compliant | | NA | AD M for Wales 3.10, p43, Table 2, p37<br>Diagram 9, p38 | Check against proposals, should not be used on public routes, or means of escape unless amended to be compliant or non-compliance mitigated. |

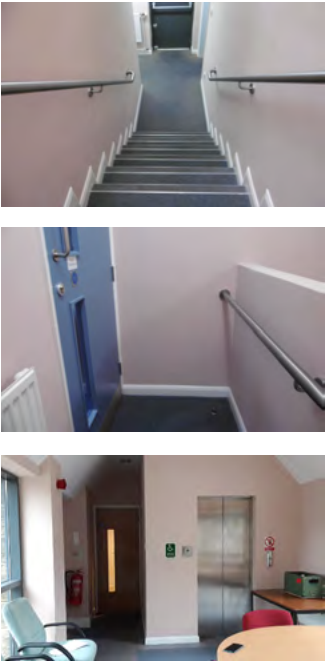
| EXISTING ARRANGEMENT | | ILLUSTRATION | PROPOSALS | GUIDANCE AD M,AD K, DFA, BS8300:2018-2 | FURTHER ACTION/ STATEMENTS WHERE DIVERGENCE FROM |
|---|---|---|---|---|---|
| 4.4.4 | <p>STAIR 4T=260 mm<br/>R=180/ 185 mm x 16 W=1090 mm HRW=890 mm<br/>HRH= 900 mm (internally) HRH= 900 mm (externally)<br/>It is assumed that this stair was compliant with regulations when constructed, but are now no longer compliant with AD K &amp; AD M.<br/>The refuge space is outside the protected lobby (Currently adjacent to lift in R1.21).<br/>Ground Floor exit door discharges to a non- compliant ramp.</p> | | | <p>AD B for Wales Table 4, p59<br/>5.7-5.9, p71<br/>Tables 20 &amp; 21, p 72 - 73<br/>AD K for Wales 1.3, p10 Table 1, p10<br/>AD M for Wales 3.51, p51 (1.33, p30)<br/>1.19 – 1.26, p28<br/>Table 1, p28<br/>Diagram 3, p29</p> | <p>Check against proposals, should not be used on public routes, or means of escape unless amended to be compliant or non-compliance mitigated, eg by management/ fire risk assessment.</p> |

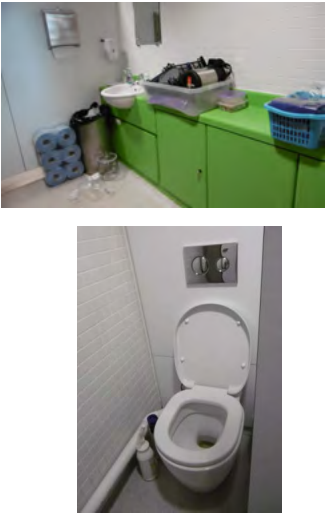
| EXISTING ARRANGEMENT | | ILLUSTRATION | PROPOSALS | GUIDANCE AD M,AD K, DFA, BS8300:2018-2 | FURTHER ACTION/ STATEMENTS WHERE DIVERGENCE FROM |
|---|---|---|---|---|---|
| 4.5.5 | Café Staff Area<br>No provision for staff requiring wheelchair access | | NA | AD M for Wales, 4.1, p53 4.3, p53 5.10, p65<br>Diagram 18, p67<br>Diagram 22, p72 | Review requirements in developing proposals to ensure inclusive design |

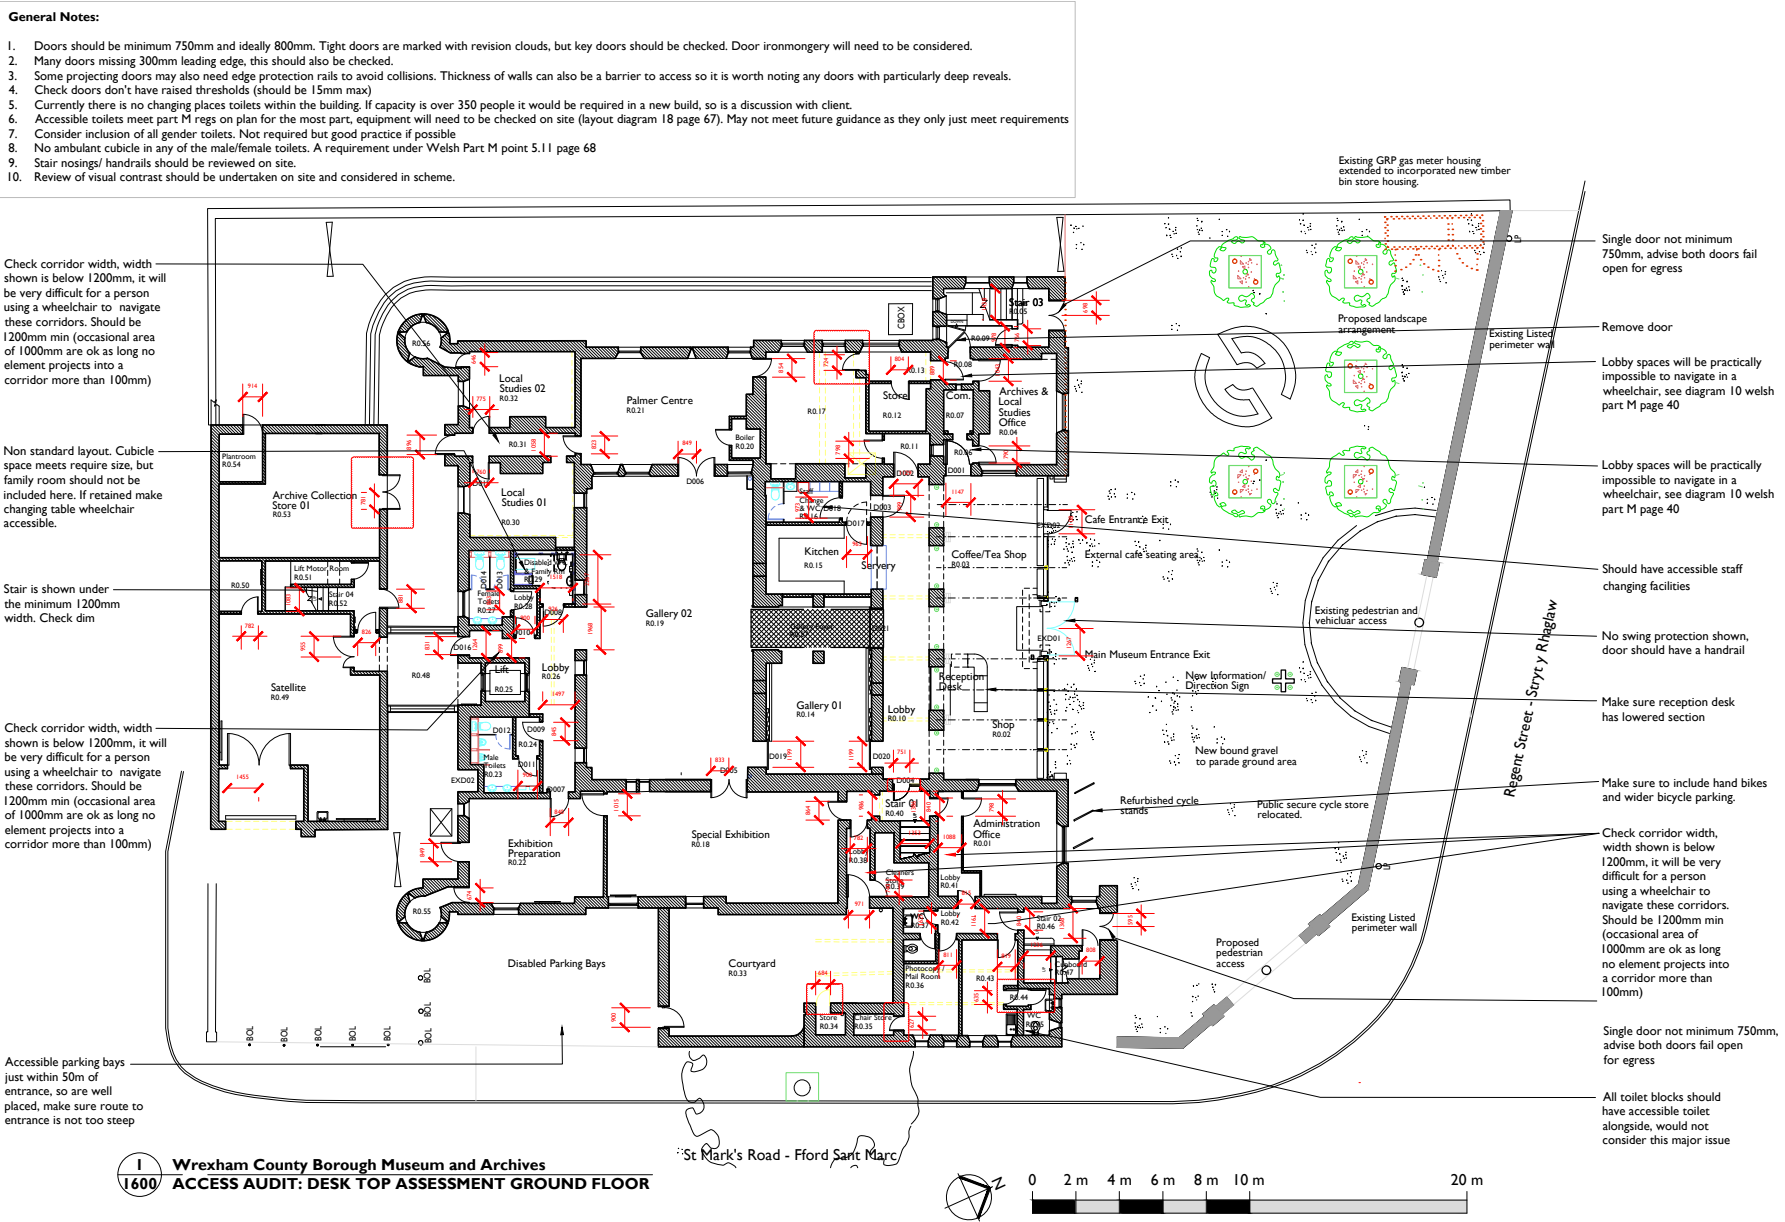
APPENDIX A: DESK-TOP ASSESSMENT OF BUILDING PLANS

1. Doors should be minimum 750mm and ideally 800mm. Tight doors are marked with revision clouds, but key doors should be checked. Door ironmongery will need to be considered.

2. Many doors missing 300mm leading edge, this should be checked.
3. Some projecting doors may also need edge protection rails to avoid collisions. Thickness of walls can also be a barrier to access so it is worth noting any doors with particularly deep reveals.

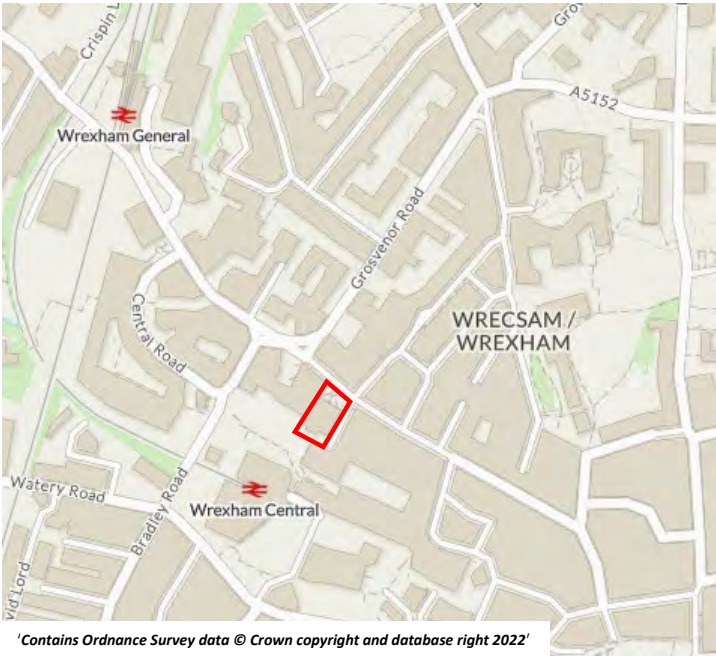
Figure 1 – Site Extent

The site is located at National Grid Reference SJ 33179 50447 and comprises a total area of approximately 0.2ha (see Figure 1).

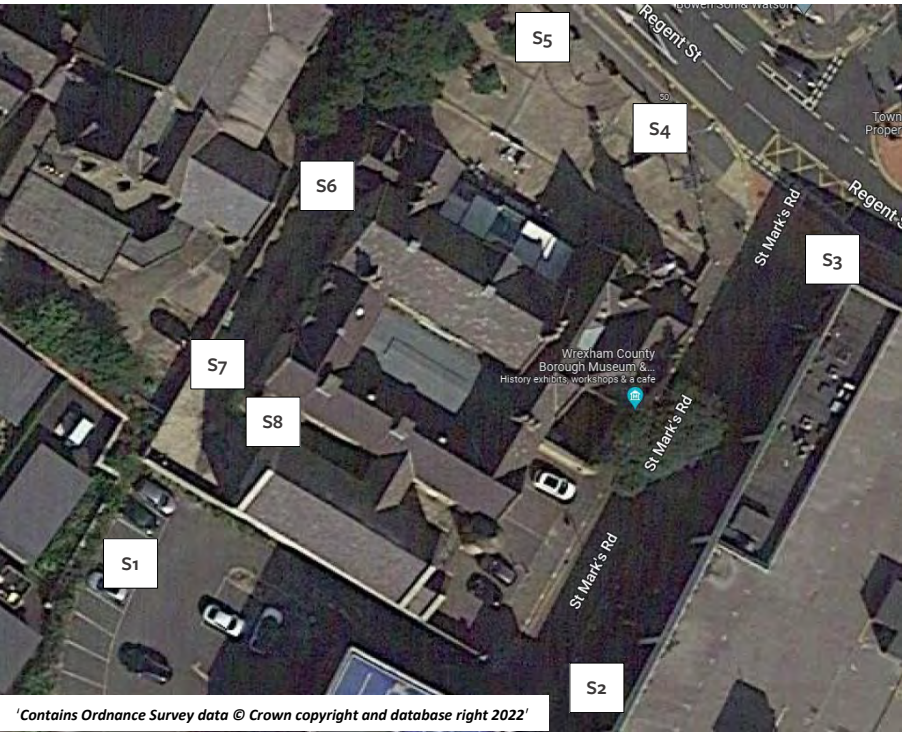
The surveys were conducted using handheld BatScanner bat detectors. Surveyors were positioned around the features to observe the Potential Roosting Features (PRF) identified during the PRA. The emergence survey started at least 15 minutes before sunset and continued until approximately 1.5 hours after sunset. The re-entry survey started approximately 1.5 hours before sunrise and continued until 15 minutes after sunrise.

Figure 2 – Surveyor vantage points

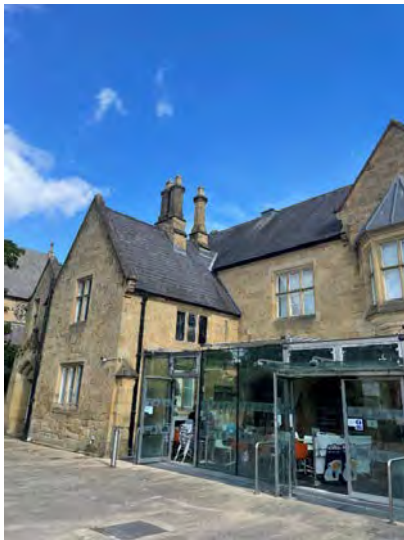
Photograph 1 – Northern aspect of building, looking to east.

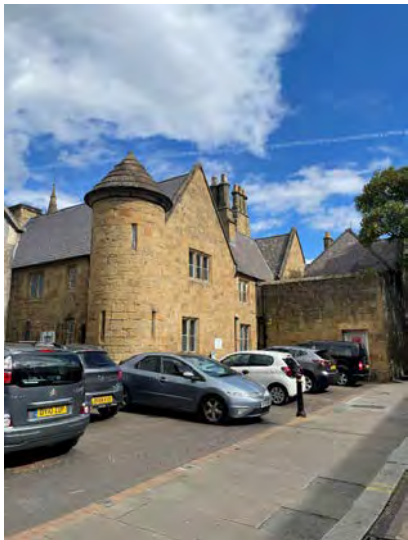
Photograph 2 – Eastern aspect.

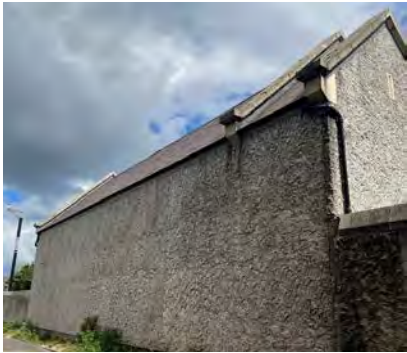
Photograph 4 – Southern aspect

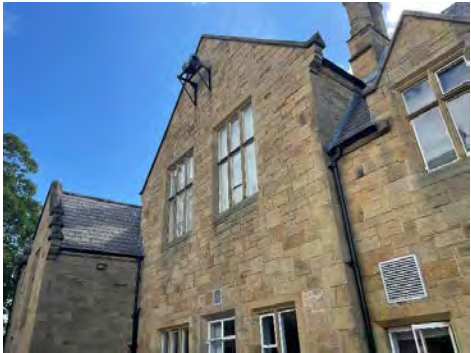
Photograph 4 – western aspect of building showing gable ends

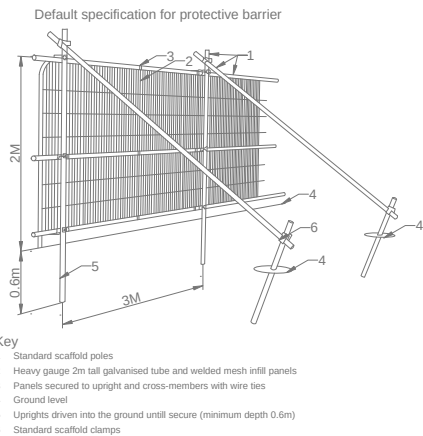
Insert 1: Tree protective fencing specification

Back-stay support

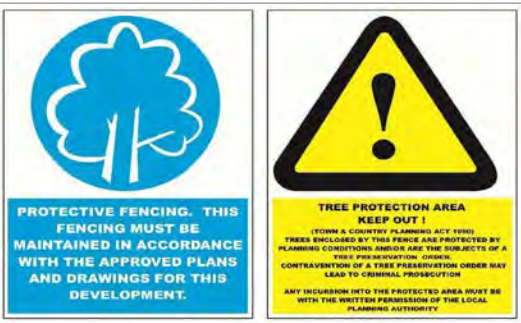
Insert 2: Tree protection notice
