**Heritage Impact Statement for Burton Buildings, Bridge Street,  
Wrexham LL13 7HP**

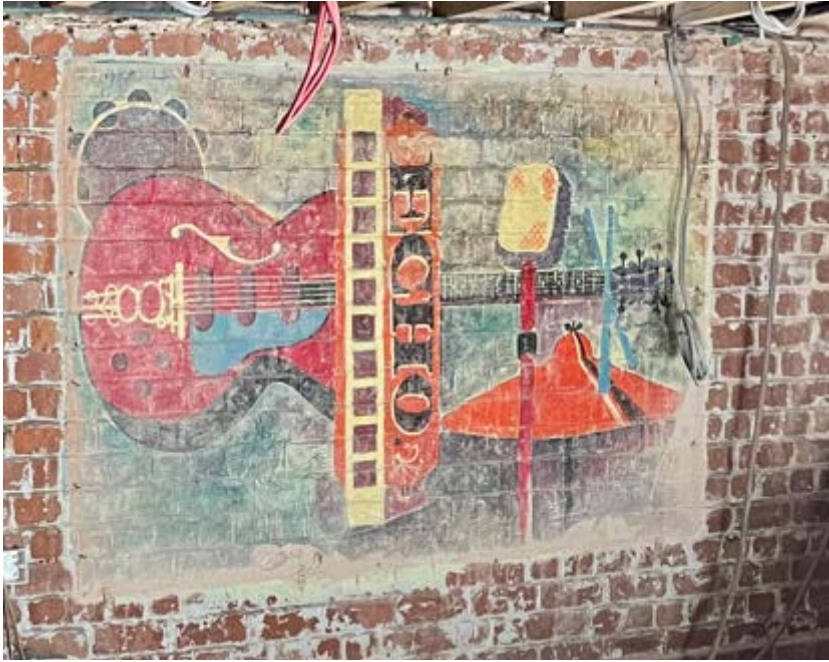
Dazzles Dog Grooming occupied 30 bridge street but has since left in 2020, refurbishment of this shop has now commenced. There is an existing kitchen to the back of the shop which needs renovating. Original pitch pine flooring has been kept and restored. Whilst refurbishing, a wall mural was found. After conversation with locals, it's been advised the unit was the oldest gentleman's club in Wrexham in the 60s or 70s. This will be retained and used as a feature. Our intention for this shop is to preserve the building using its original materials, this has been shown with retaining exposed brickwork and any repairs will be undertaken using lime mortar.

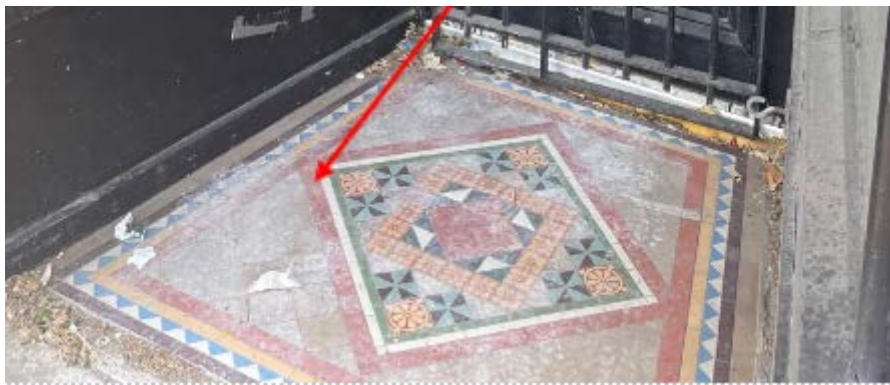
There are mosaic tiles to the front of the building, we have purchased the same age tiles and will be replacing any damage to the original design.

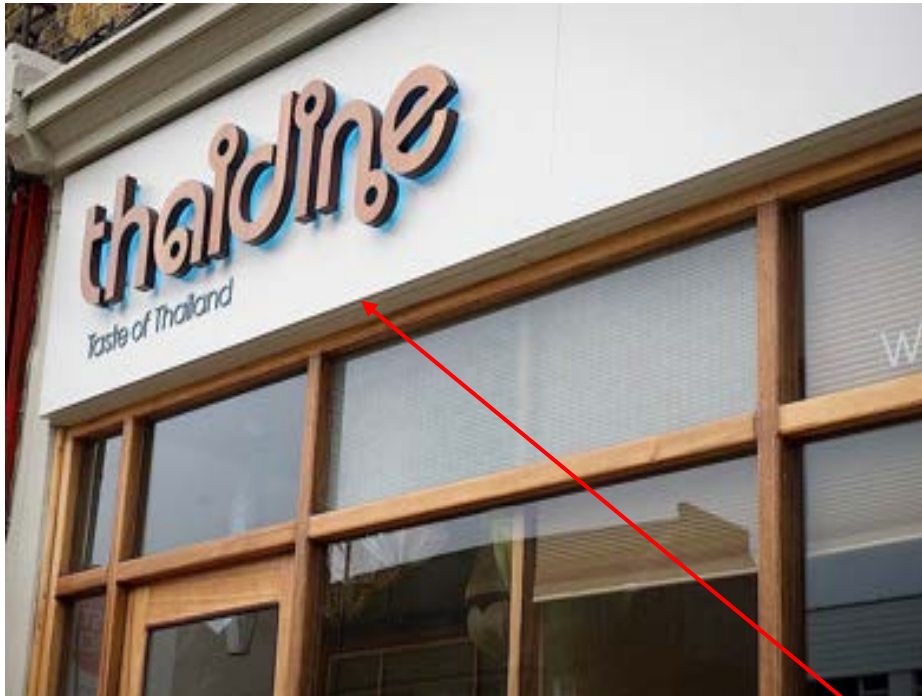
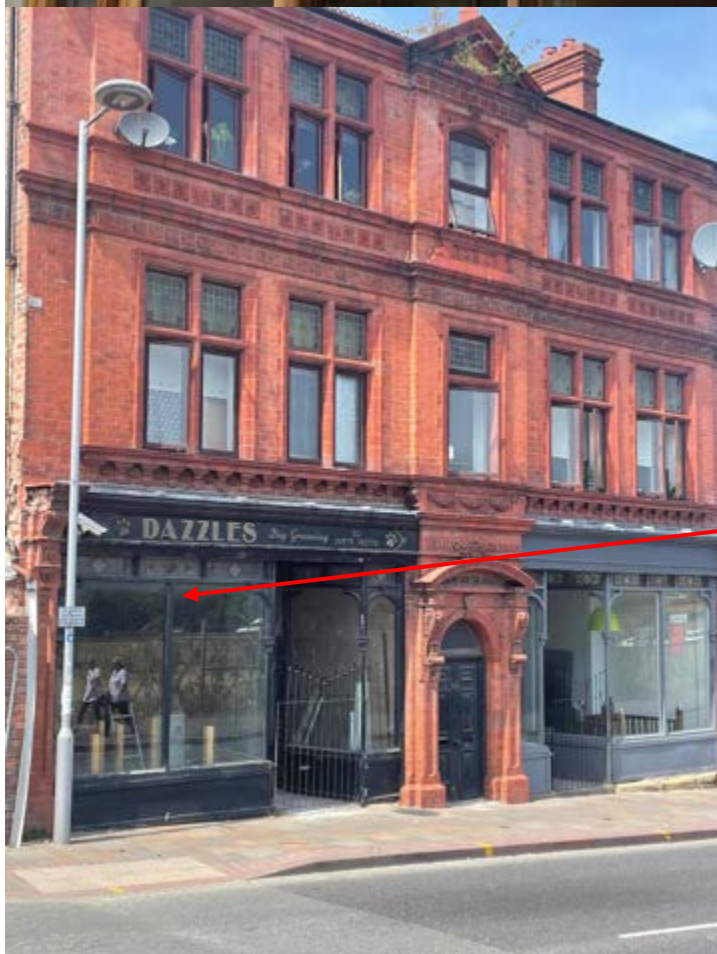
### Shop front and signage

Wording and design will be similar to the photo but will be painted as opposed to letters placed on front.

Intention is to restore shop front with only name change to the top sign to incorporate restaurant name.

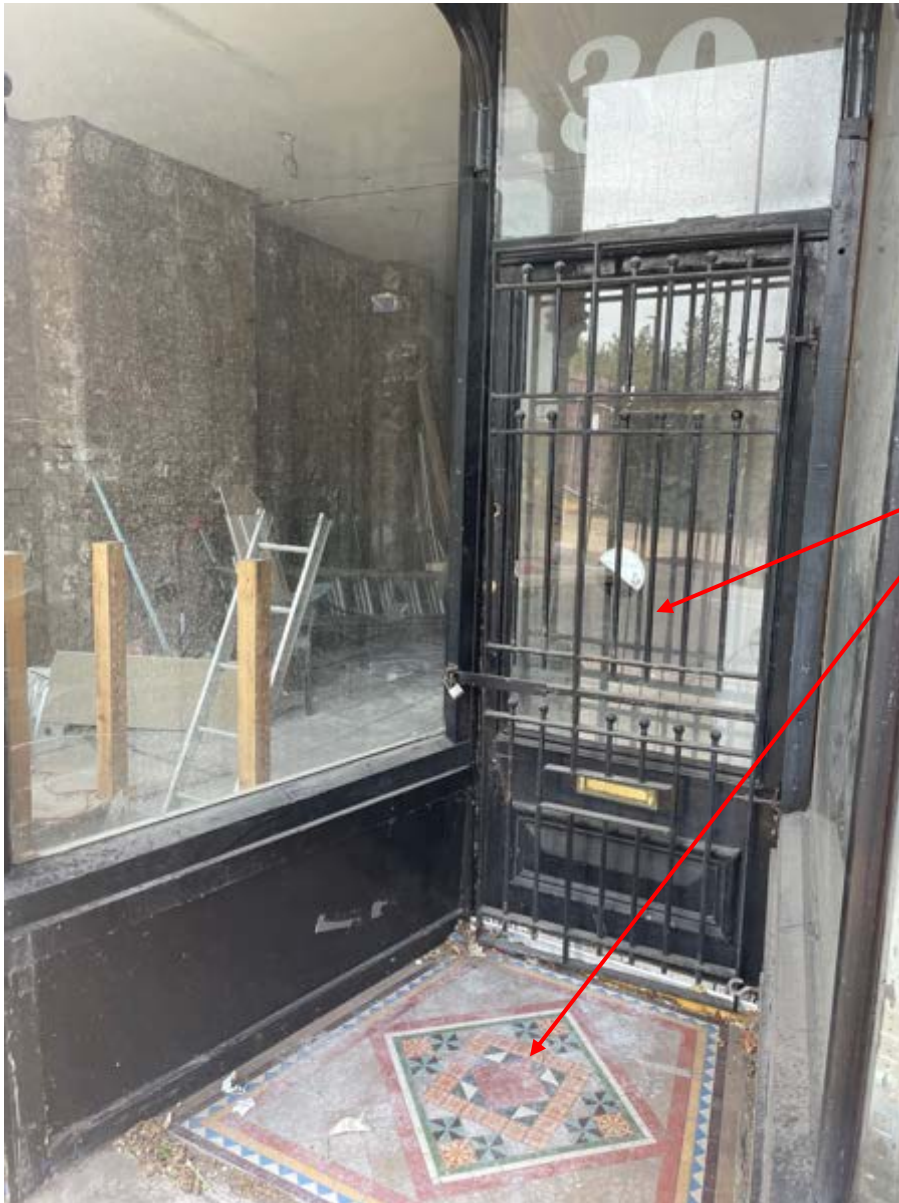
## Doorway

Keeping the original  
door and tiles

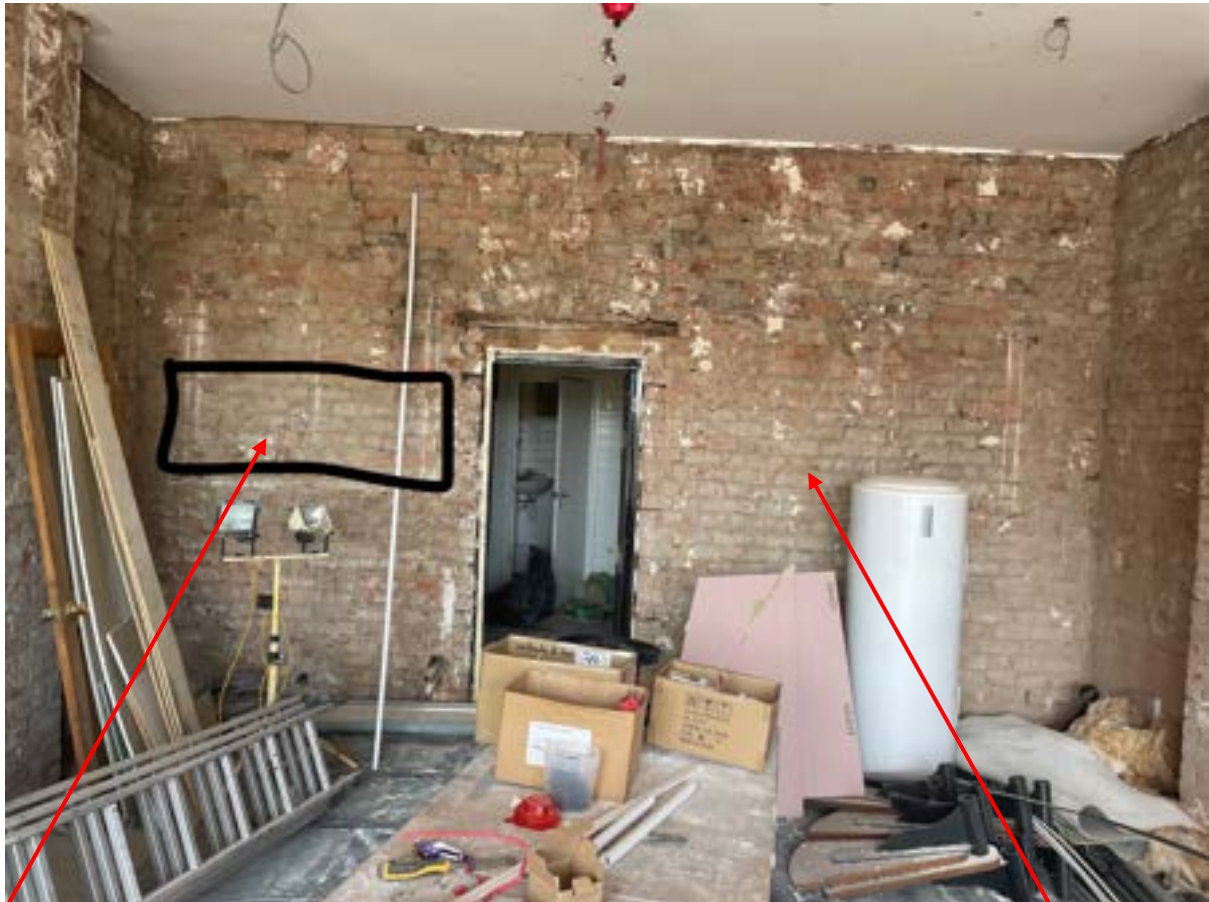
Kitchen area

Window

Bar area

Door to kitchen will remain in the same place with small bar to right side and window to the left side.

Due to the fact that the existing kitchen has no window access we are proposing an internal opening between the kitchen and the proposed restaurant floor. This will be approximately 2ft x 4ft.

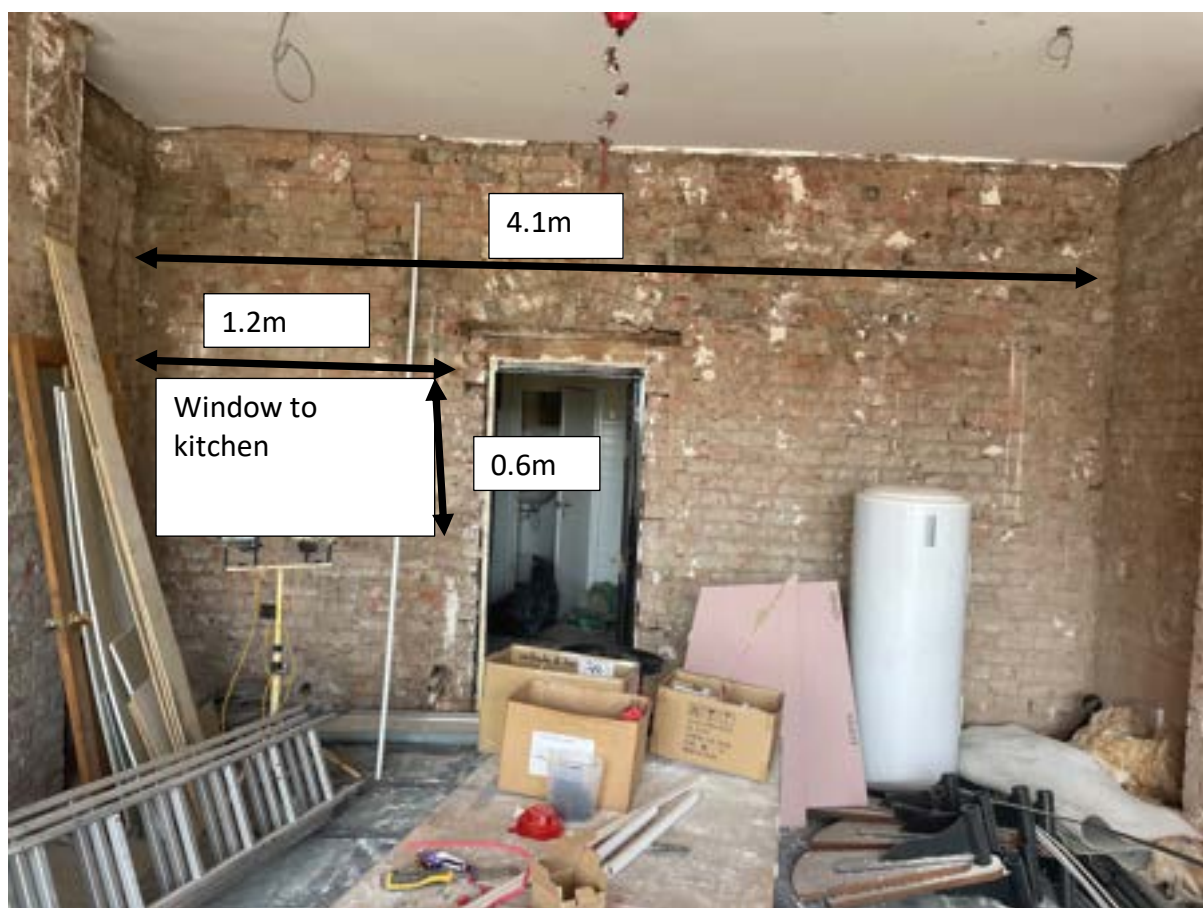
Kitchen area which will require a small hole made at the rear of building for extractor. It may be possible to pipe it through the roof.

The proposed work to the first-floor shop is to have an outlet to the rear of the building for a cooking extraction unit. There will be minimum structural alterations for this as we will be extracting through the existing lean-to roof.

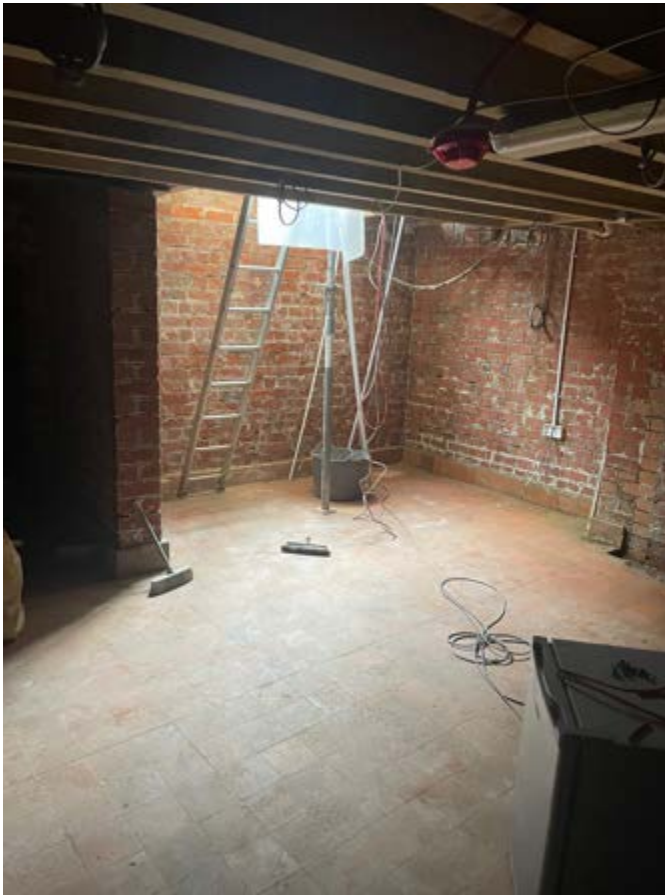
Entrance to toilet door and fire exit

The cellar will be accessed down a spiral staircase, identical to the already refurbished shop next door. There is an existing toilet in the cellar which will need to be upgraded and there is a fire exit through the old cellar access to the back which leads to the hallway for the residential flats.

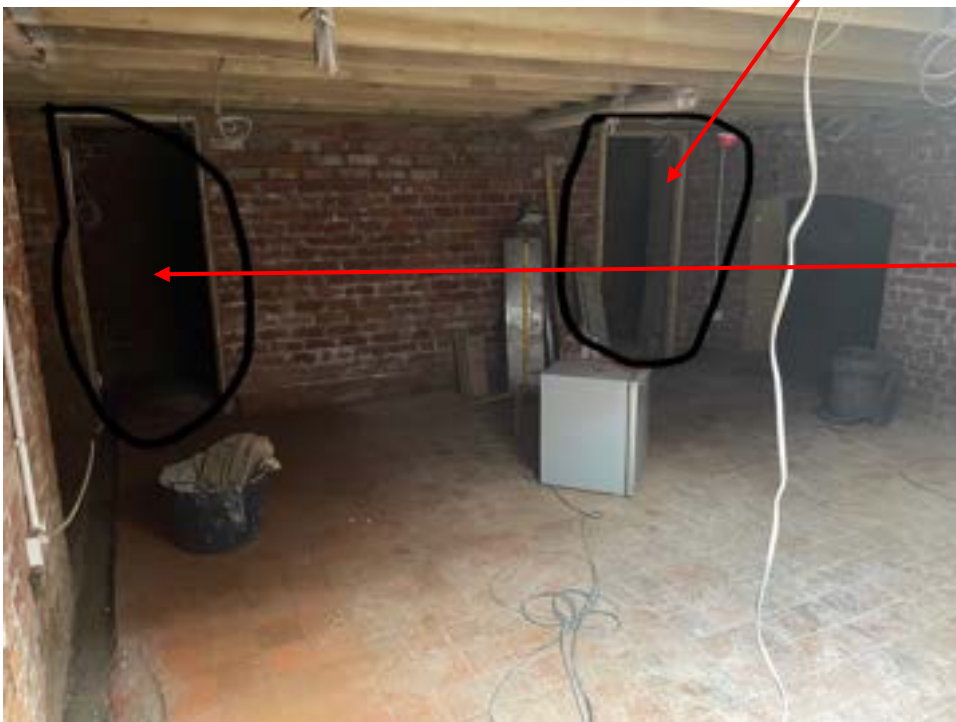
Second toilet door

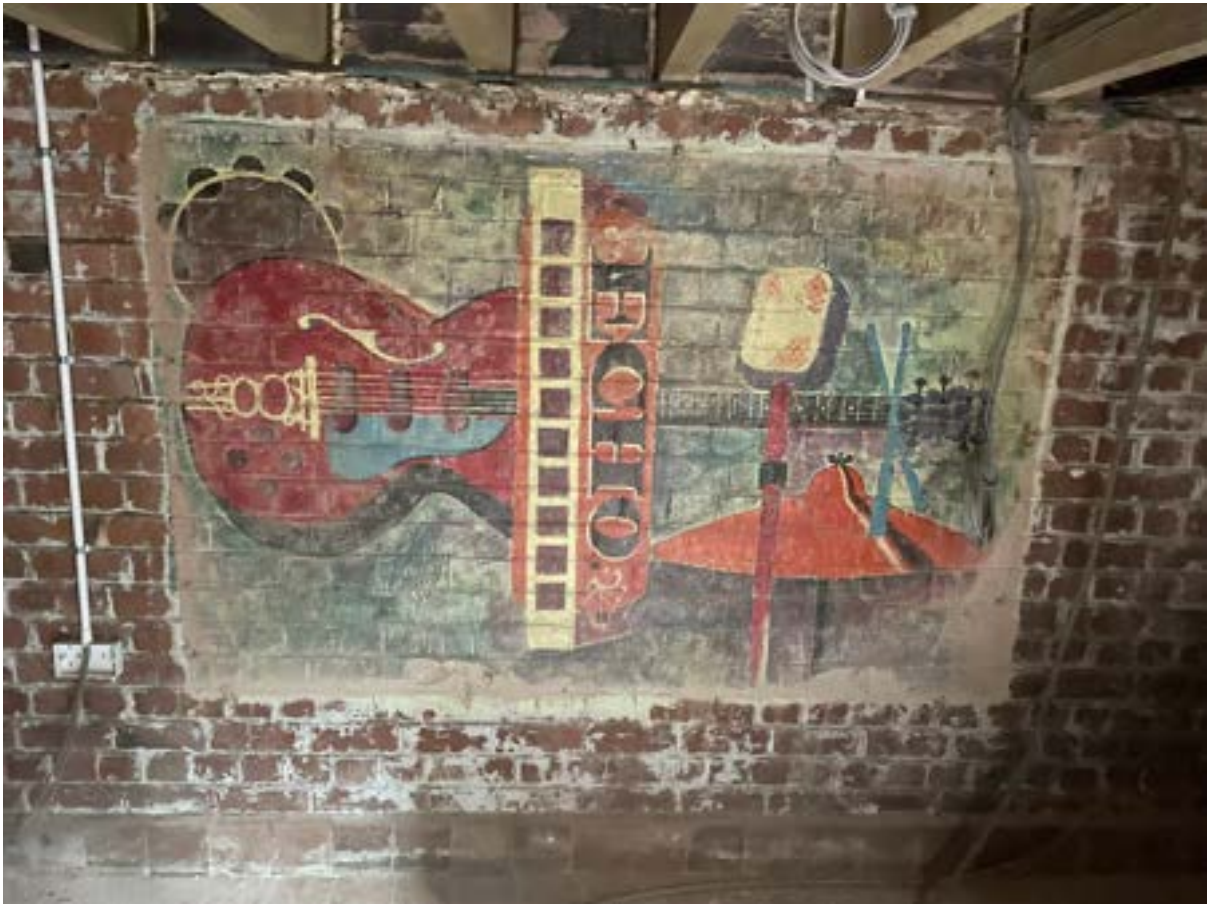
Mural from the original gentleman's club which will be preserved

The building will still have its original layout and detail. Specifically, we are retaining exposed brickwork, pitch pine flooring, the mural, the front windows, signage and any existing doors available.

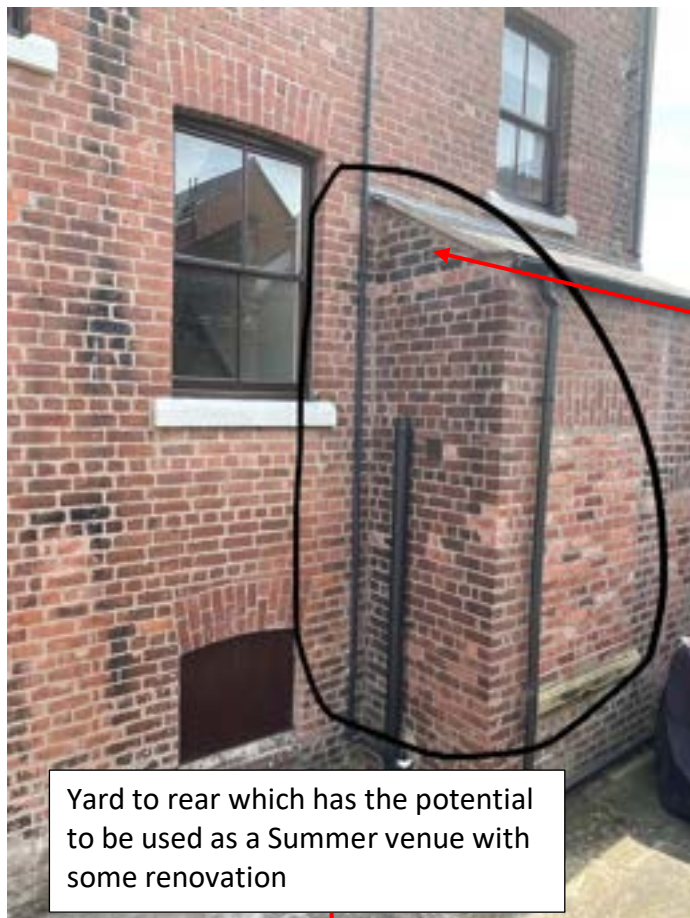
Rear of building for where extractor will be installed
