WREXHAM MUSEUM REDEVELOPMENT  
DESIGN, ACCESS AND HERITAGE STATEMENT  
ISSUE 01  
DECEMBER 2022

# WREXHAM MUSEUM REDEVELOPMENT: DESIGN, ACCESS AND HERITAGE STATEMENT

This Design and Access Statement supports applications for Planning and Listed Building Consent for the Wrexham Museum Redevelopment. The document has been written by Purcell, Architects, Heritage Consultants and Masterplanners. It was commissioned by hsd on behalf of the Wrexham County Borough Council (WCBC). The proposals seek to transform the current museum building into a new ‘museum of two halves’ incorporating a Football Museum for Wales (Amgueddfa Bêl-droed Cymru) and a new museum for Wrexham based on the area’s local heritage and the Welsh Football Collection, where inclusivity, learning, well-being and enjoyment are key priorities.

The Museum is located in the County Buildings, a Grade II listed building, located at the junction of Regent Street with St Mark’s Road to the west of Wrexham town centre. It is a Grade II listed building and sits in the Grosvenor Road Conservation Area at its southern boundary.

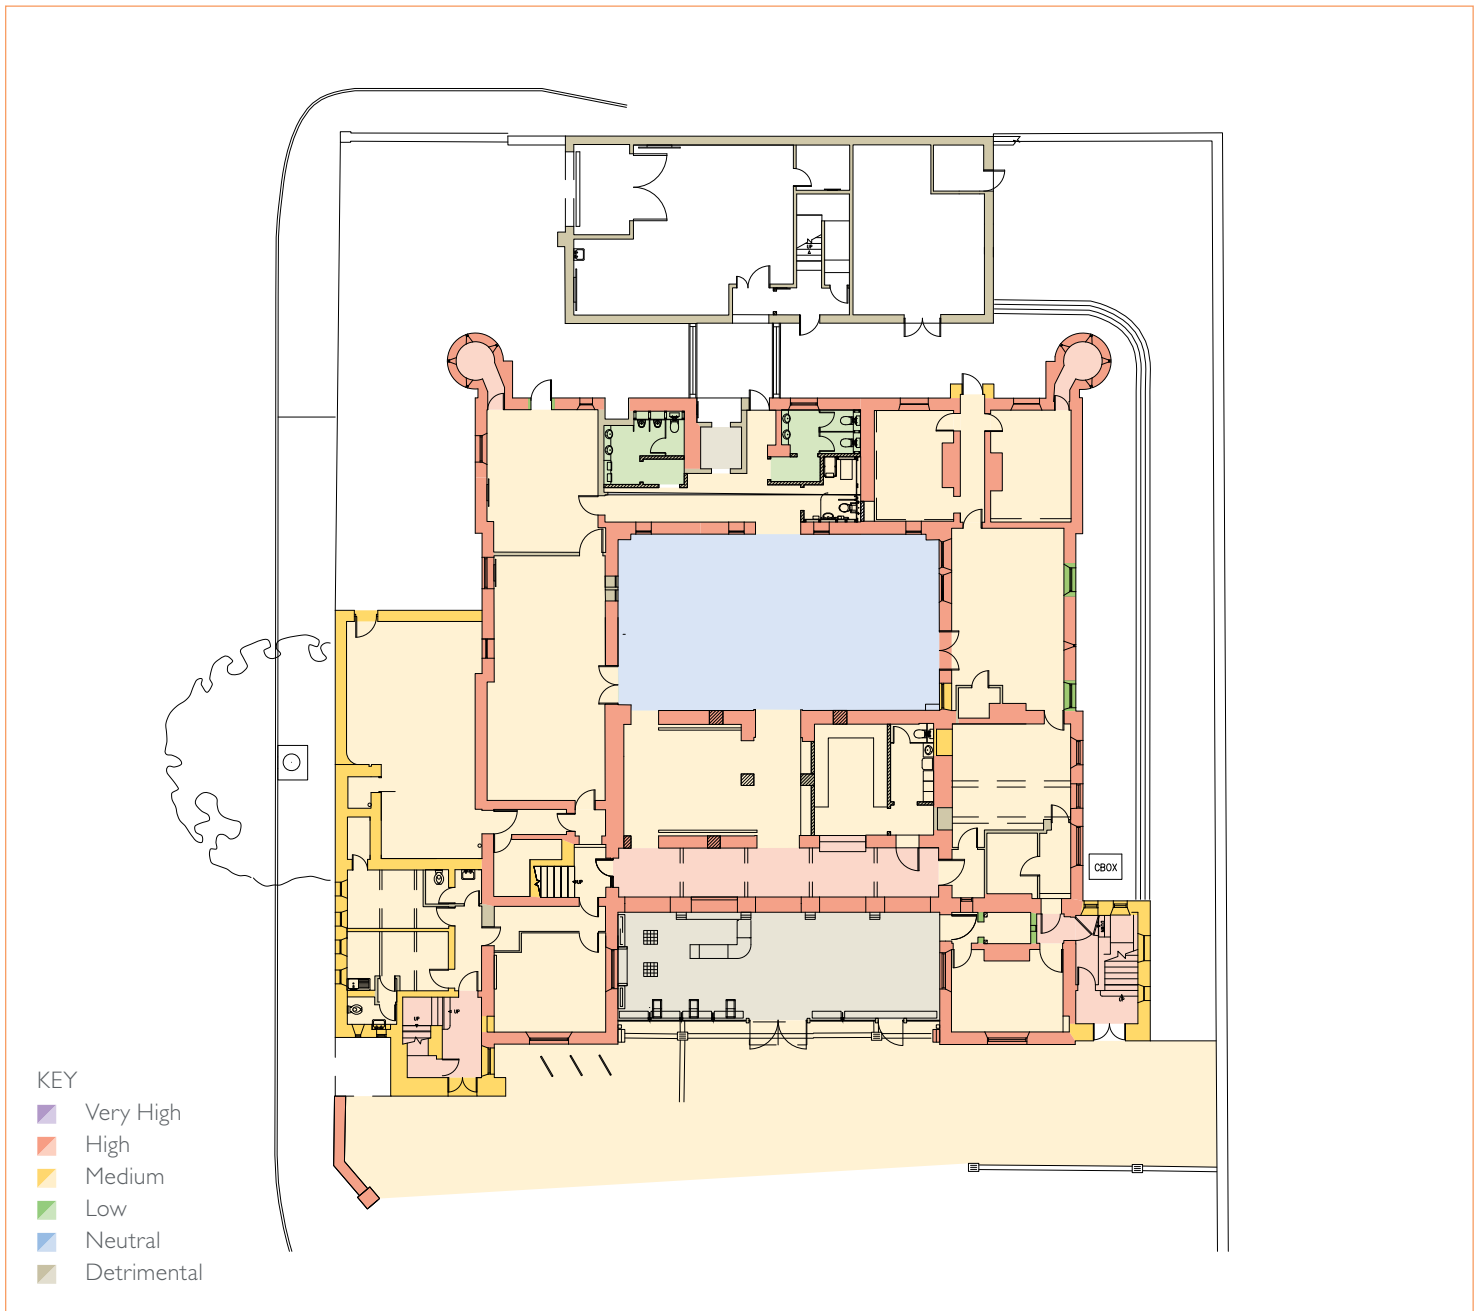
Ground Floor  
Significance Plan

Themes, features or spaces which actually detract from the values of the site and its character and appearance. Efforts should be made to remove these features. The significance plans provide a level of significance for both the physical fabric and the spatial characteristics of internal areas.

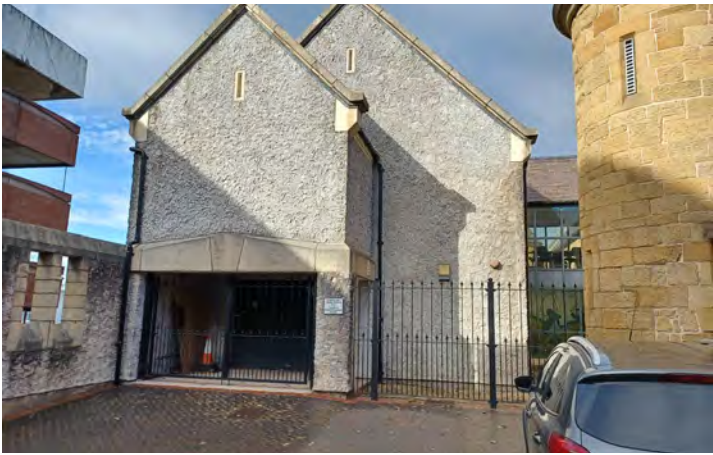
Satellite Building to the rear of the east elevation

In 1997 the 2 storey Satellite building was constructed in a facsimile style with parapet gables slates roof, but with the walls finished in grey roughcast render with reconstituted stone window and door dressings. A 2 storey glazed link was also constructed at the period, located in the position of the opening of the original rear range.

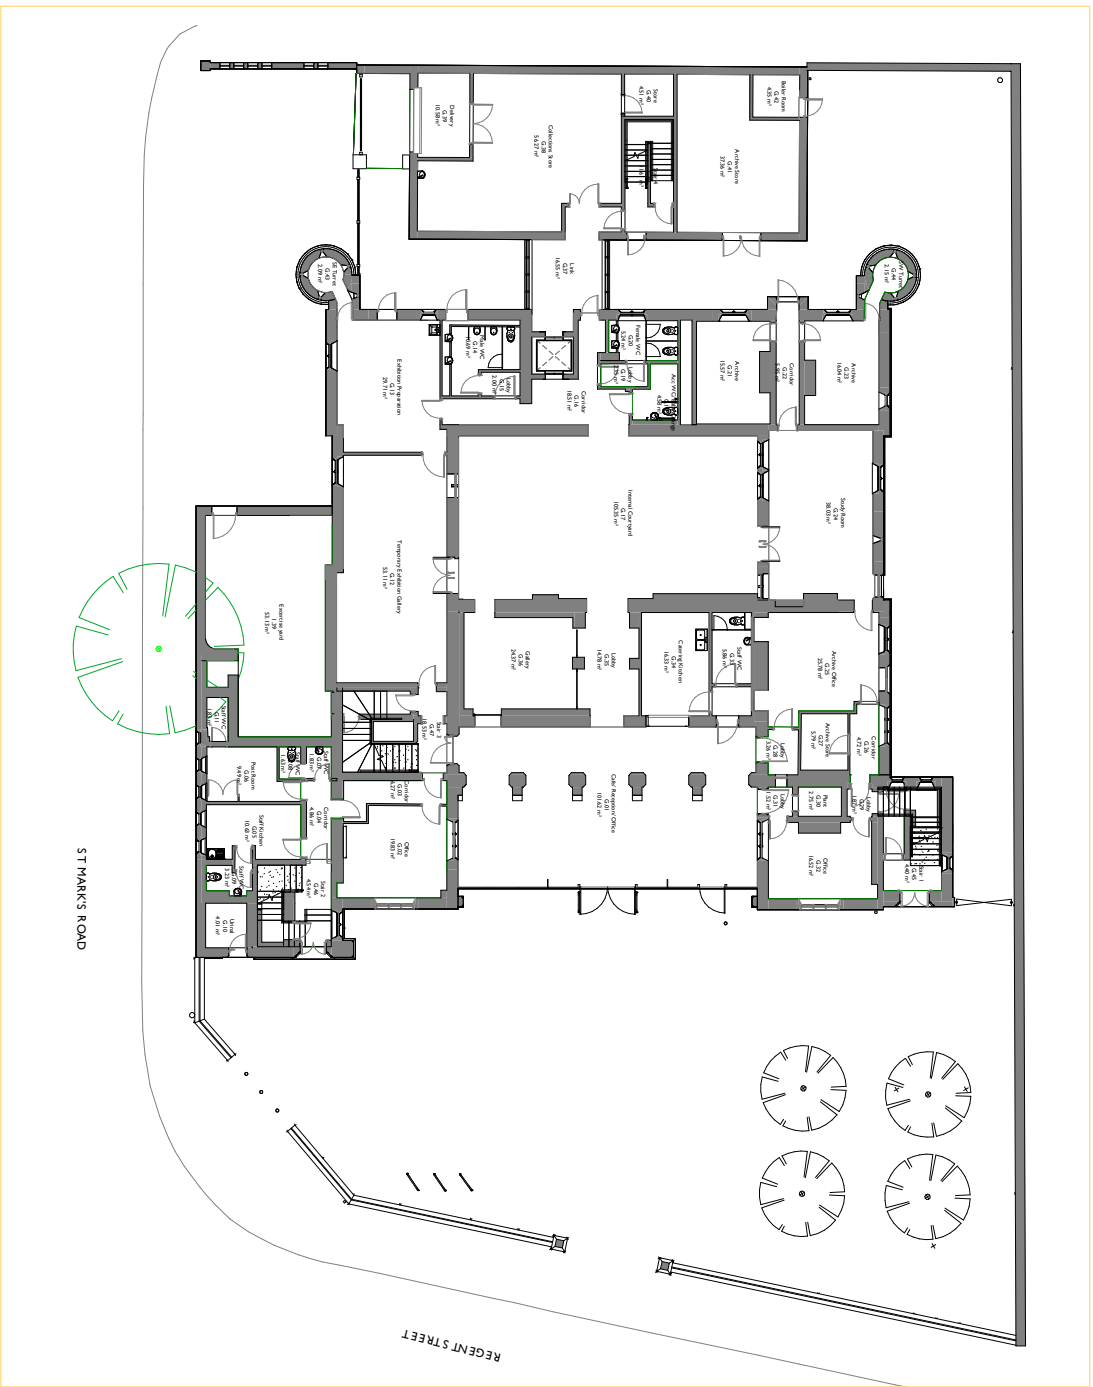
Ground Floor Plan  
Existing

The Satellite building accommodates Collections storage and a small plant room at ground level with further Collections storage, the Collections office and conservation workshop at first floor level. The glazed link provides informal meeting space and breakout activities for children visiting the Museum.

Refer to the existing plans for details of the layout of the existing building. For a detailed breakdown of accommodation refer to the existing Schedule of accommodation in [Appendix I](#).

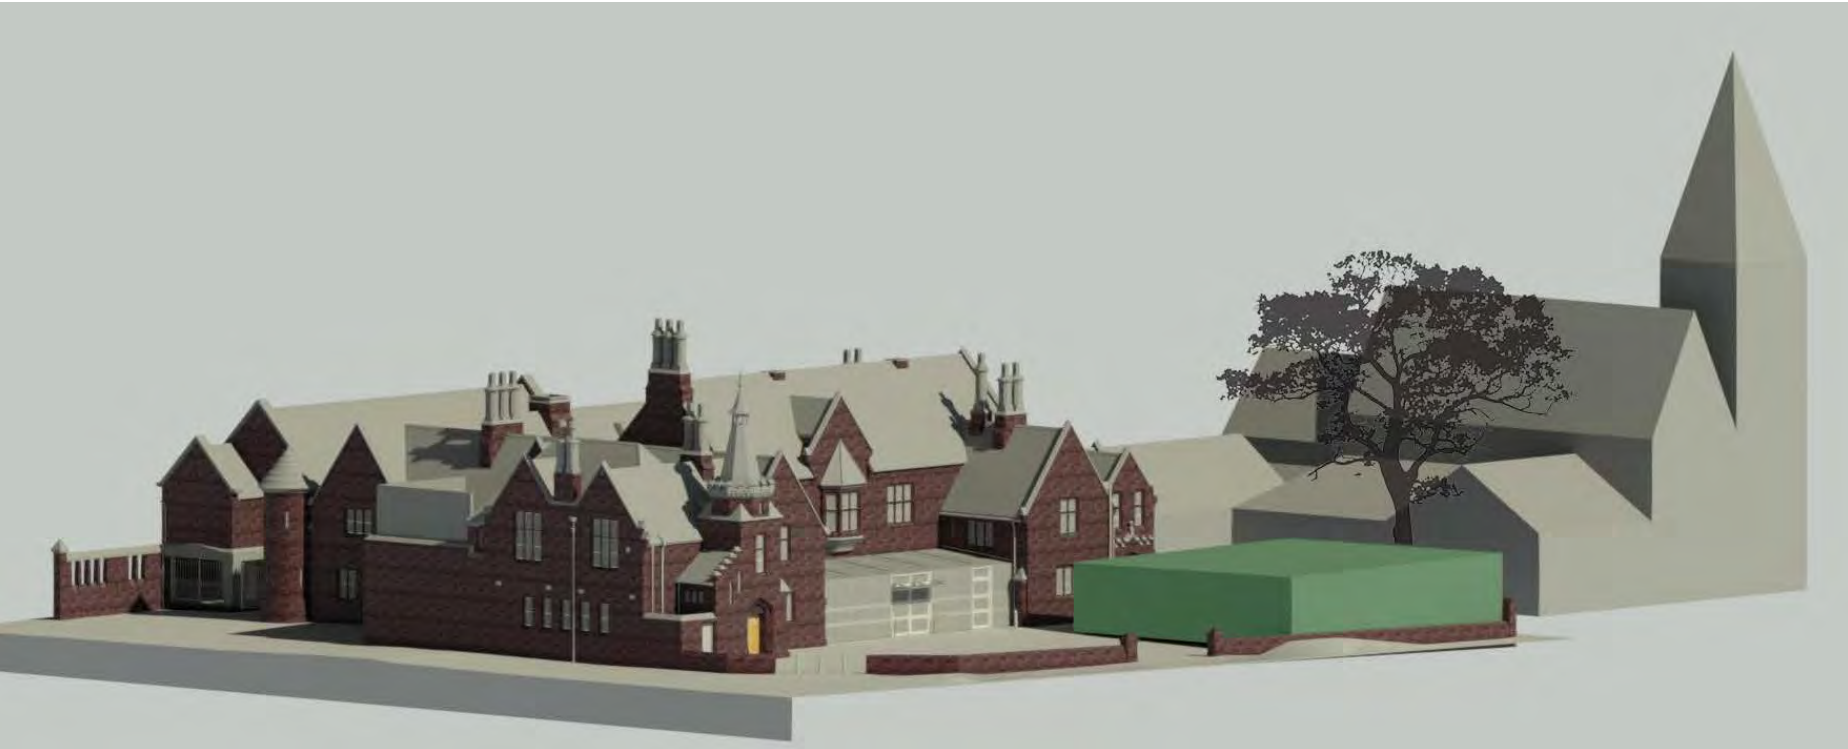
Massing Study Option A

Following this meeting a submission for preapplication advice was made on 27th April 2022 to the planning department and the initial response received 19th May 2022. The proposals for County buildings were generally acceptable but there were some concerns regarding the size and scale of the proposed new building and its impact on the principal facade of the listed building and its impact on the Grosvenor Road Conservation Area. A massing study was undertaken to better understand that impact.

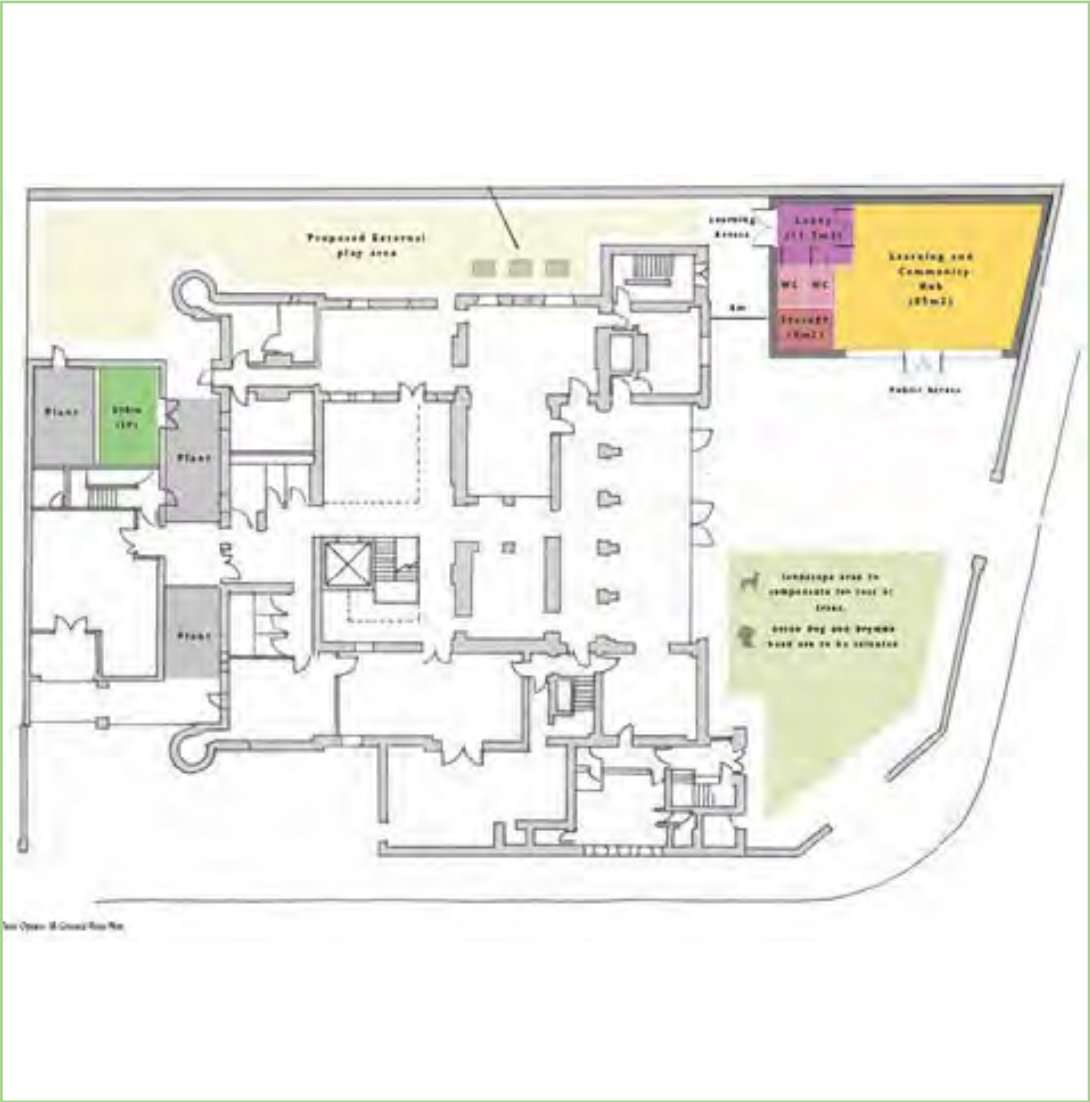
**Option 1B**  
Reduced Area New Building on Forecourt

As part of the discussions further options have been explored for the building on the forecourt and options to extend the Satellite building, as well as the massing study. The solution has been to reduce the proposed accommodation to enable the proposals to fit within the perimeter of the existing building, with the exception of a new external store for furniture and bins at the west side of the frontage.

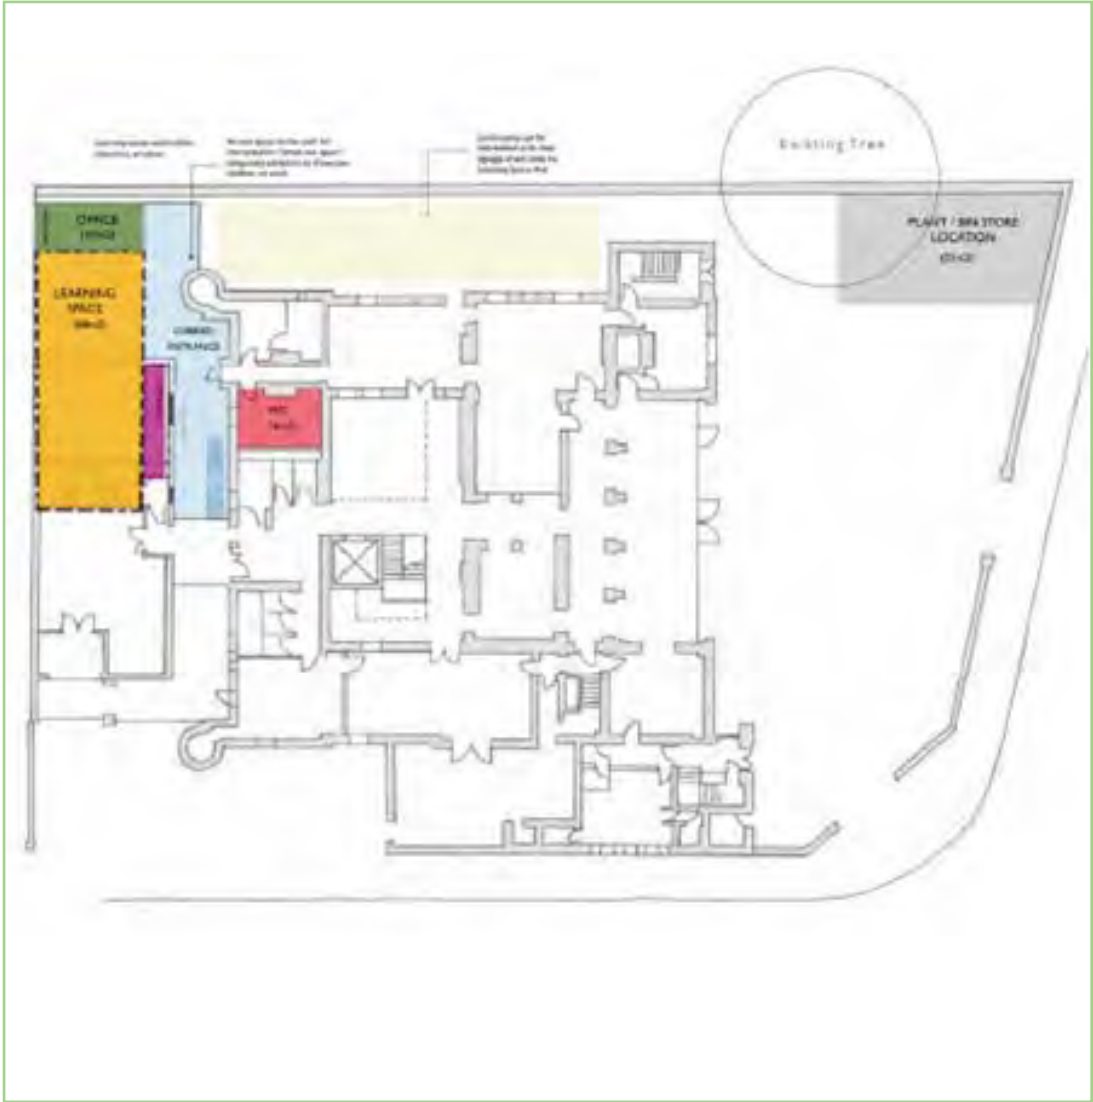
**Option 4**  
Extension of Satellite Building

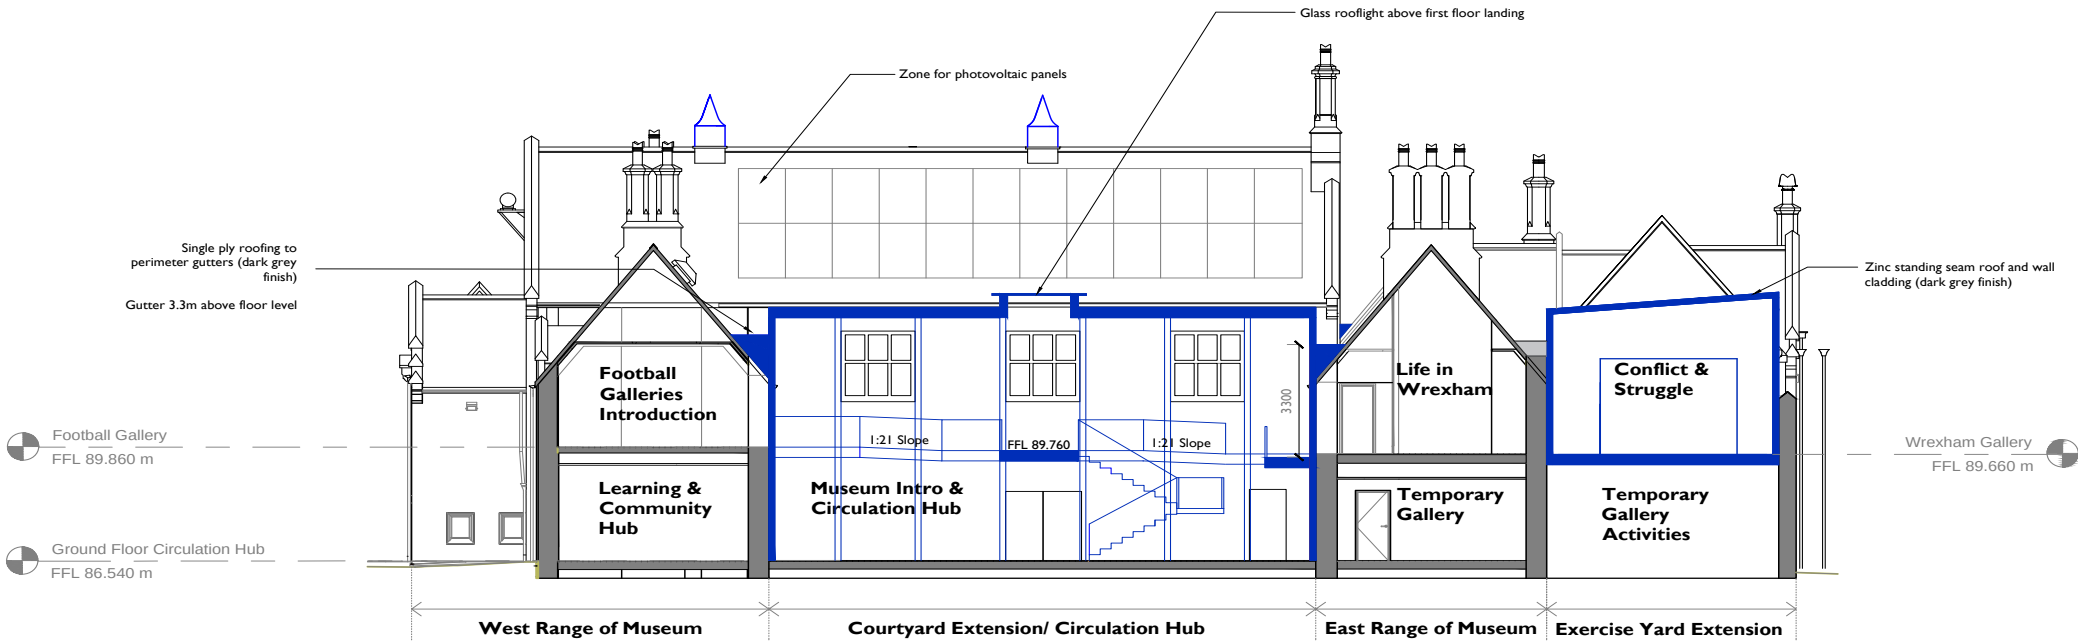
Section 1  
Proposed

The central circulation hub is also two storey and is located in the internal courtyard area. This houses the lift and stair access to the first floor landings and ramps which provide access to the galleries, the staff offices and the first floor of the satellite building. It has a low monopitch roof with a rooflight over the central landing and a ridge height of 8900mm, which is lower than the adjacent ridges. A plant area has been created at loft level as there is insufficient space to locate it within the existing floor plans. This loft will also provide access to the valley gutters around the perimeter of the new roof. This central courtyard currently has a single storey extension located within it.

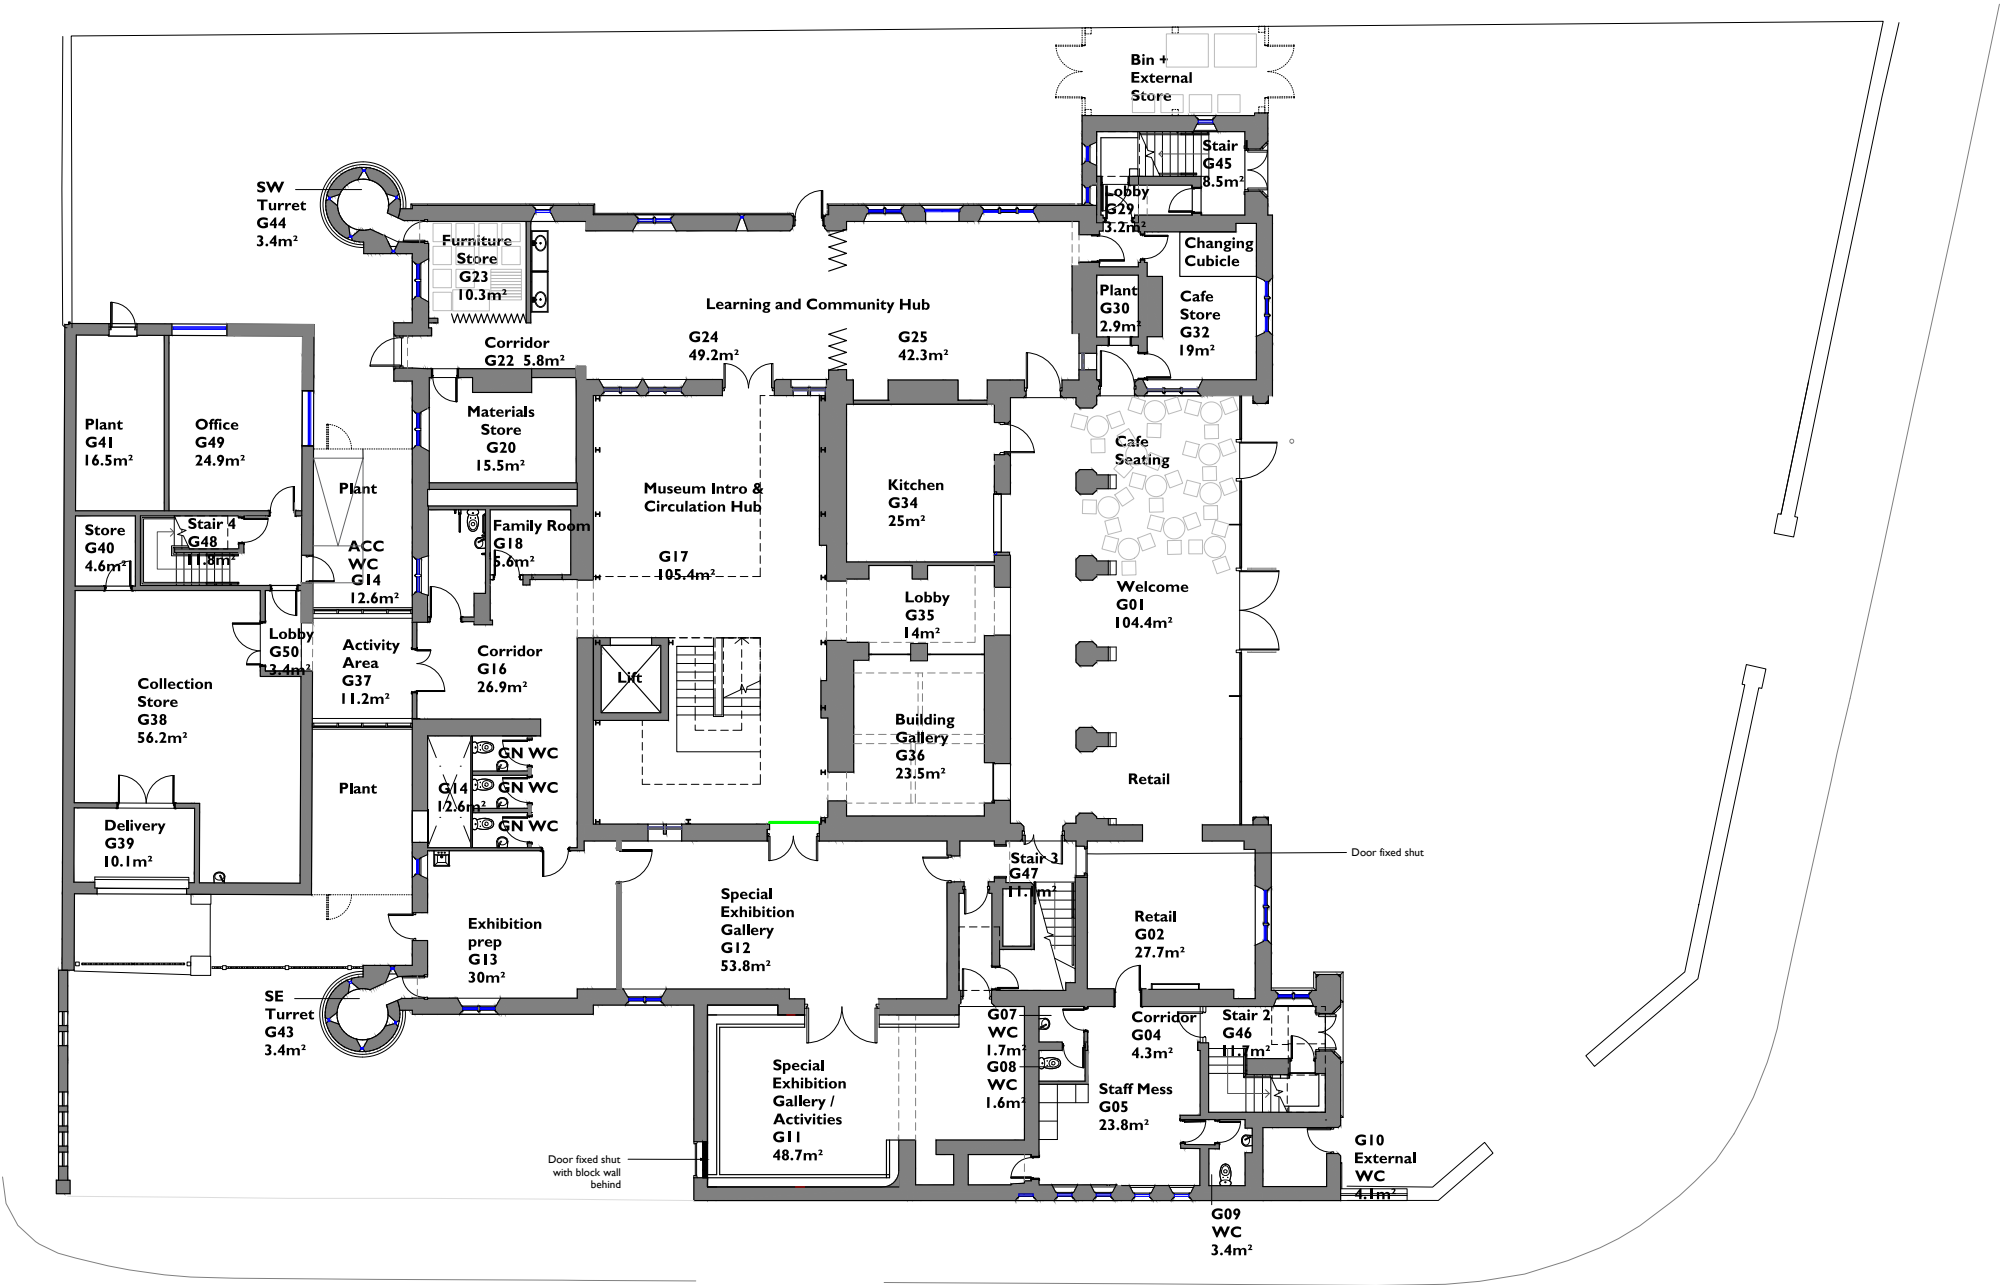
Ground Floor Plan  
Proposed

- A two-storey circulation hub in the location of the original central courtyard. It is hoped that sufficient of the original elevations will remain to enable these to be repaired and expressed as external elevations. (105 m² on 2 floors)
- A two-storey extension in the Exercise Yard to create 53 m² of gallery space to increase expand the Special Exhibition Gallery, and 36 m² of gallery space at first floor level as part of the Wrexham Gallery.

In addition an external covered store of 18 m² is proposed at the west end of the north elevation. This store will re-use the existing decorative gates to secure the frontage and an additional set of metal gates will secure the rear of the area. This will be used for bins and storing loose external furniture.

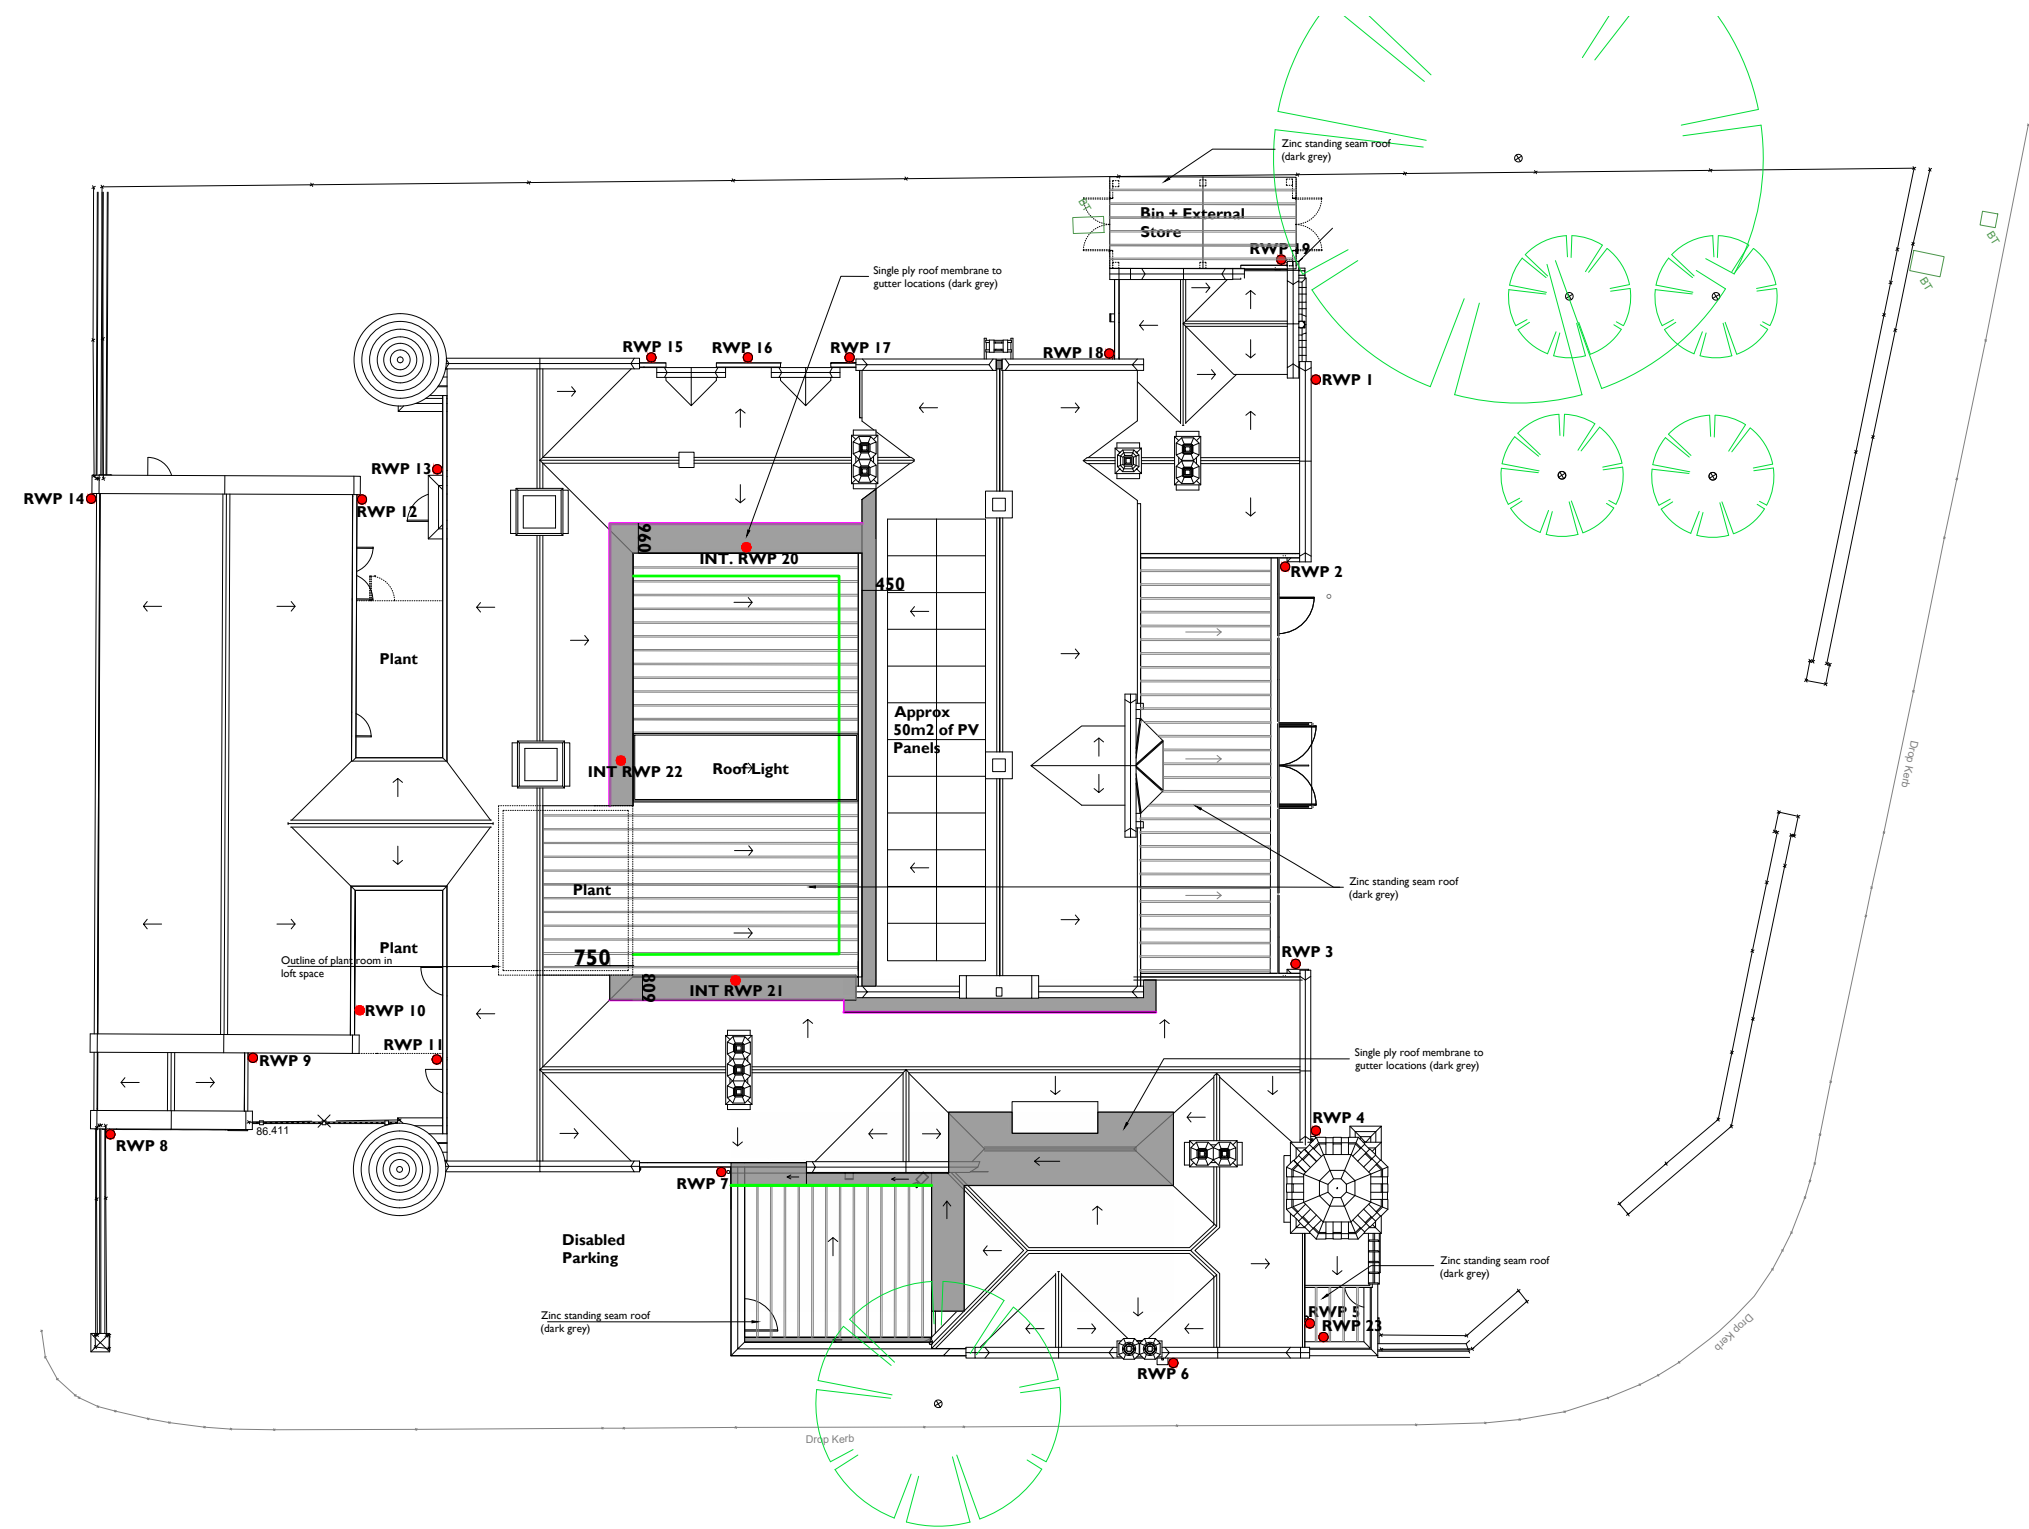
Roof Plan  
Proposed

The external masonry walls and slate roof will be repaired along with the cast iron rainwater goods. The vents to the roof pitch of principal facade will be restored to provide passive ventilation to the football gallery. Some work will be required to the hidden valley gutter to remove the maintenance issue and access for maintenance will be improved. Minor modifications will be required to improve rainwater discharge and a number of the cast iron downpipes will need to be increased in size.

The glass roof to the front entrance extension will be replaced with a low pitch zinc standing seam roof which will reduce solar gain and internal temperature fluctuations and improve the internal acoustics.
