### **HERITAGE IMPACT STATEMENT**

**Project: Porch Replacement**  
**Site: 7 Belgrave Road, Wrexham, LL13 7ES**

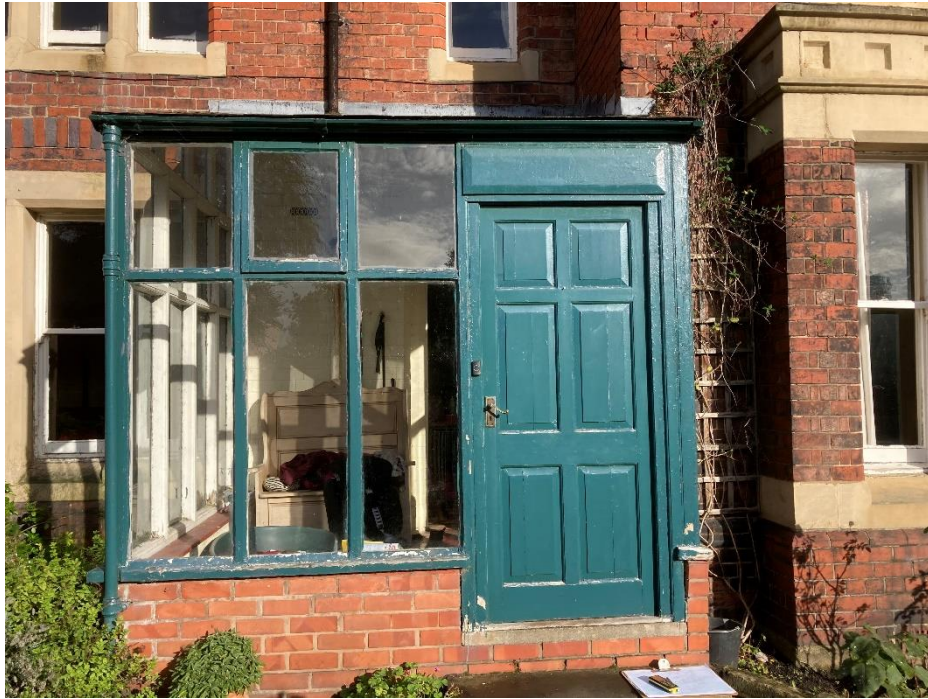
**Figure 3 – Existing Porch**

The front elevation also shows the existing porch, which consists of a green porch door and conservatory styled windows. The roof to the porch is slate and the brick is matching with the rest of the property, being the red brick.

The benefit of replacing the existing porch is as it is in a bad state of disrepair and the porch is not original. The roof tiles are slate and we planning to retain these roof tiles for the replacement porch.

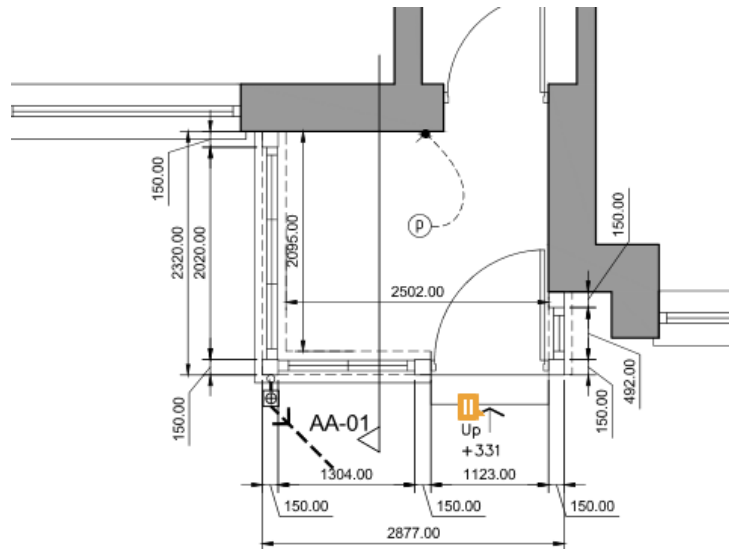
**Figure 5 – Proposed Floor Plan**

The proposals are to replace the existing porch to 7 Belgrave Road. The replacement porch will include canted brick detail, along with brick to match the existing property.

The objective of the replacement porch to 7 Belgrave Road is to provide a water and thermal tight porch. The half-height brick is to be a red brick, commonly used in the surrounding area, which is a Ruabon Red Brick to match the existing property and also the brick detail of canted around the porch under the windows. The windows are to be tall, as per the drawing and the roof is to match the existing porch, which is slate.
