### 1.0 INSTRUCTION

- 1.1 Tree Solutions Ltd has been instructed by Pendine Park Care Organisation to provide an Arboricultural Method Statement (AMS) to satisfy and discharge Planning Conditions 7 of Planning Code No: P/2019/0126. Provision of new specialist & extra care facility at Pendine Park Nursing Home, Summerhill.

# TREE SURVEY SCHEDULE (BS5837: 2012)

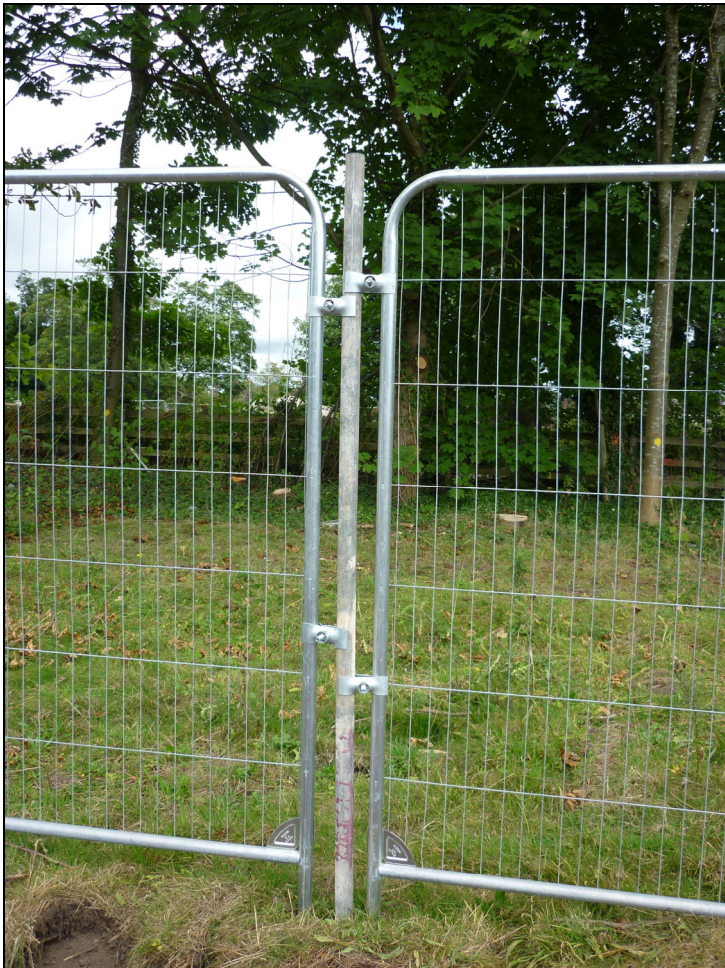
**Tree Protective Fencing Specification**

2.0M high heavy-duty Heras panels (with extra central support bar) mounted on scaffold poles (driven into the ground) and secured with anti-tamper bolts – as illustrated below.

- 2 The fencing will consist of a scaffold framework in accordance with Figure 2 of BS 5837 – 2012 (illustration below) comprising a metal framework, both vertical and horizontal, well braced to resist impacts. Vertical tubes will be spaced at a maximum interval of 3m. Onto this, weldmesh panels shall be securely fixed with wire or scaffold clamps. Weldmesh panels on rubber or concrete feet are not considered resistant to impact and for this reason will not be used. The site manager or other suitably qualified appointed person will be responsible for inspecting the protective fencing daily; any damage to the fencing or breaches of the fenced area will be rectified immediately.

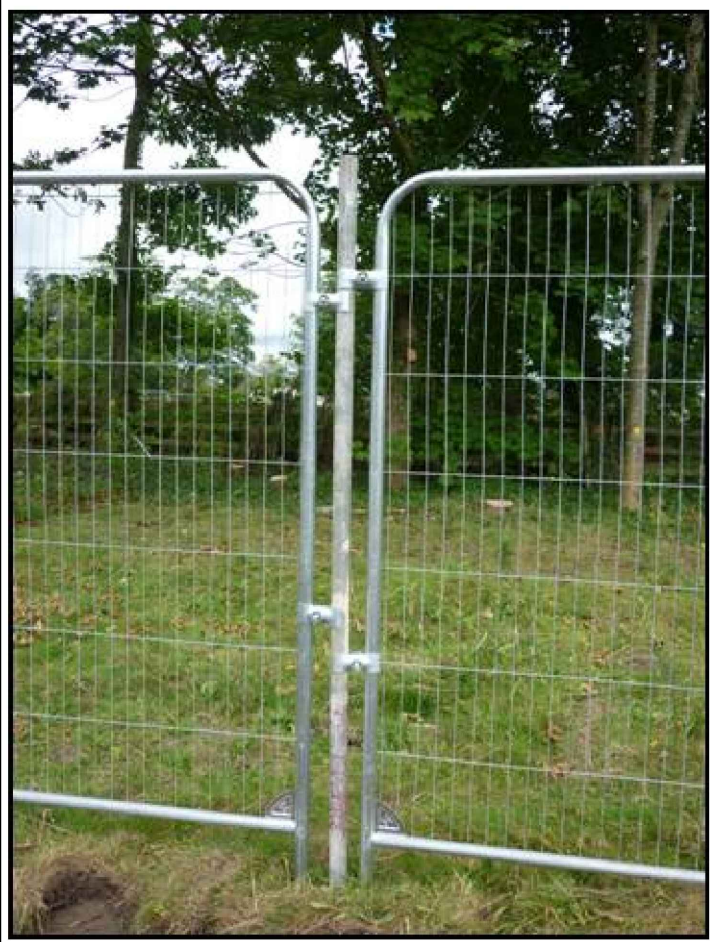
### **Tree Protection Plan**

- 1.4 Trees to be retained and details including the designated Root Protection Area (RPA) and location of tree protective fencing are clearly indicated on the Tree Protection Plan Ref 20/AMS/WXM/263, Drawing No 2 which is at **Appendix 3** to this report.
