## Appendix C: Linesearch and Services

## Bridgeway Centre

Appendix E: Coal Mining Report (*Report Reference 51001490083001*)

# CON29M Non-Residential Mining Report

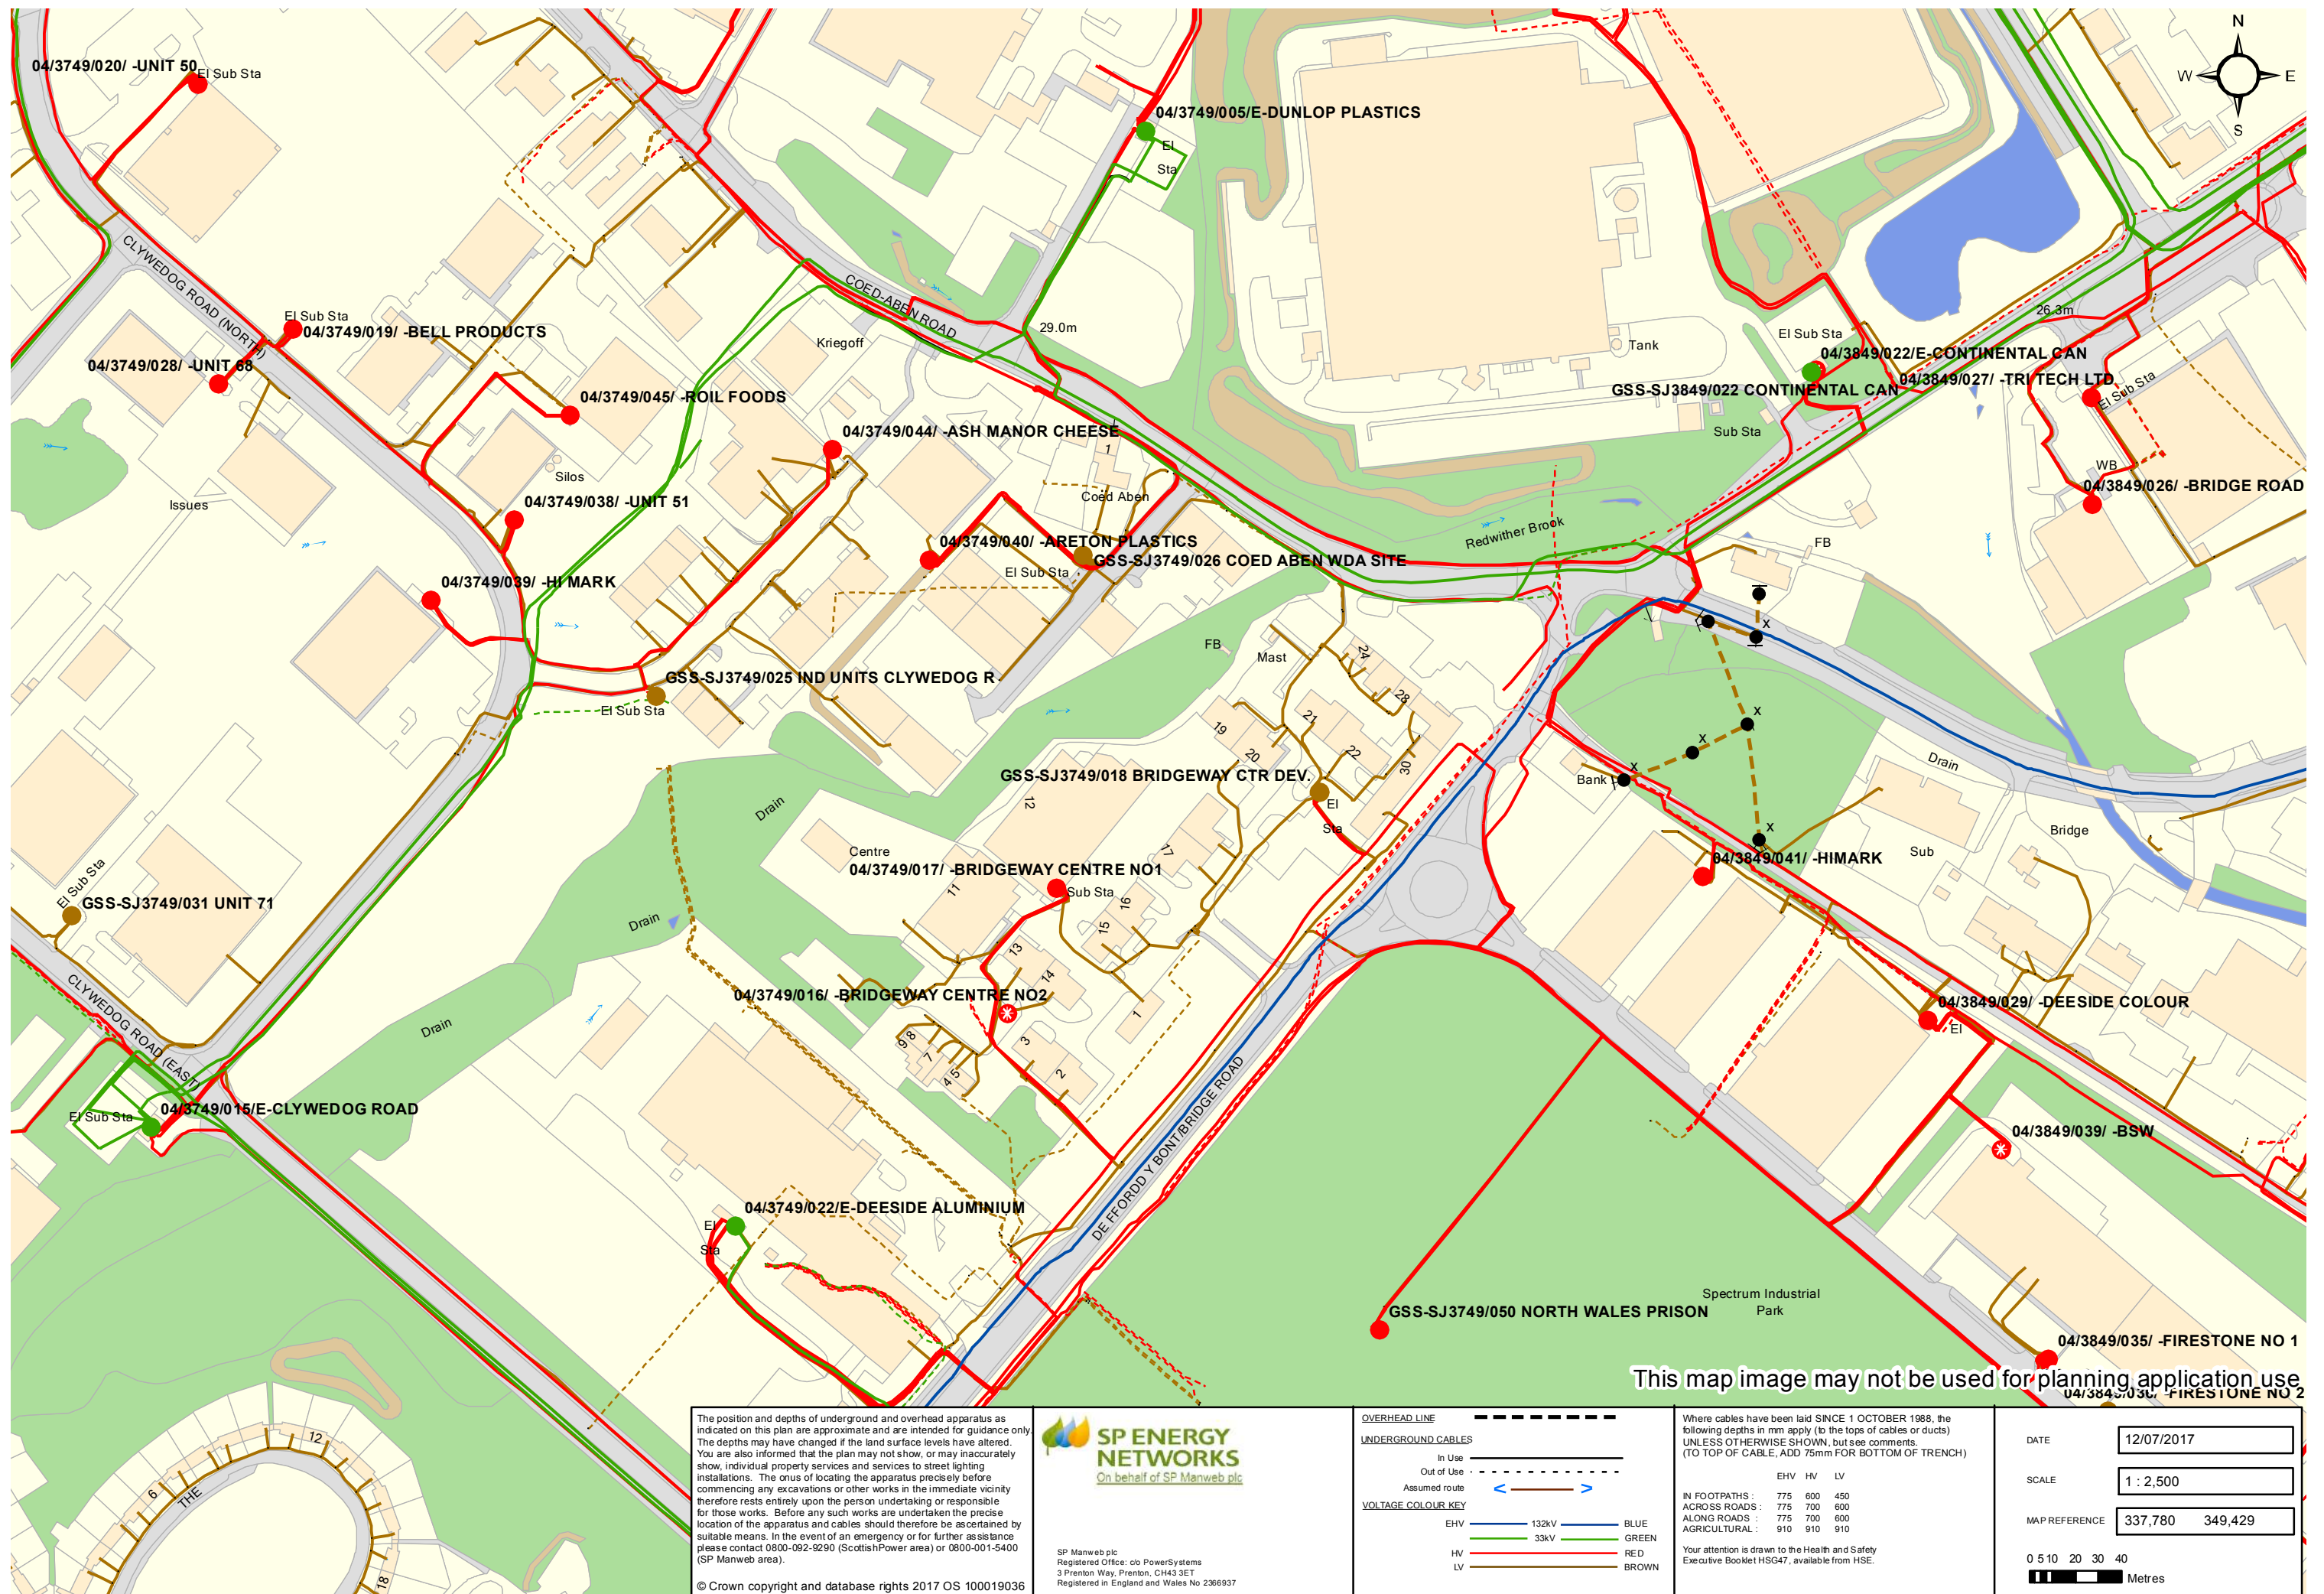
Extreme caution. Major Accident Hazard Pressurised Gas Plant in Vicinity.  
Extreme caution. Major Accident Hazard Pipeline in Vicinity.  
**\*\*RISK OF DEATH OR SERIOUS INJURY\*\***  
Prior to excavation starting you must contact the plant protection team on 02920 278912.

| <div><div><div></div><div></div><div></div><div></div><div></div><div></div></div><div>Low Pressure<br/>Medium Pressure<br/>Intermediate Pressure<br/>High Pressure<br/>Design Pipes<br/>Abandoned</div></div> | | <div><div><div></div><div></div><div></div><div></div><div></div><div></div></div><div>Valve<br/>Depth of Cover<br/>Siphon<br/>Discharge Change<br/>Manhole Change</div></div> <div><div>03060</div><div>Meters</div></div> | | © All MasterMap data is reproduced by permission of Ordnance Survey on behalf of HMSO. © Crown copyright and database right 2017. All rights reserved. Ordnance Survey Licence number 0100044308. |

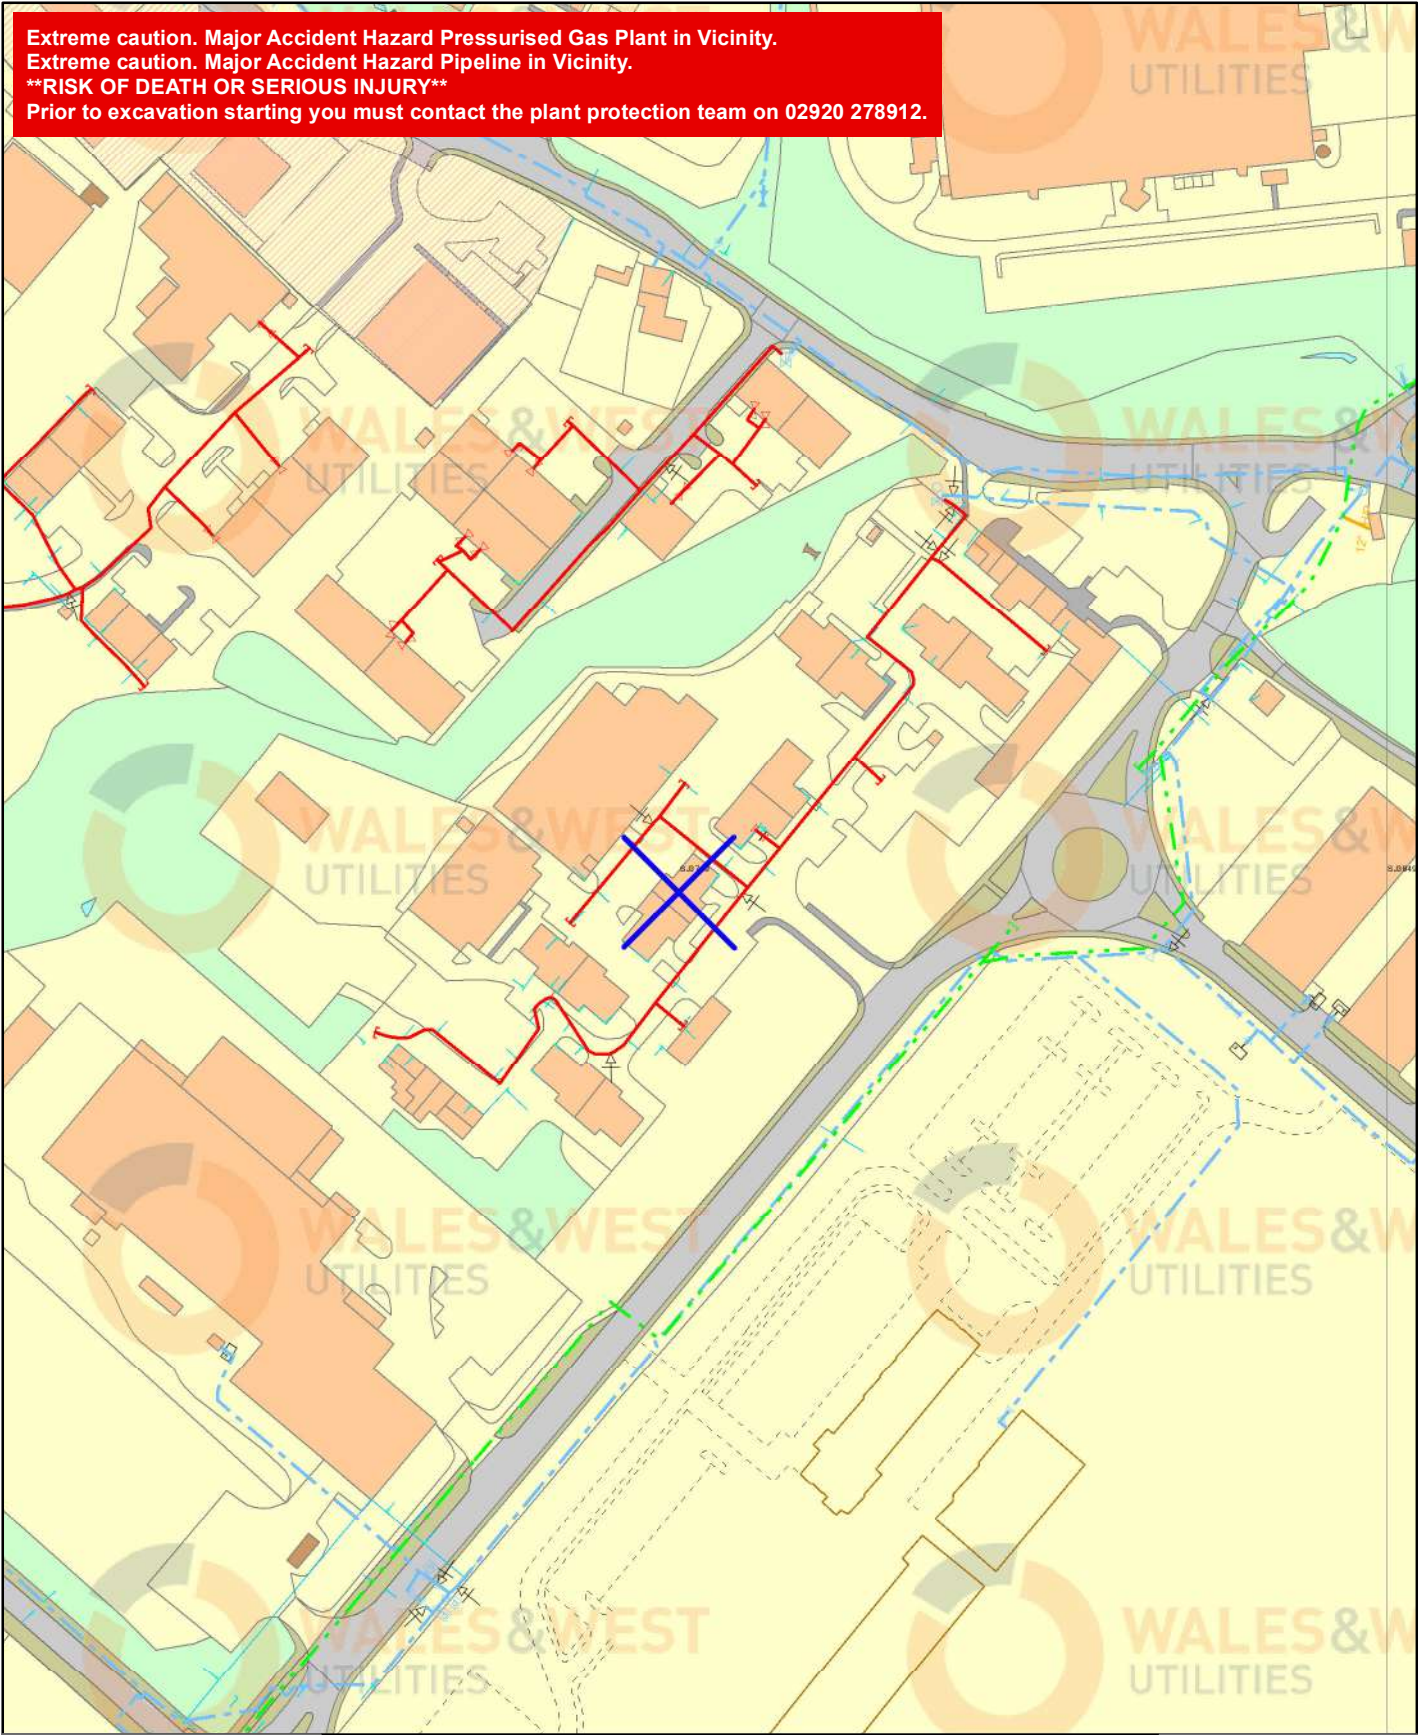
| User ID | martin.pocock@sutcli | The plan shows those pipes owned by Wales & West Utilities (WWU) in its role as a Licensed Gas Transporter (GT). The information shown on this plan is derived from historic information and may have involved re-scaling plans, and the accuracy of it cannot be guaranteed. Service pipes, valves, syphons, stub connections, etc. may not be shown but their presence should be anticipated. No warranties are therefore given in respect of it. WWU its employees and contractors do not accept any liability for any inaccuracy or incompleteness in it. | | |

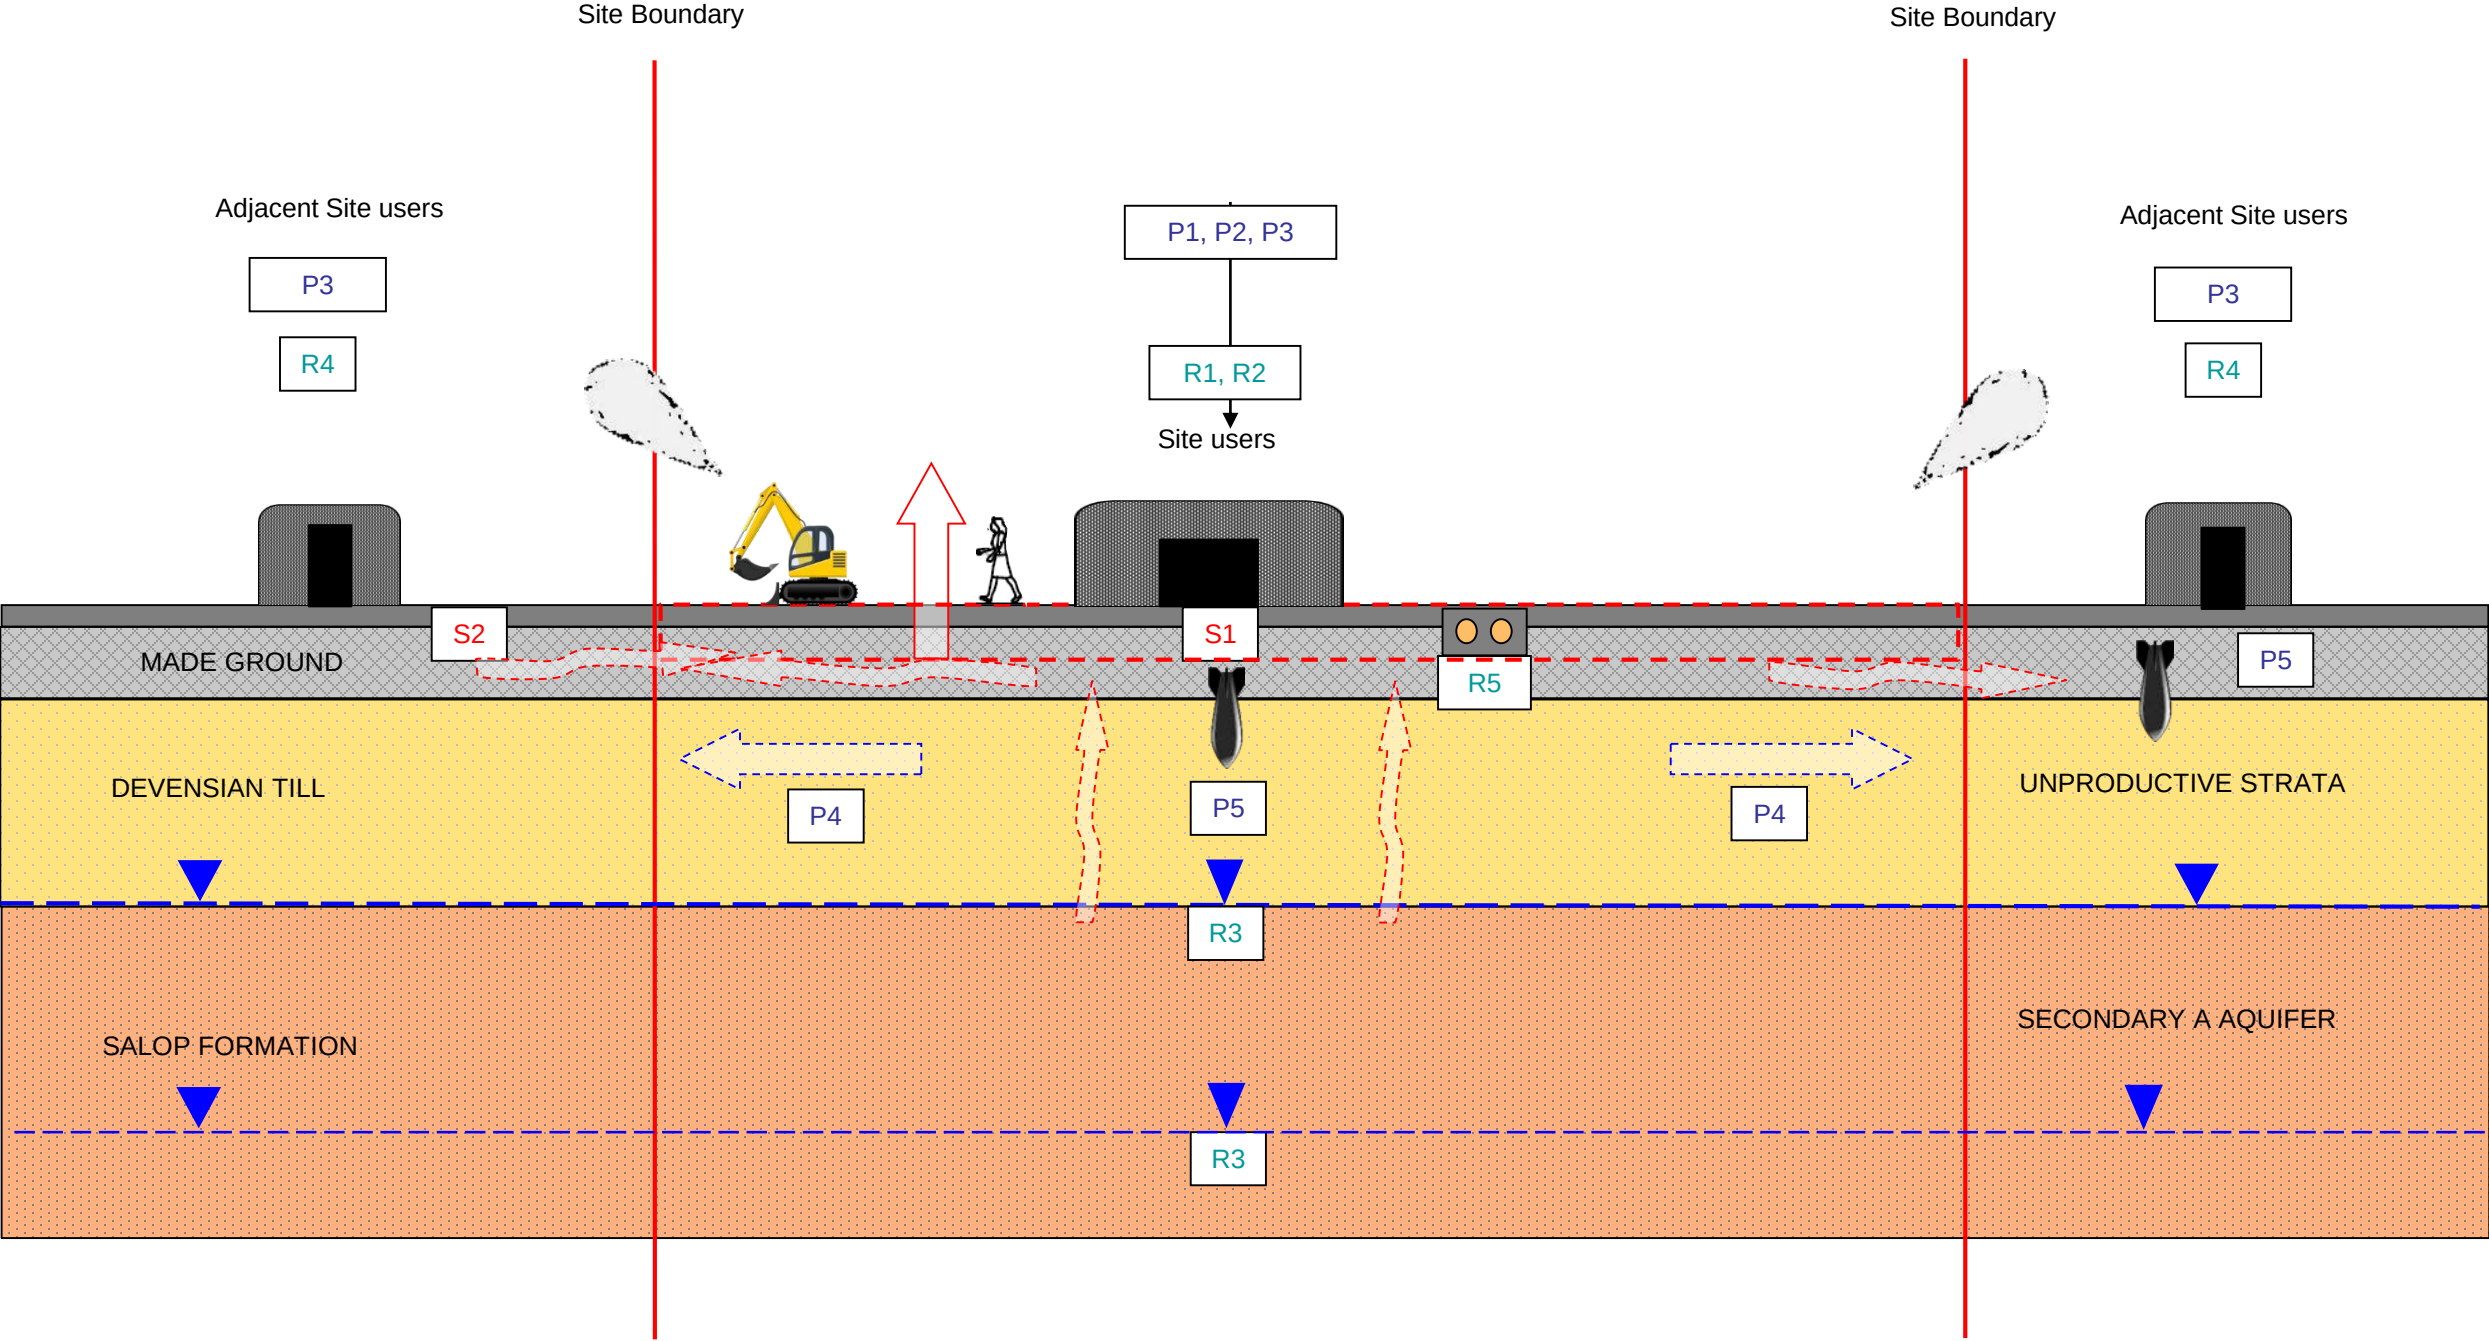
Figure 4: Preliminary Conceptual Site Model

| Key | | |
|---|--|--|
| <div><div>S1 – Potentially Contaminated Soil – On site</div><div>S2 -- Potentially Contaminated Soil – Off site</div></div> | | |
| <div><div>R1 Future site Users</div><div>R2 Construction Workers</div><div>R3 Controlled waters</div><div>R4 Adjacent Site Users</div><div>R5 Infrastructure &amp; Buried services</div></div> | | |
| <div><div>P1 Direct Contact</div><div>P2 Ingestion</div><div>P3 Inhalation</div><div>P4 Leaching &amp; Migration</div><div>P5 Vertical &amp; lateral migration of ground gas</div></div> | | |
| <div><div></div><div>Ground gas migration</div></div> | | |
| <div><div></div><div>Leachate migration</div></div> | | |
| <div><div></div><div>Direct contact/ ingestion</div></div> | | |
