# **Audit/Inspection Report for the Mitigation Stand-Along Bat House at Mill Cottage**

**MILL COTTAGE  
MARCHWIEL HALL  
WREXHAM  
LL13 0SS**

**DATE: SEPTEMBER 2021**

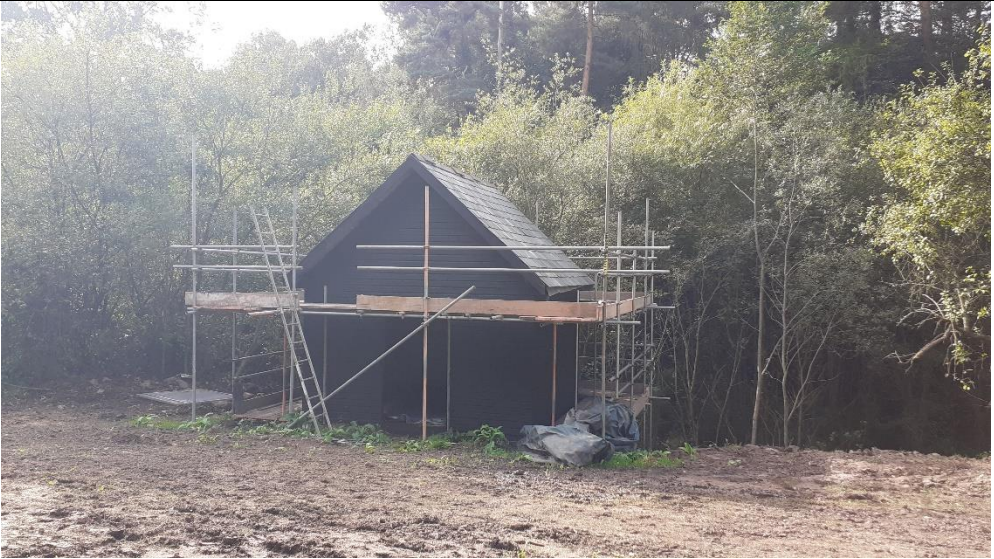
| Number | Photograph |
|---|---|
| 1 | A photograph of a small, dark-colored wooden building under construction. The building has a steep gabled roof and is surrounded by scaffolding. It is situated in a clearing with trees in the background. |

| Report Name | Audit/Inspection Report for the Mitigation Stand-alone Bat House at Mill Cottage | Site name: | Mill Cottage, Marchwiell Hall, Wrexham, LL13 0SS |
|---|---|---|---|
| The purpose-built bat house is to be situated 2-3m distance from the bank of the Gefelliau Brook (as the bank is too steep to support construction), where it will receive solar gain to support a maternity colony. | The structure is situated approximately 2-3m from the bank of the brook. | 1 | |
| The partitioned loft space is to measure 4.2m x 4.2m and 2m in height from floor to ridge. | The structure is approximately 5.4m in length, 4.5m in width and approximately 2.3m from the floor of the loft to ridge. | 1 | |
| It will be built using reclaimed timber frame, with blackened cladding to match the extension and outbuilding, | The structure is constructed of timber and contains blackened cladding. | 1. | |

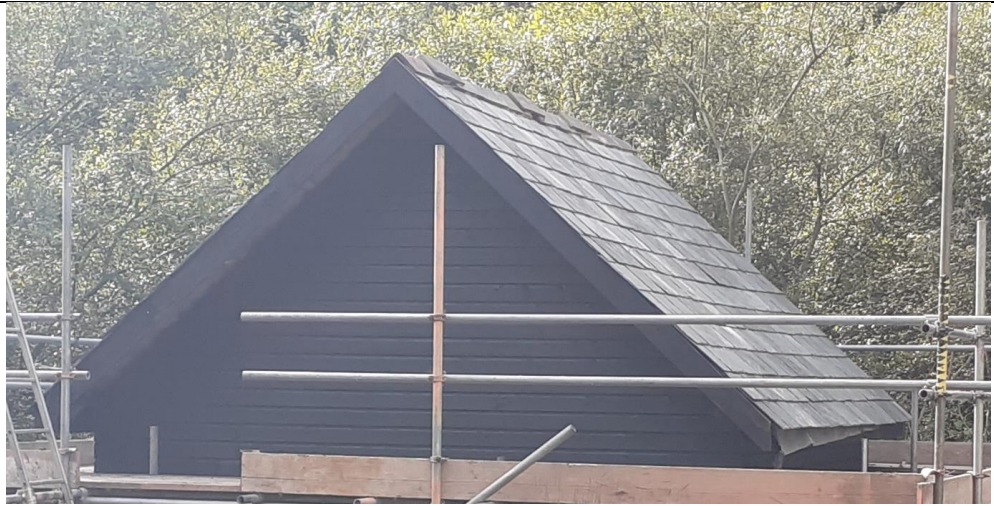
| Number | Photograph |
|---|---|
| 2 | A close-up photograph of the wooden building under construction, showing the dark siding and the steep gabled roof. Scaffolding is visible around the structure. |

| Report Name | Audit/Inspection Report for the Mitigation Stand-alone Bat House at Mill Cottage | Site name: | Mill Cottage, Marchwiell Hall, Wrexham, LL13 0SS |
|---|---|---|---|
| The roof will be slate tile to match the existing roofs, with Bitumen 1F felt underlay. | The roof is constructed of Welsh slate roof tiles and angled ridge tiles. Bitumen 1F felt provides the underlay. | 2, 6 and 7. | |
| Crevice opportunities are to be created, with gaps between the cladding. | Three raised ridge tiles have been created. Two of these provide access into the structure, and the other provides crevice-roosting opportunities. | 2 | |
| Access to the structure | Three raised ridge tiles have been created. Two of these provide access into the structure, and the other provides crevice-roosting opportunities | 2 and 4 | |

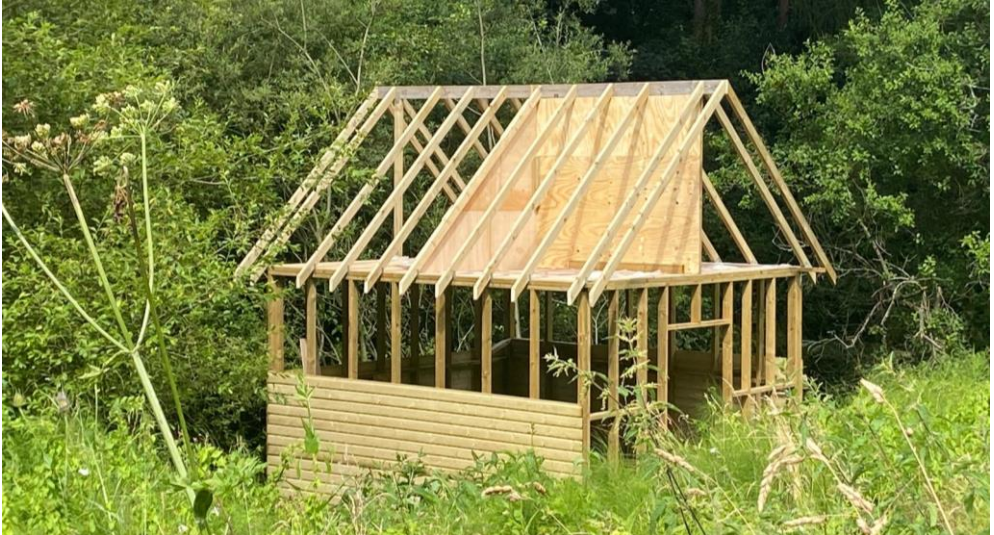
| Number | Photograph |
|---|---|
| 3 | A photograph of the wooden building under construction, showing the wooden frame and the steep gabled roof. The building is surrounded by green vegetation. |

| A smaller compartment created in the loft will provide a warmer area (a hotbox). | The smaller compartment has been constructed within the quarter of the structure. | 3 and 7 |

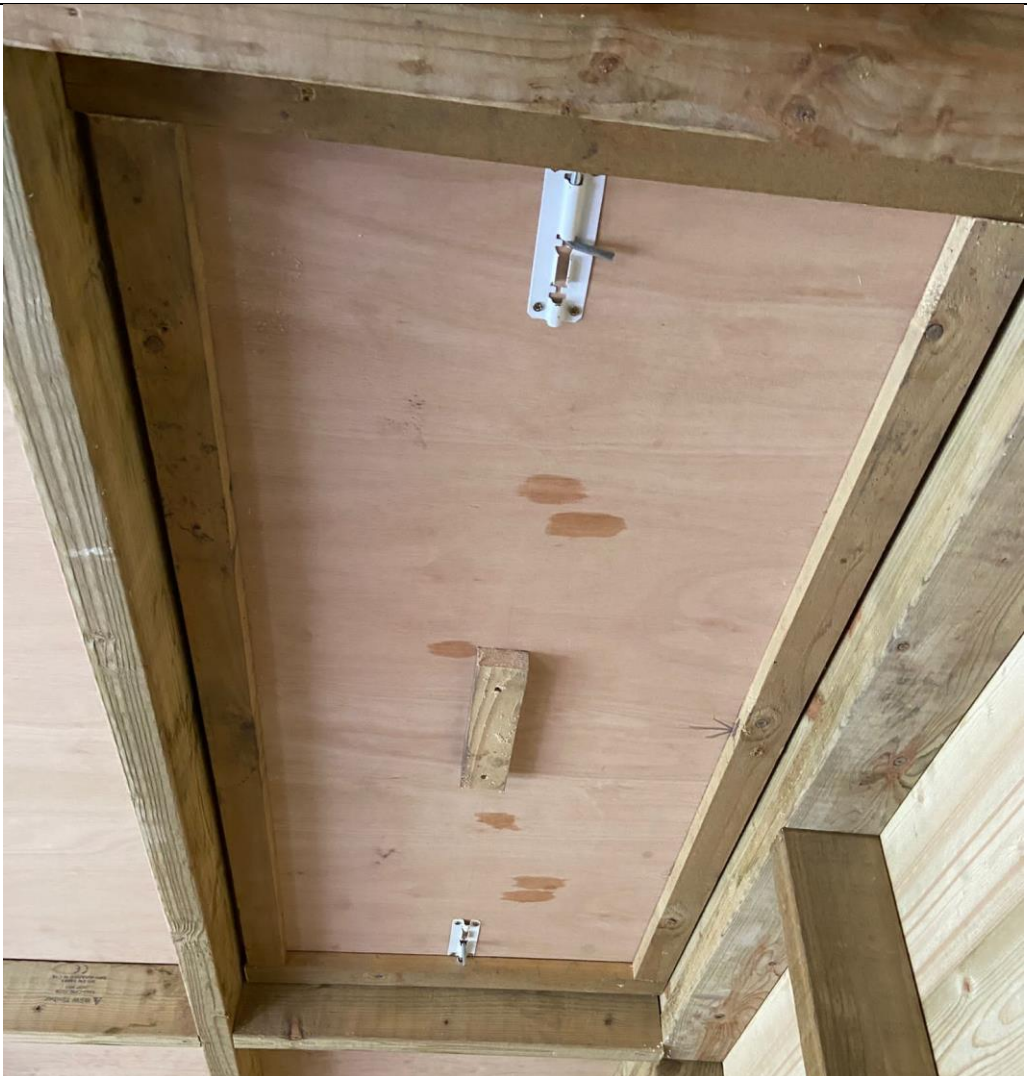
| Report Name | Audit/Inspection Report for the Mitigation Stand-alone Bat House at Mill Cottage | Site name: | Mill Cottage, Marchwiell Hall, Wrexham, LL13 0SS |
|---|---|---|---|
| A 500 x 500mm hatch on the rear underside of the loft will provide access for monitoring. | An access hatch has been created with bolts | 5 | |
