## **Arboricultural Impact Assessment & Method Statement**

### **Land at Vicarage Hill Court, Vicarage Hill, Minera**

Our Ref: 21/AIA/WXM/277

April 2021

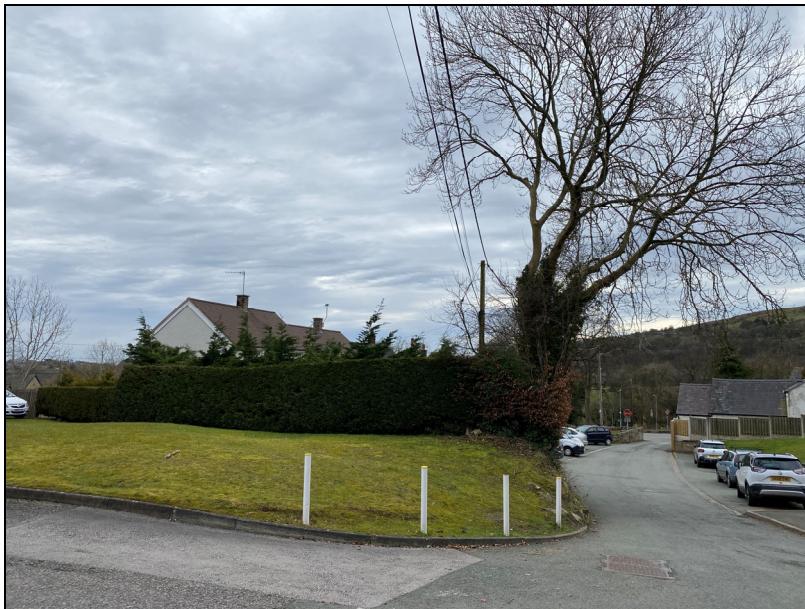
P1 – T1-viewed from Vicarage Hill to NW

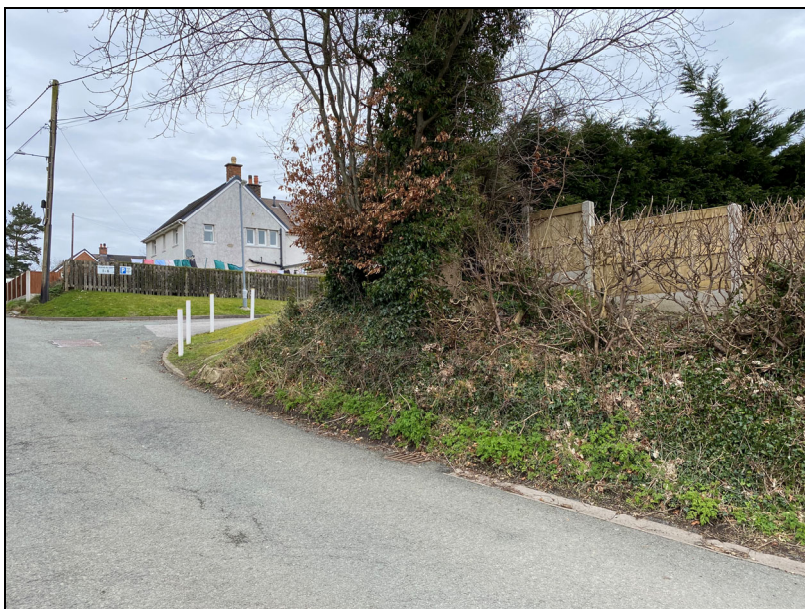
P2 – T1-viewed from Vicarage Hill to SW

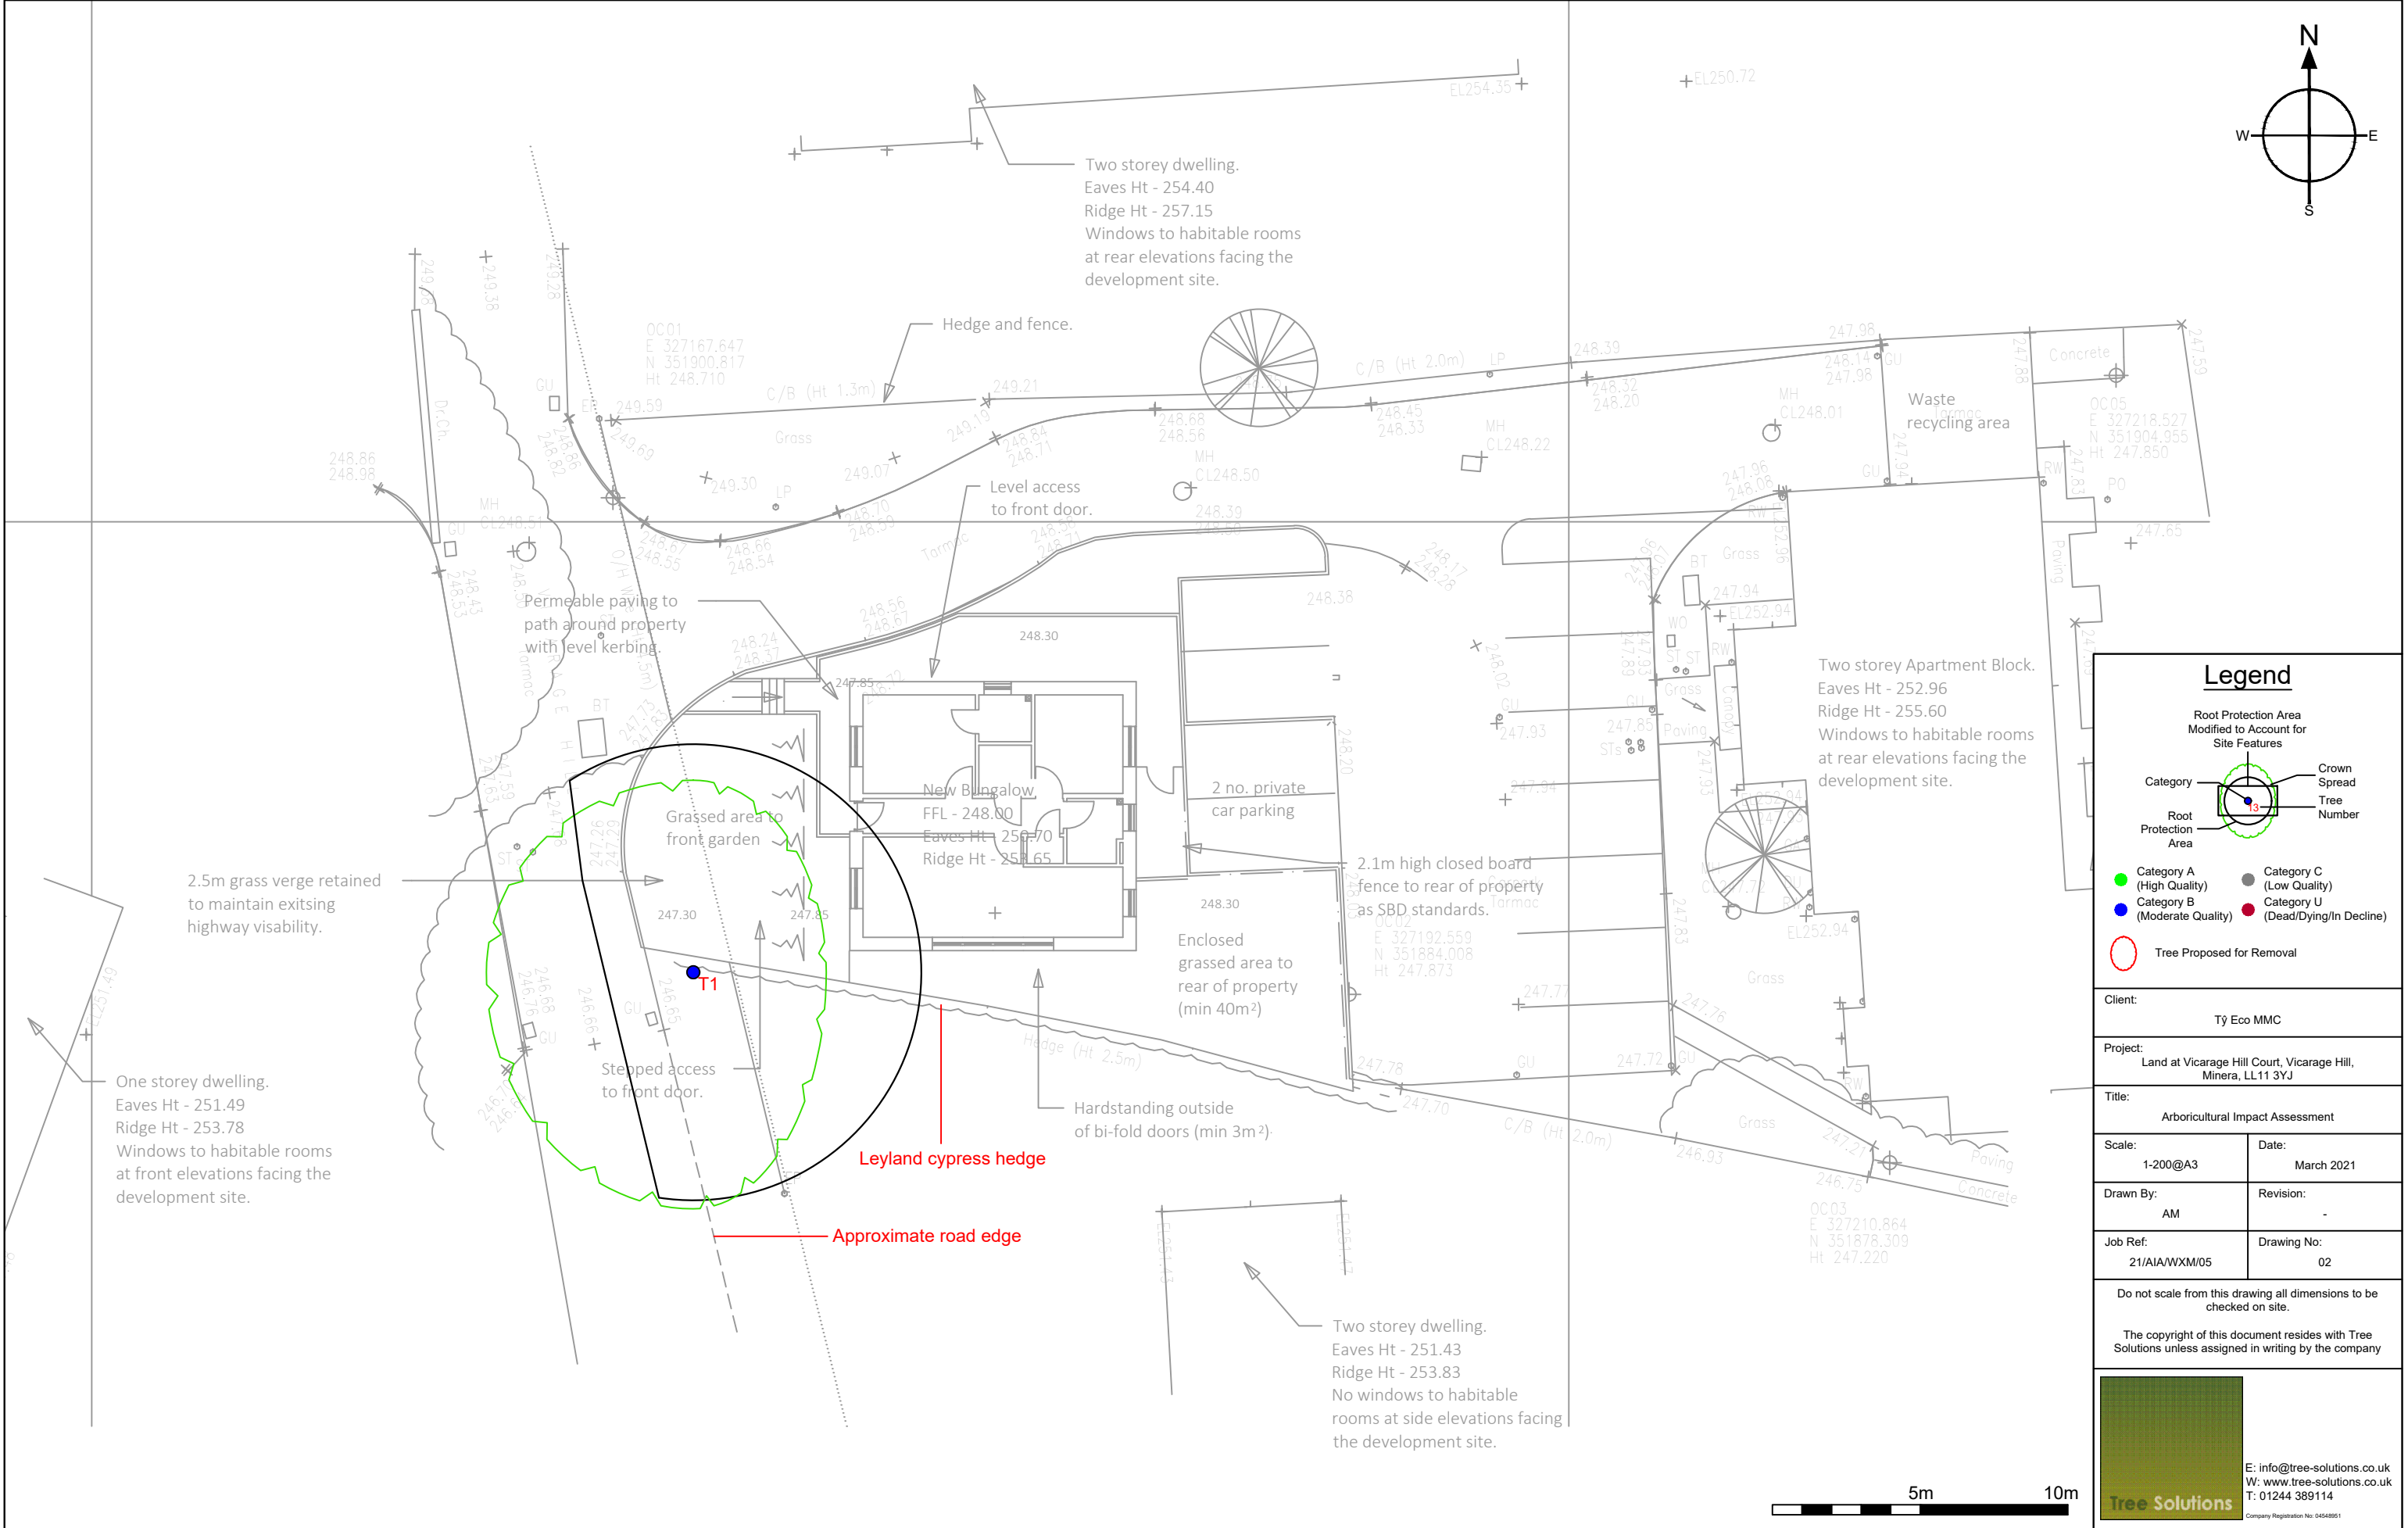
### **Impact Assessment Plan**

1. The SW corner of the dwelling encroaches within the RPA of tree number 1 by 2.3m. . We have therefore advised the architect that as this incursion is less than the suggested 20% tolerance specified at para. 7.4.2.3 of BS5837: 2012 the location complies with the recommendations of the BS. As the presence of underlying roots cannot be substantiated without a trial trench or ground radar, we have advised that the incursion area of this plot should be supported on beams set on or above the existing ground level on a piled foundation. This will be detailed by the project structural engineer in such a way as to ensure that the final design is sufficiently flexible to allow the piles to be moved if significant roots (over 25mm diameter) are encountered in the preferred pile location. The engineers design will be in accordance with recommendations contained within paragraph 7.5 of BS 5837: 2012. As the piling is required to be installed within the RPA, the smallest practical pile diameter shall be used in order to reduce the possibility of striking any major roots and reduce the size of rig required to sink the piles. All piles shall be sheathed in order to protect

the soil and any adjacent roots from the potential toxic effect of concrete. Site specific foundation design shall be calculated by the project structural engineer and submitted for approval by the LPA. The installation of the piles can be carried out under the direct supervision of the project arboricultural consultant if required.

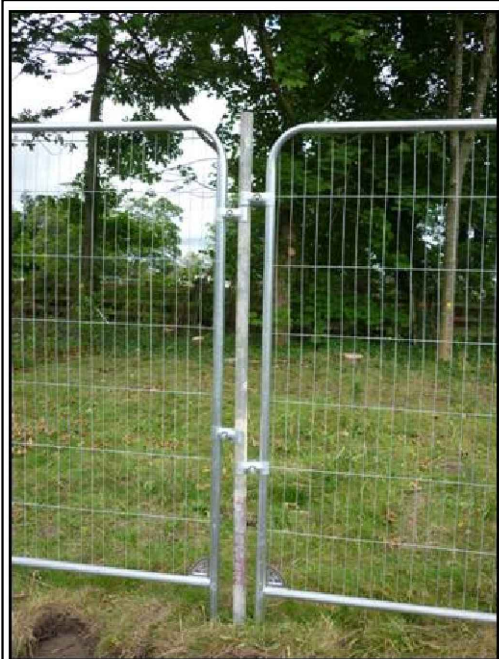
Tree Protective Fencing Specification

2.0M high Heras (with extra central support bar) mounted on scaffold poles (driven in to the ground) and secured with anti tamper bolts – as illustrated.

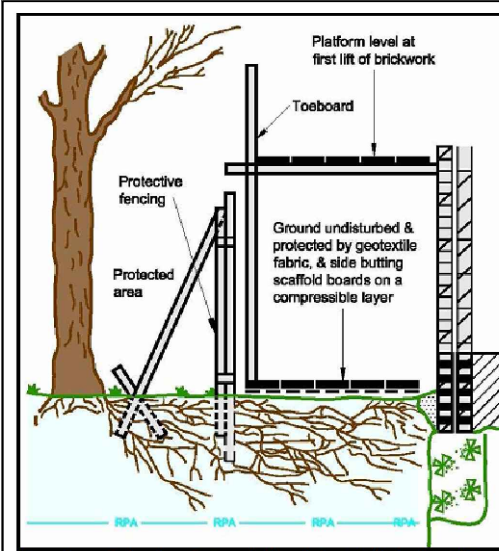
Figure 1 - protective boards & scaffolding to be installed within RPA

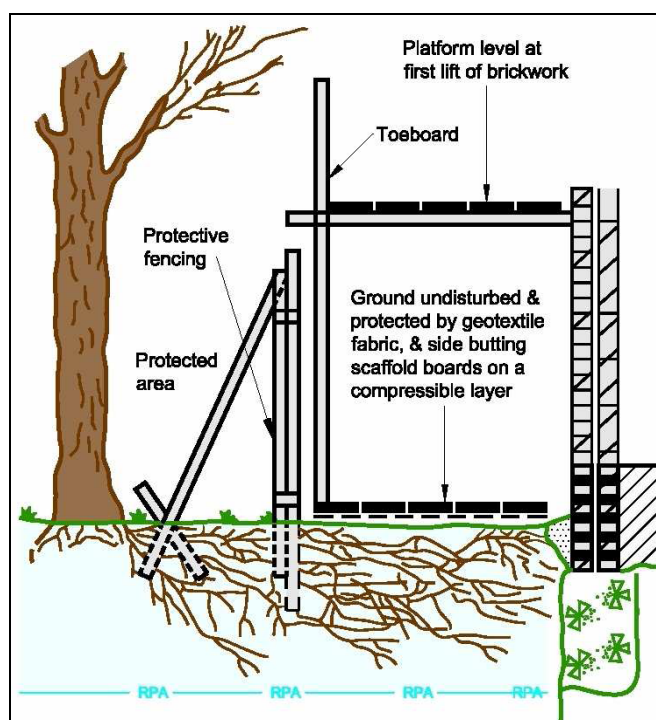
Plate 1- protective boards & scaffolding to be installed

1. Ground protection shall be installed prior to commencement of any construction work on site and shall be in accordance with the specification in plate 1 below.
2. The ground beneath any protection boarding will be left undisturbed and will be protected with a porous geotextile fabric and side butting scaffold boards on a 100mm compressible layer such of sharp sand
3. Boards will remain in-situ until the construction of the building has been completed

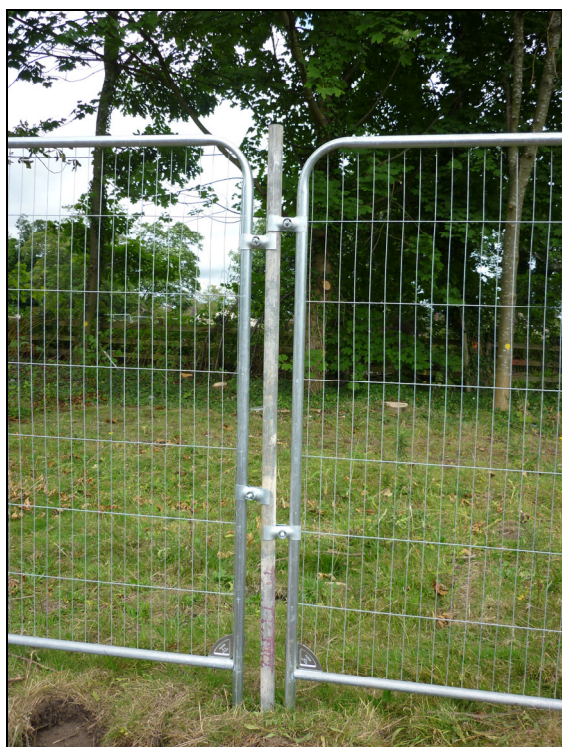
**Tree Protective Fencing Specification**

2.0M high heavy-duty Heras panels (with extra central support bar) mounted on scaffold poles (driven into the ground) and secured with anti-tamper bolts – as illustrated below.

- 2 The fencing will consist of a scaffold framework in accordance with Figure 2 of BS 5837 – 2012 (illustration below) comprising a metal framework, both vertical and horizontal, well braced to resist impacts. Vertical tubes will be spaced at a maximum interval of 3m. Onto this, weldmesh panels shall be securely fixed with wire or scaffold clamps. Weldmesh panels on rubber or concrete feet are not considered resistant to impact and for this reason will not be used. The site manager or other suitably qualified appointed person will be responsible for inspecting the protective fencing daily; any damage to the fencing or breaches of the fenced area will be rectified immediately.
