# PLAS GRONO, ERDDIG:

## BAT MITIGATION AND CONSERVATION PLAN

Report Ref EE.756.22.1.KW

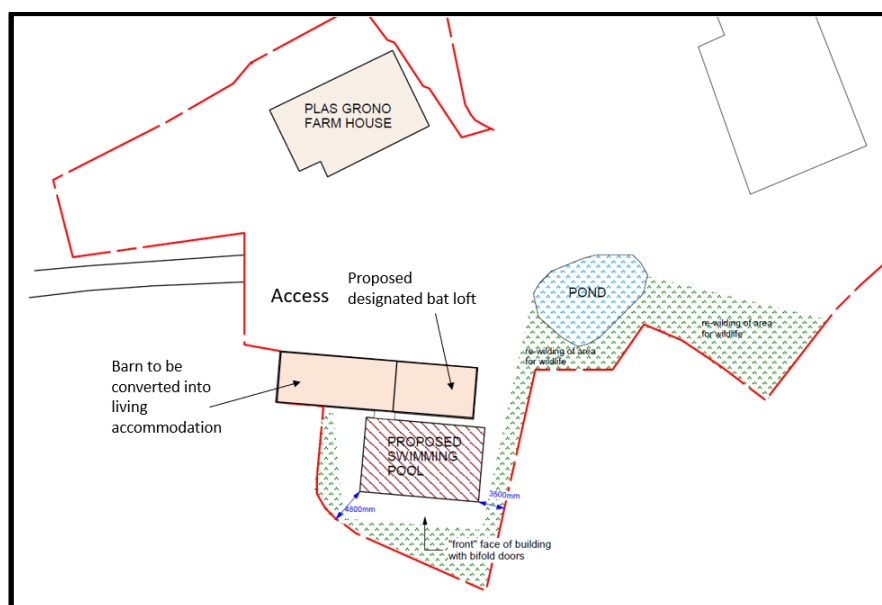
**FIGURE 1.1: PROPOSED SITE PLAN SHOWING THE BARN TO BE CONVERTED AND THE LOCATION OF THE SWIMMING POOL BUILDING**

- 1.3 The proposed works comprise converting an existing barn into living accommodation, which has had planning approval (Ref: P/2020/0742) with the condition of the production of a bat conservation plan (Condition 14); as well as a more recent proposal of constructing a new build to host a swimming pool on an adjacent area of grassland, to adjoin the existing barn (Figure 1.1 for locations and Figure 2.1 for elevations of the swimming pool building). Planning permission has not yet been granted for the swimming pool building.

2.4.2 To compensate for the loss of the day and night roost and feeding perches, a new bat roost area will be created within the roof space of the adjoining stable (Figure 1.1). **The new bat roost must be completed before works can begin to the barn.**

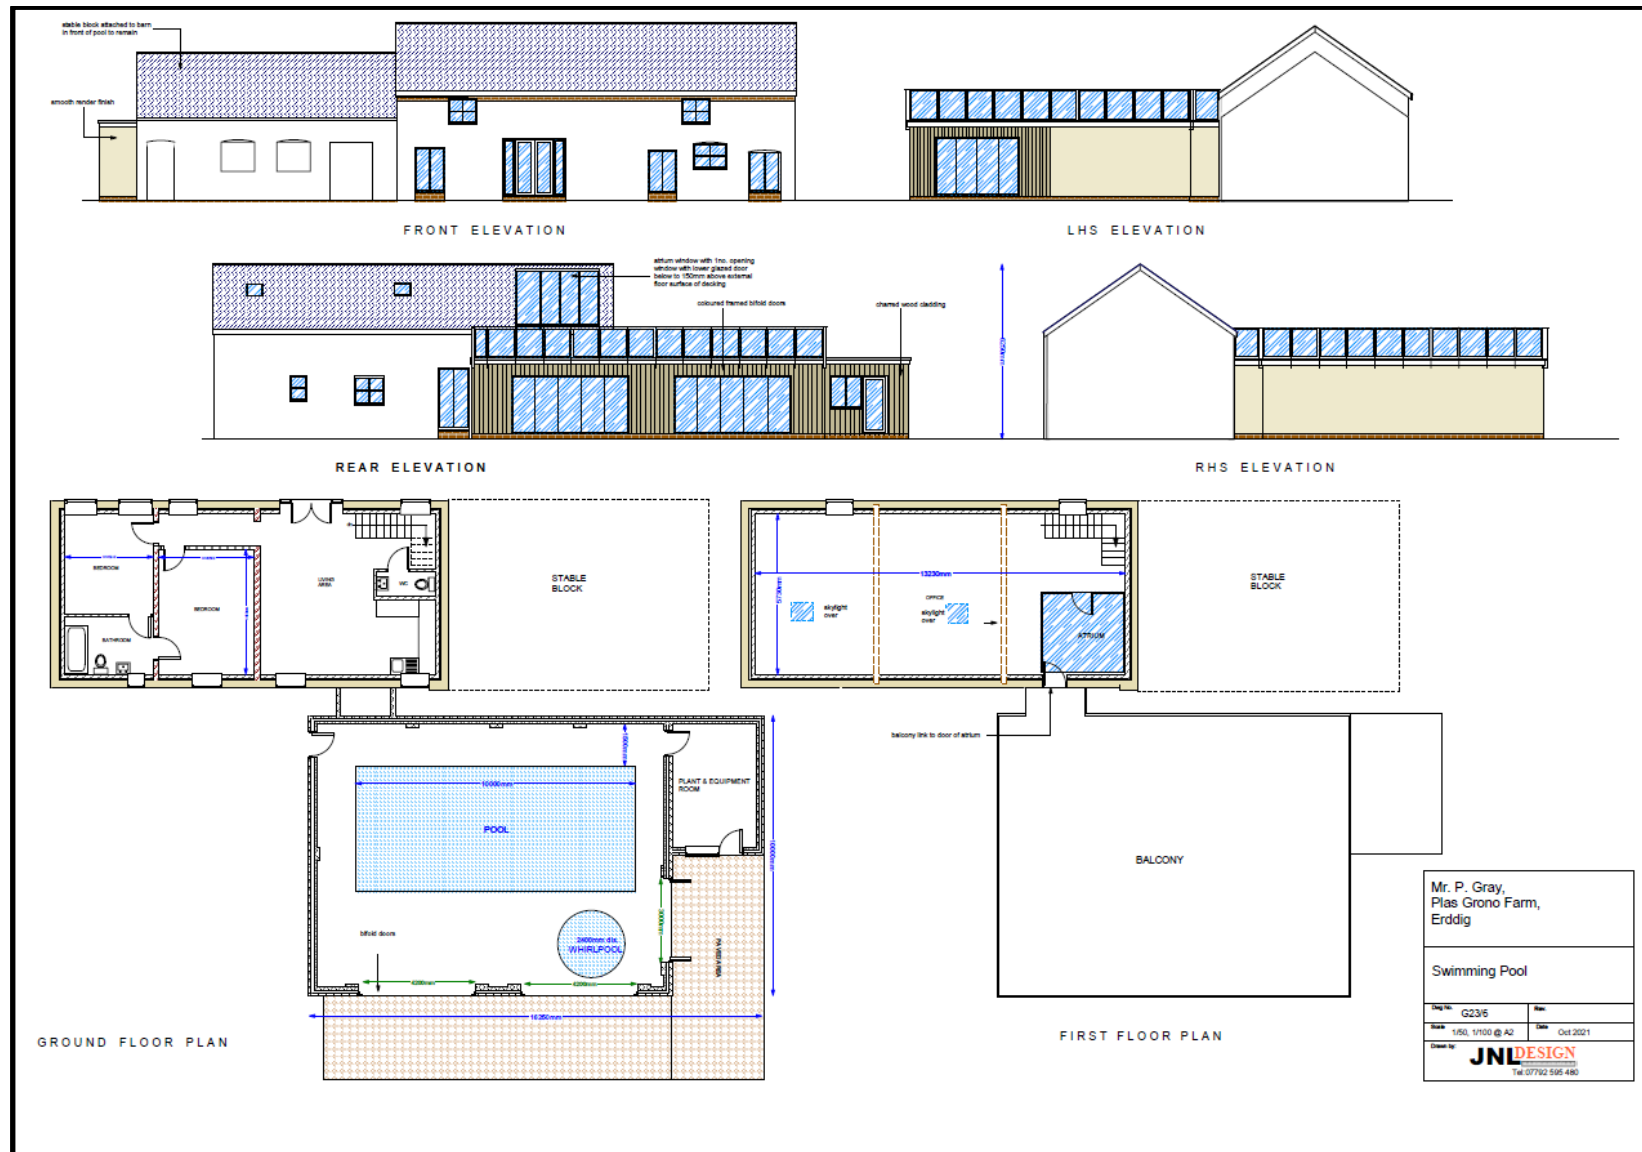
**FIGURE 1.2: PROPOSED ELEVATIONS AND FLOOR PLANS OF SWIMMING POOL BUILDING. BASE IMAGE ©JNL DESIGN**

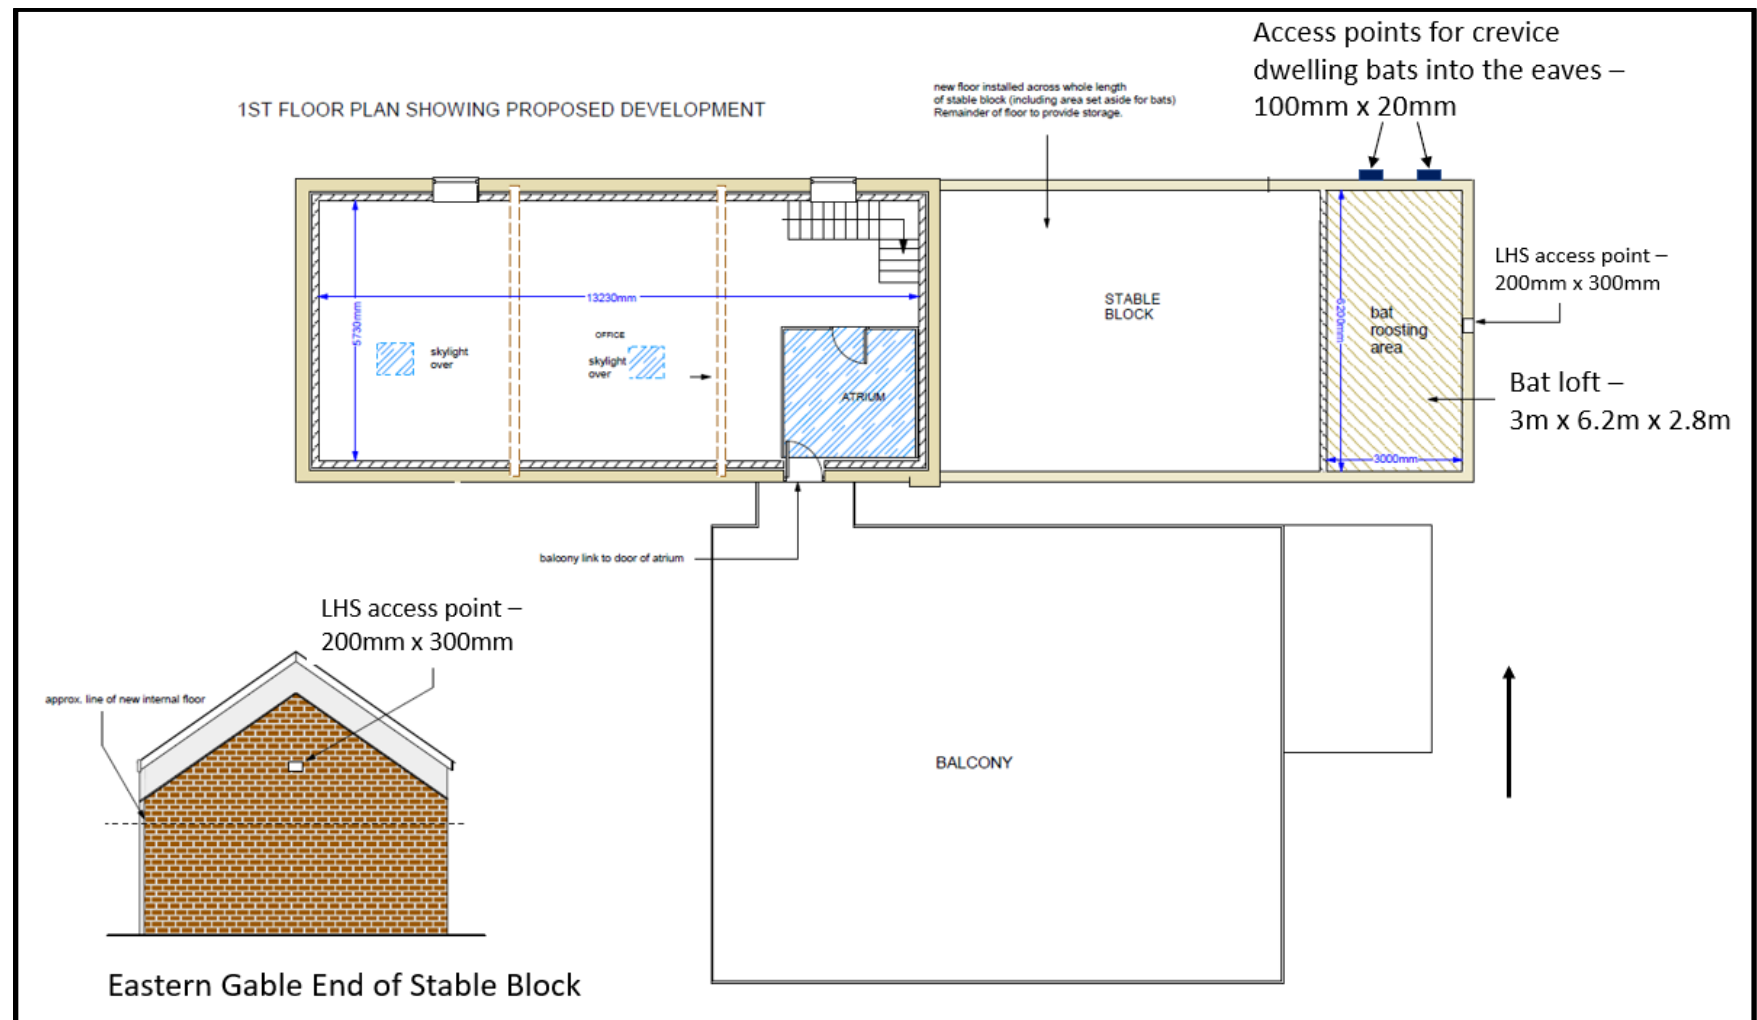
**FIGURE 2.1: PLANS SHOWING BARN CONVERSION, PROPOSED DESIGNATED BAT AREA IN STABLE BUILDING AND PROPOSED SWIMMING POOL BUILDING ©JNL DESIGN**

- The new roost will comprise a boarded area within the roof space, towards the eastern end of the stable block (See Figure 2.1). The bat loft area will measure at least 3m x 6.2m, with a floor to roof apex height of 2.8m (1.8m minimum, as not a maternity roost); a timber stud wall will separate the designated bat area from the remainder of the roof space.

- The roof within the bat roost will be retained as it is currently; if the roof is to be re-lined, only bitumen 1F felt will be used.
- An access point for LHS will be created within the eastern gable wall of the stable building (Figure 2.1). The entrance point will be 200mm x 300mm and provide direct access into the designated bat loft area; baffles will be used where necessary to prevent an increase of light and airflow into the bat loft.

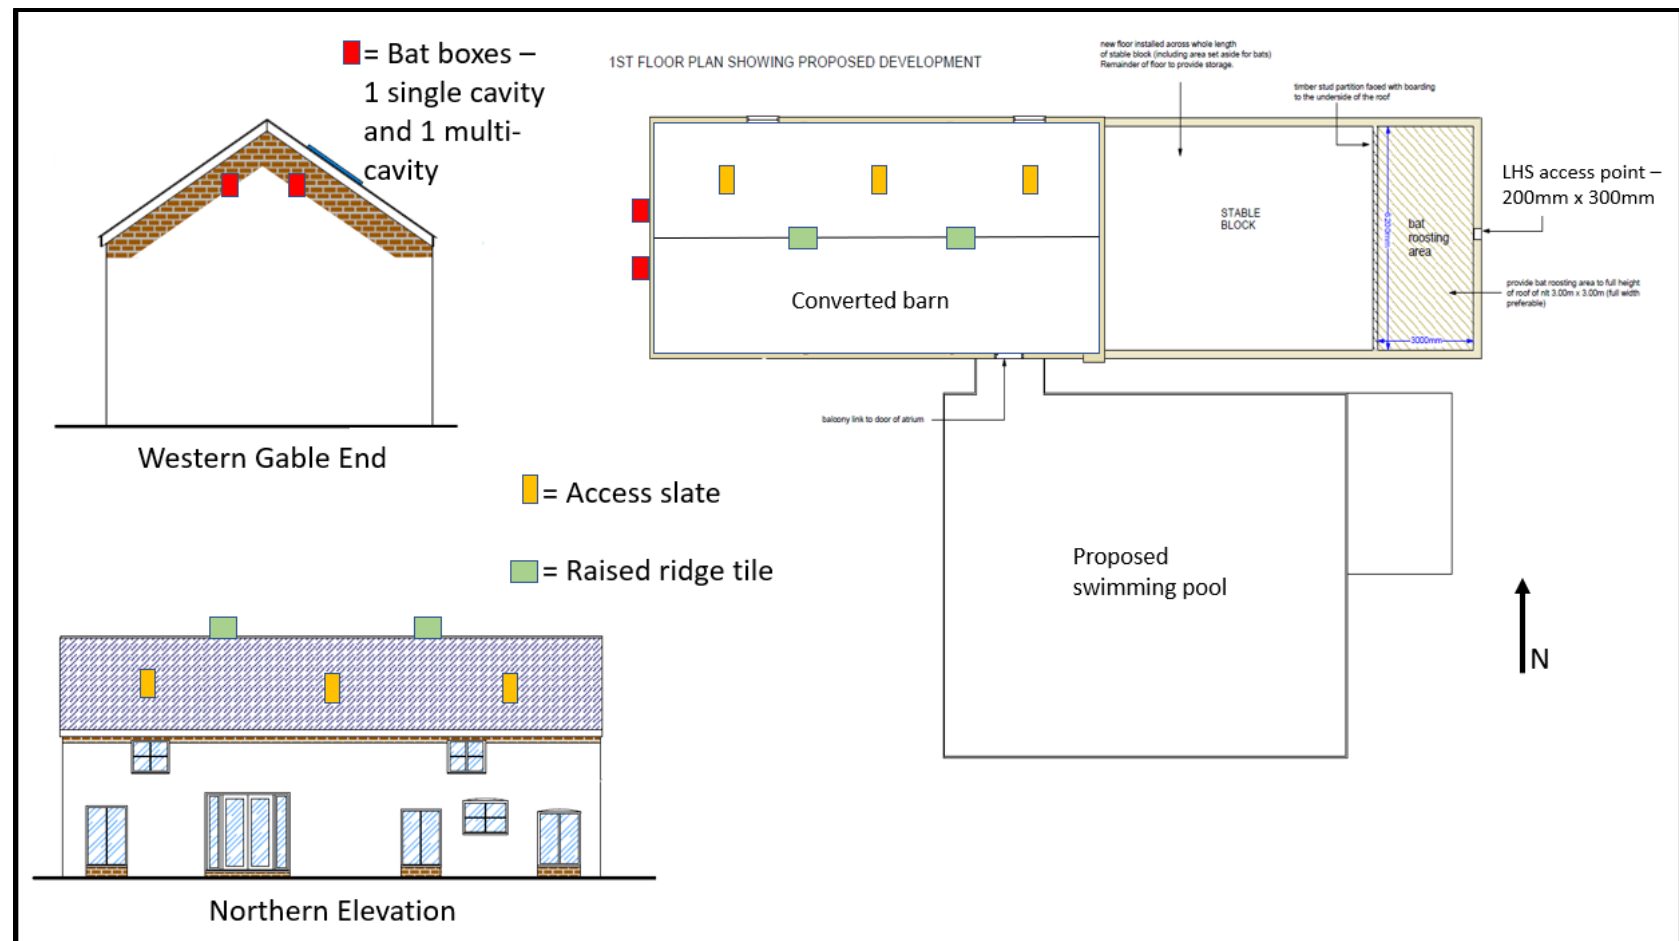
FIGURE 2.2: PLAN AND ELEVATIONS SHOWING LOCATIONS OF BAT MITIGATION. BASE IMAGE ©JNL DESIGN

2.5.1 To provide further roosting opportunities and enhancements for bats, access slates, raised ridge tiles and bat boxes will also be integrated into the site (Figure 2.2 for locations).

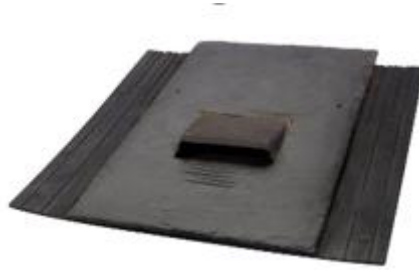
**FIGURE 2.3: EXAMPLE OF ACCESS SLATE**

- The roof of the converted barn building will be lined with a non-breathable membrane and three access slates (Figure 2.3) and two raised ridge tiles (Figure 2.4) will be installed to provide roosting opportunities for crevice dwelling bats between the tiles and the felt.
- Two woodstone bat boxes; one Beaumaris bat box and one multi-cavity bat box; will be erected onto the western gable end of the converted barn, as close to the apex as possible, approx. 1m apart.

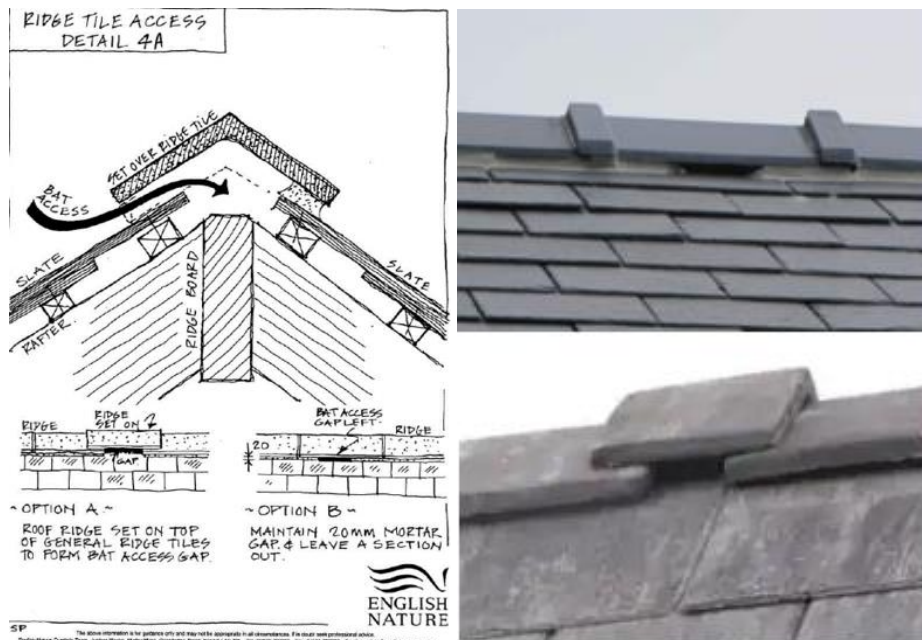
**FIGURE 2.4: EXAMPLE OF RAISED RIDGE TILE ACCESS**

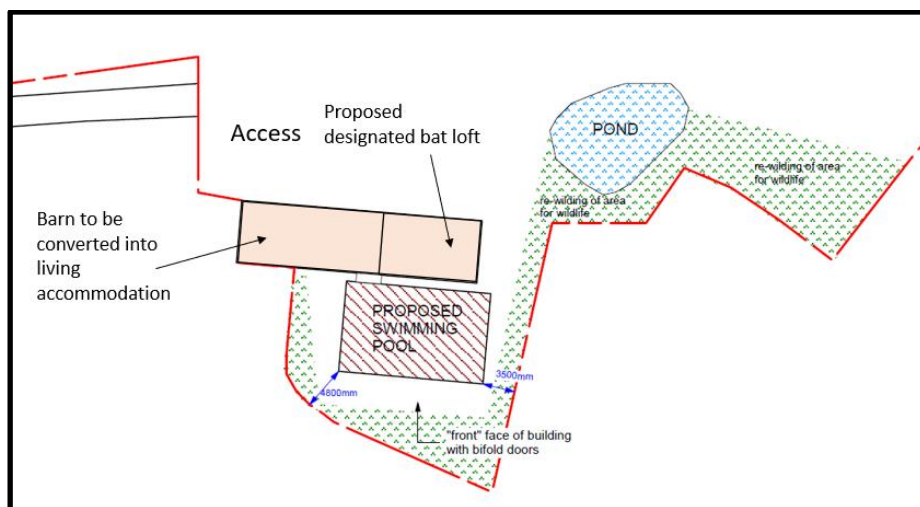
**FIGURE 2.5: PROPOSED SITE PLAN SHOWING THE ADDITIONAL PLANTING IN GREEN MARK-UP. BASE IMAGE ©JNL DESIGN**

2.5.2 The removal of vegetation to accommodate the new swimming pool building will result in the loss of suitable foraging habitat for bats. This will be compensated for with additional planting around the swimming pool building and the pond within the site (Figure 2.5), which will increase connectivity and foraging opportunities for bats, as well as increase biodiversity and benefit other wildlife within the site.

- Species included in the planting scheme are hawthorn (already present on site and will be retained), blackthorn, guelder/dog rose and holly.

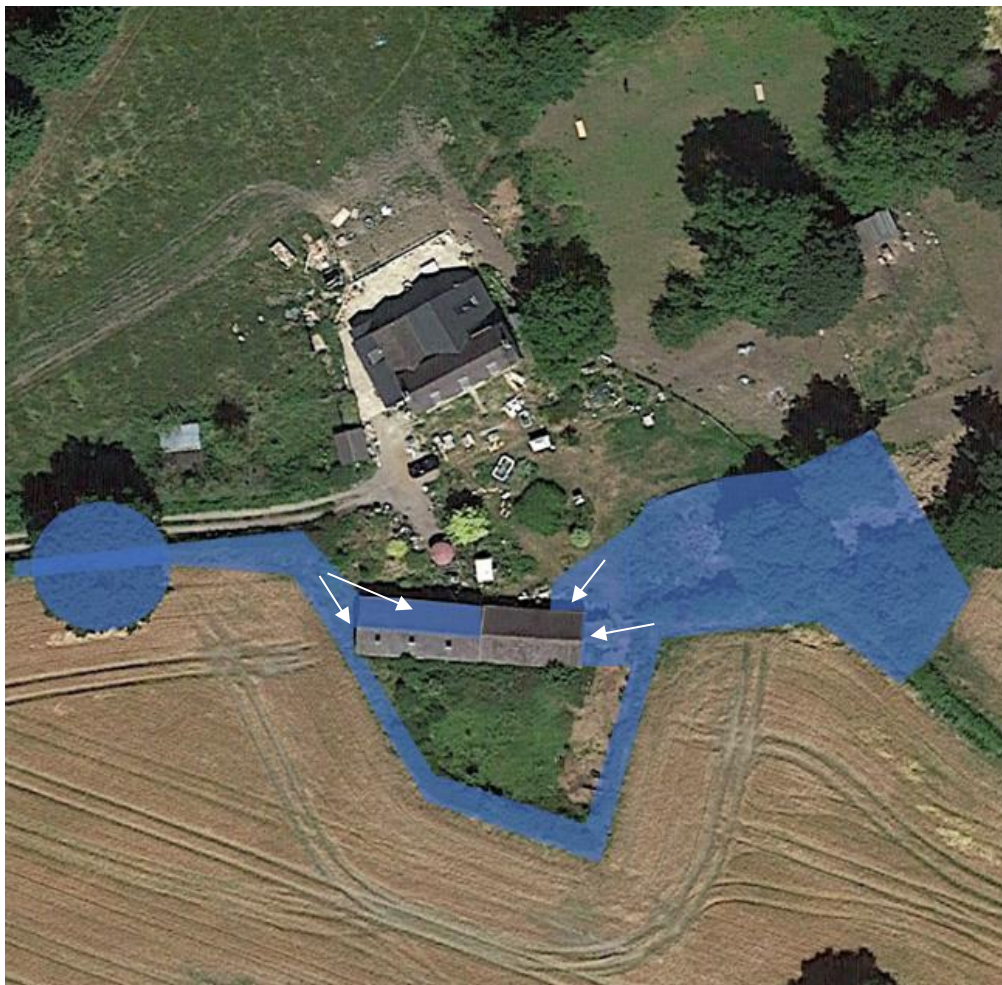
**FIGURE 2.6 – PROPOSED SITE PLAN SHOWING DARK BUFFER ZONE (BLUE) FROM THE MITIGATION ACCESS POINTS (WHITE ARROWS) AND THE SURROUNDING FORAGING HABITAT (NOT TO SCALE)**

- There must be no lights focused on the pond or any of the surrounding hedgerows (including the proposed planting) and mature trees within the site, during or after the works. There will be a dark 'buffer zone' from the western and eastern gable ends of converted barn and stable block respectively, following the boundary vegetation, that will not be subject to light spillage (Figure 2.6). There will be no illumination of the recommended bat mitigation, bat access points and bat boxes once the works are complete.
