Client John Brookshaw

Project The Plassey  
Eyton  
Entrance Drive / Recycling Centre

Title Tree Removal and Protection Plan

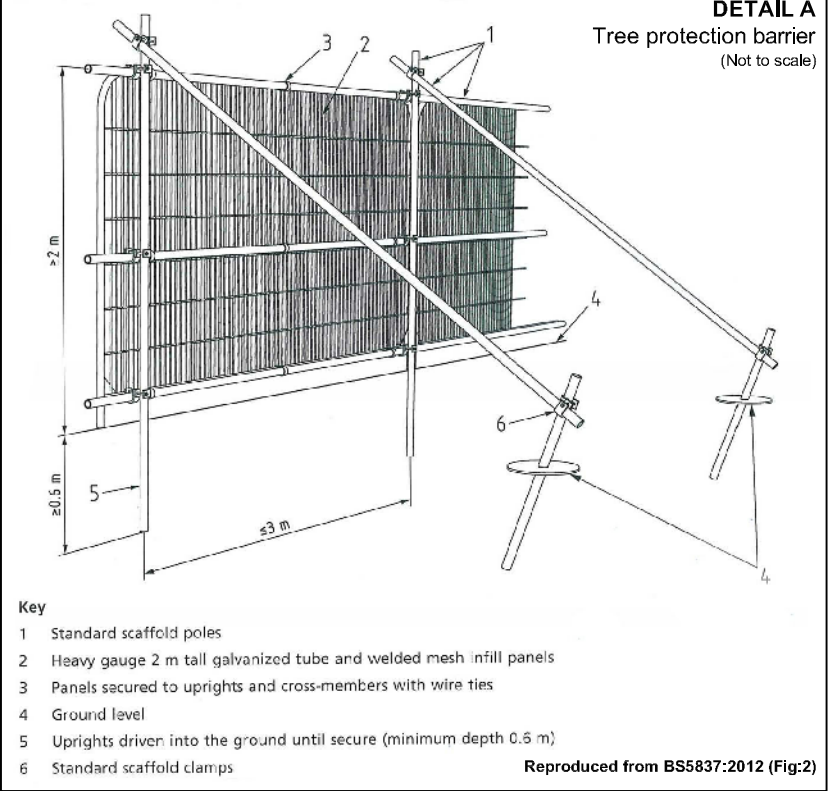
Figure 2 Default specification for protective barrier

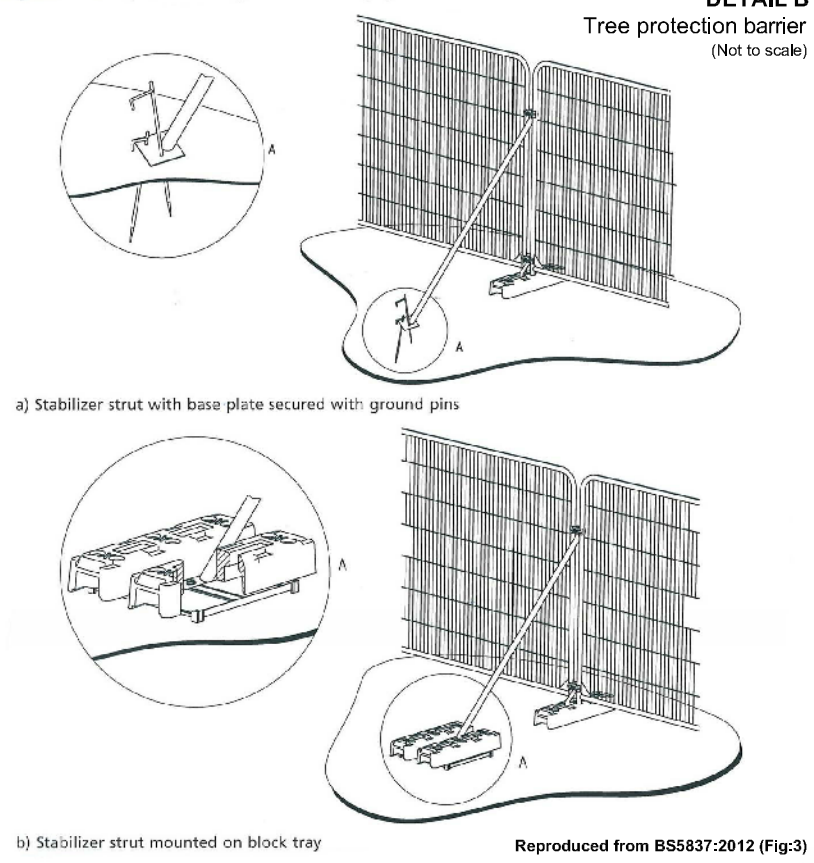
Figure 3 Examples of above-ground stabilizing systems
