## **Arboricultural Method Statement**

**Chestnut Court, off Summerhill Road, Gwersyllt, Wrexham, LL11 4SP**

Our Ref: 14/AIA/WXM/135(Rev C)

11 August 2016

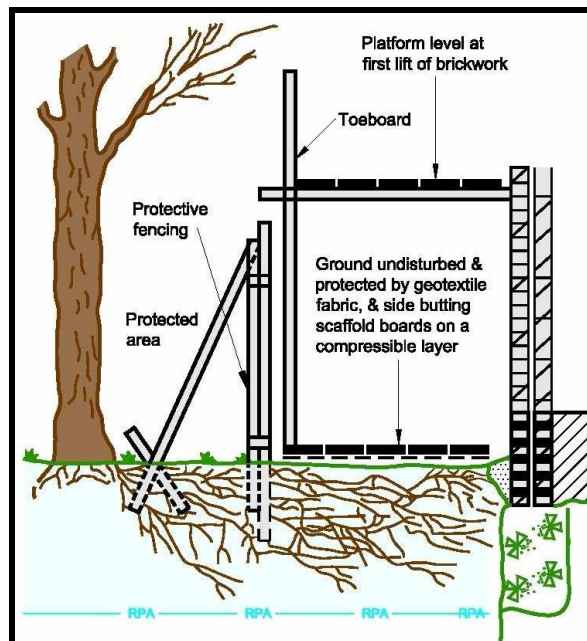
Plate 3 protective boards & scaffolding to be installed within the RPA of T2 & T43

1. The ground protection measures must be capable of supporting the expected loads and evenly distribute the carried weight that will use the route in order to avoiding rutting, compaction and damage to the soil.
2. The method of protecting the ground within the RPA of tree numbers 2 & 43 will involve the use of a marine plywood boards laid across the RPA that extends beyond the protective fencing location side butted together to form a continuous line as indicated on the Tree Protection Plan. The boards will be fixed in place by construction tie-rods to avoid any displacement details of which are to be approved for use by Tree Solutions and the LPA before installation commences.
3. Temporary ground protection materials shall be delivered and moved by low impact tracked machinery and installed by hand.

4. The ground beneath any protection boarding will be left undisturbed and will be protected with a porous geotextile fabric and side butting scaffold boards on a 100mm compressible layer such of sharp sand
5. Boards will remain in-situ until the construction of the dwelling has been completed and will only be lifted to install the no-dig driveway section

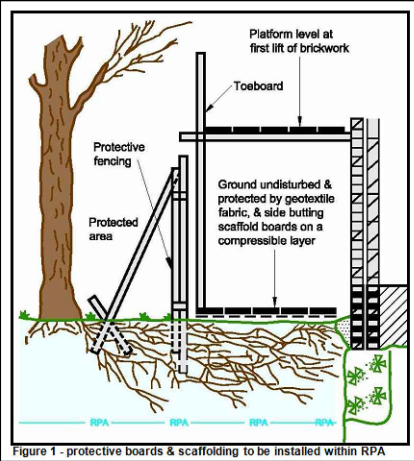
Figure 1 - protective boards & scaffolding to be installed within RPA

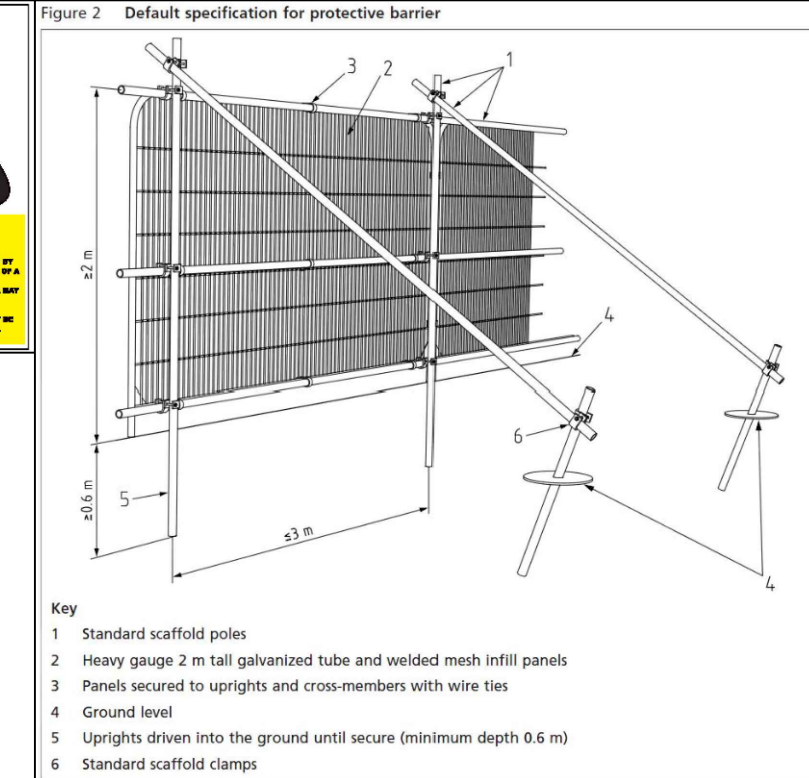
- Key
- 1 Standard scaffold poles
  - 2 Heavy gauge 2 m tall galvanized tube and welded mesh infill panels
  - 3 Panels secured to uprights and cross-members with wire ties
  - 4 Ground level
  - 5 Uprights driven into the ground until secure (minimum depth 0.6 m)
  - 6 Standard scaffold clamps

- 2 The fencing will consist of a scaffold framework in accordance with Figure 2 of BS 5837 – 2012 (illustration below) comprising a metal framework, both vertical and horizontal, well braced to resist impacts. Vertical tubes will be spaced at a maximum interval of 3m. Onto this, weldmesh panels shall be securely fixed with wire or scaffold clamps. Weldmesh panels on rubber or concrete feet are not considered resistant to impact and for this reason will not be used. The site manager or other suitably qualified appointed person will be responsible for inspecting the protective fencing on a daily basis; any damage to the fencing or breaches of the fenced area will be rectified immediately.

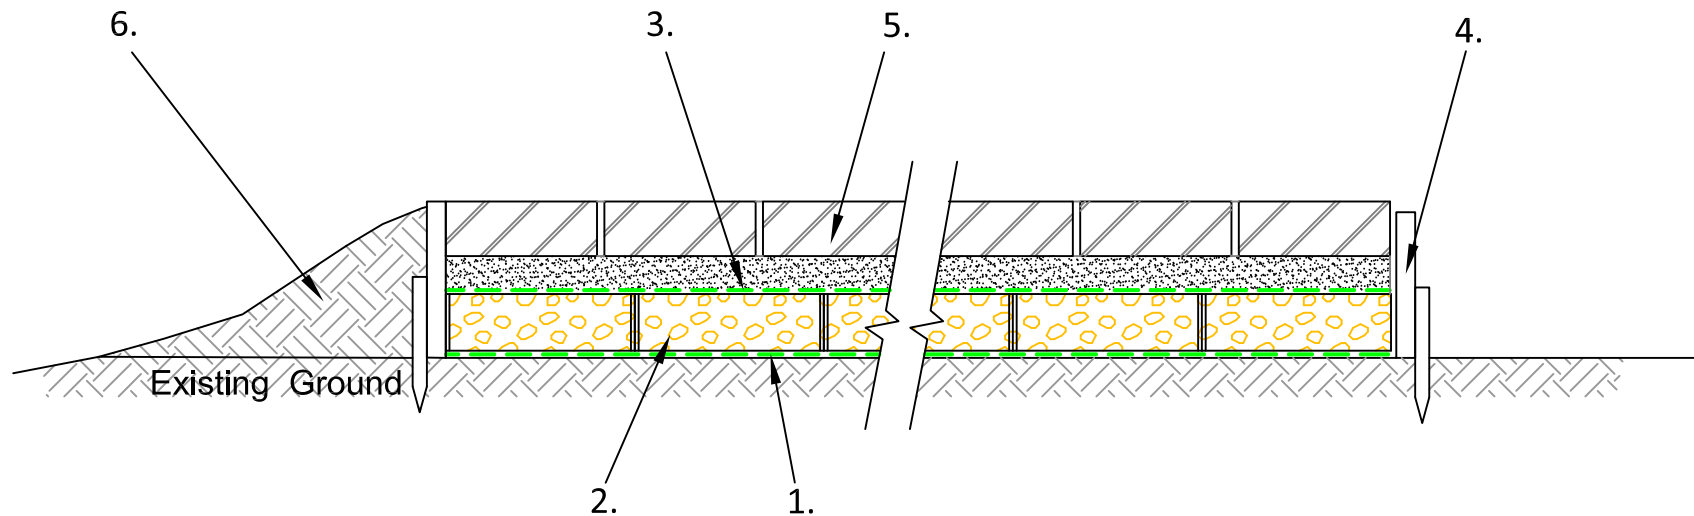
| | | DRAWING NO<br>IG-SD-IW-BP-75 | | REVISION<br>A | APPROVED |

1. Permatex 300 geotextile
2. 75mm deep InfraWeb tree root protection System infilled with 4/20 Clean angular Stone to BS EN 13242 / EN 12620
3. Permatex 200 separation geotextile
4. Treated Timber Edging (Or other Edging Detail Acceptable)
5. Block Paving with sand bed to Engineers Specification
6. Soil graded to edging (if required)

| | TITLE<br>InfraWeb Section - Tree Root Protection<br>c/w Block Paving Surface | DRAWN BY<br>PP | SCALE<br>1:10 | DATE<br>01/14 | CHECKED BY<br>RP |

*Driveway - refer to Infraweb Section Drawing Ref: IG-SD-IW-BP-75 at Appendix 3*

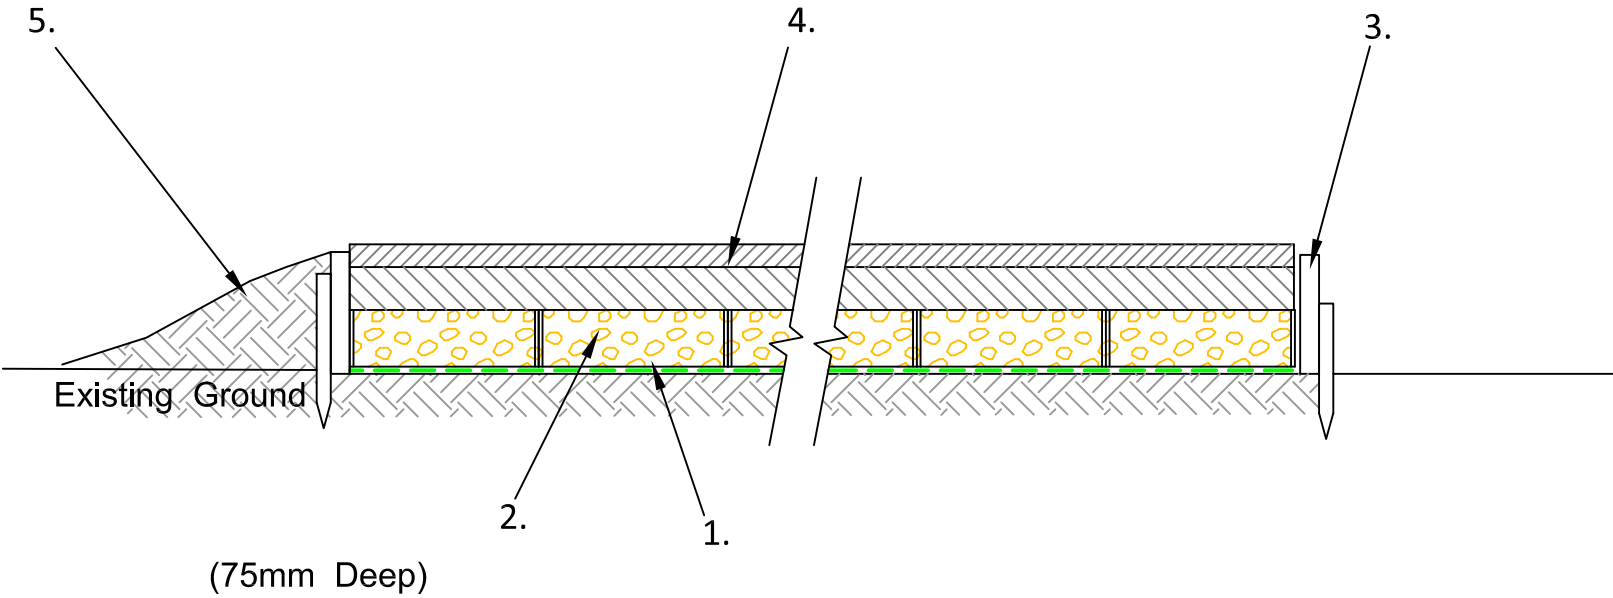
- 1. Permatex 300 geotextile
- 2. 75mm deep InfraWeb tree root protection System infilled with 4/20 Clean angular Stone to BS EN 13242 / EN 12620
- 3. Treated timber edging (Or other Edging detail acceptable)
- 4. Pervious asphalt surface to engineers details
- 5. Soil graded to edging (if required)

| | TITLE | InfraWeb Section - Tree Root Protection<br>c/w Pervious Asphalt Surface | DRAWN BY | SCALE | DATE | CHECKED BY |

*Pedestrian Footpath - refer to Infraweb Section Drawing Ref: IG-SD-IW-PA-75 at Appendix 4*
