| Community | <b>Maelor South</b> | Grade | <b>II</b> |
| Locality | <b>Sandy Lane</b> | Date Listed | <b>18/11/2005</b> |

Name **Stable and shippon at Sandy Lane Farm**  
Entry Name/No **Stable and shippon at Sandy Lane Farm / 4376**  
Street No, Name

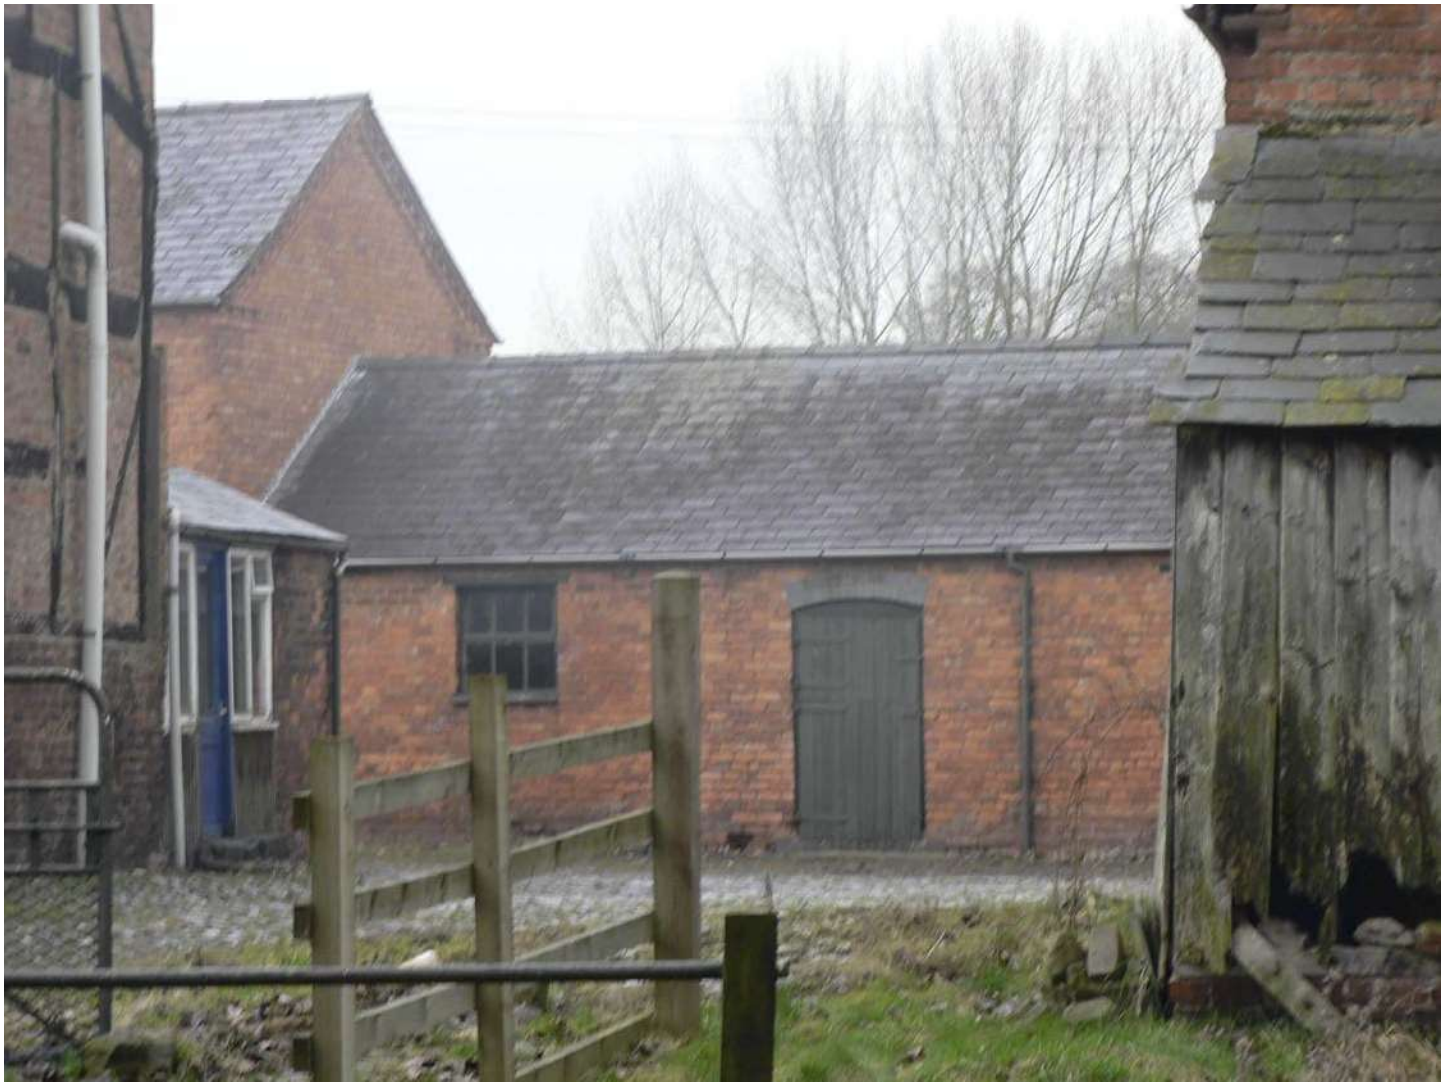
A lofted stable and shippon of brick with blue-brick segmental-headed openings, and slate roof. It has large replacement double doors, in an original opening, to the R, then a split door and window to the L. The loft has 3 openings, the R-hand open, the central retaining some original glazing bars and the L-hand with boarded shutter under a wooden lintel. A lean-to against the L gable end has a split door. Set slightly back to the R is the lower shippon. It has a split boarded door flanked by steel-framed hopper windows under lintels. Its gable end has a boarded door for the feeding passage to the R. The rear has 2 windows similar to the front and the stable has a single window on the L side.
