| | | Grade | <b>II</b> |
| Name | <b>Sandy Lane Farmhouse</b> | | |
| Entry Name/No | <b>Sandy Lane Farmhouse / 3671</b> | | |

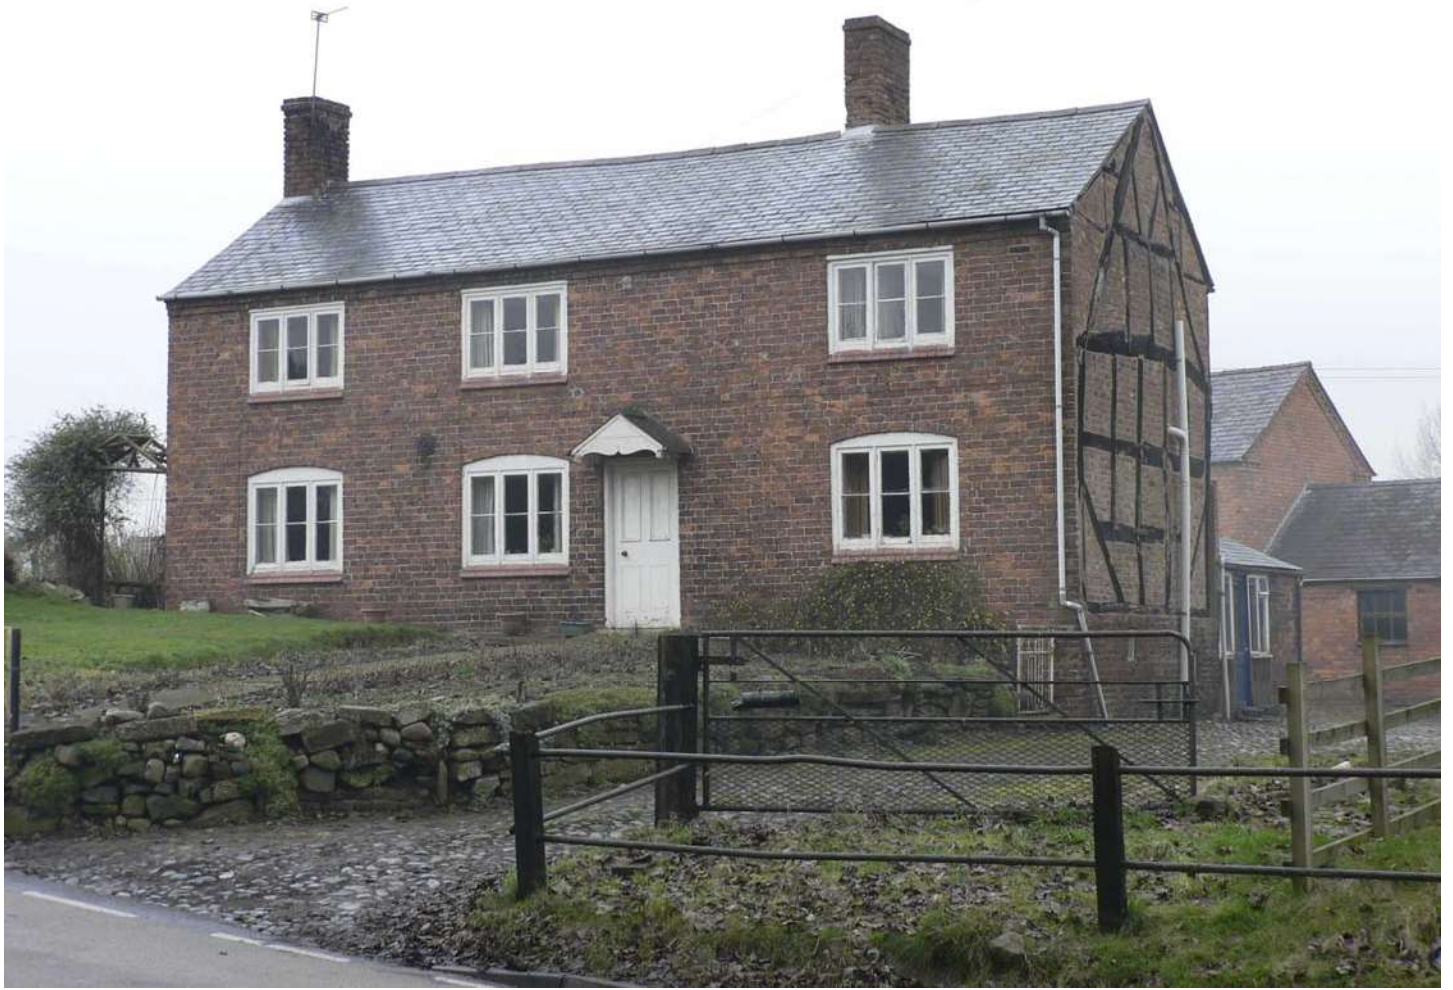
A 2-storey 3-window house of hand-moulded brick with slate roof and brick stacks to the L end and to R of centre. Offset to the R of centre is a panel door under a gabled canopy. Windows have segmental heads in the lower storey, flat arches in the upper storey, and are 3-light casements inserted in the late C19 or early C20 in original openings, but with added sills. The central windows are offset to the L. Above the entrance and beneath the eaves is a Sun insurance badge.

To the right, the ground level is lower and within the brick plinth of the gable end are 2 small barred basement openings. Above this is the box-framed gable end of the earlier house, with brick nogging and steeper original roof. Further R and set back is a 1-storey lean-to against the lower 2-storey rear wing. The lean-to has a half-glazed door flanked by 2-light windows, and boarded door and inserted window in its end wall. The main rear wing has, in its gable end, two 2-light casements in the upper storey, above an added lean-to with boarded door in the end wall. On the R side of the wing is a lean-to with boarded door, above the eaves level of the wing is an inserted window in the main range. The L gable end of the house has a narrow segmental-headed window.
