## BS5837 Tree Survey, Arboricultural Impact Assessment and Method Statement.

Whitegate Cottage Llanarmon

10/09/2020

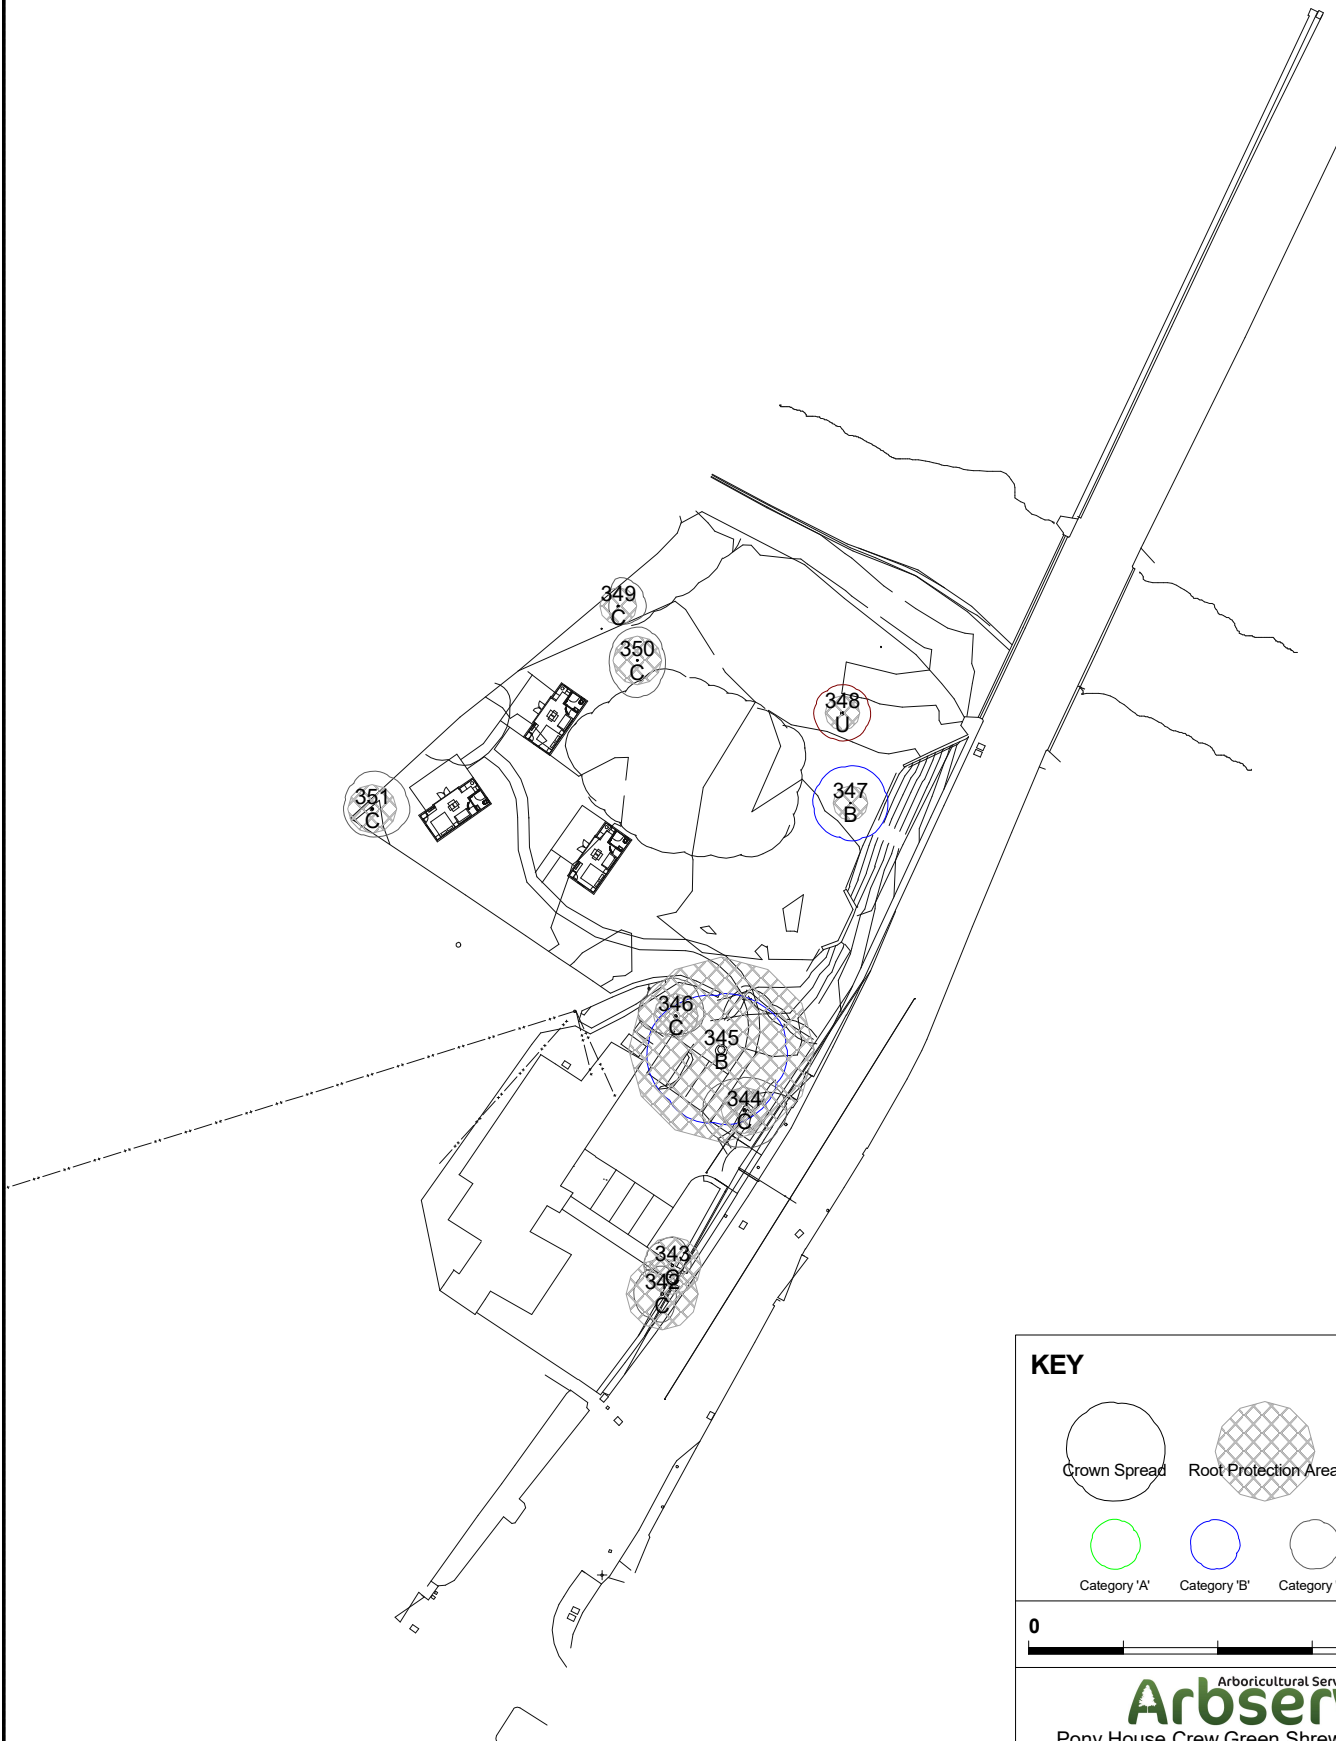
## Appendix 1 figure 1 tree location plan.

- 6.1 The survey was carried out on 02/09/20 by Matthew Owen, the weather at the time was clear and sunny with good visibility. Figure 1 shows the general layout of the site and the locations of all trees. The full results are tabulated in BS5837 tree survey schedule table (appendix 4) and should be read in conjunction with the tree protection plan Figure 3

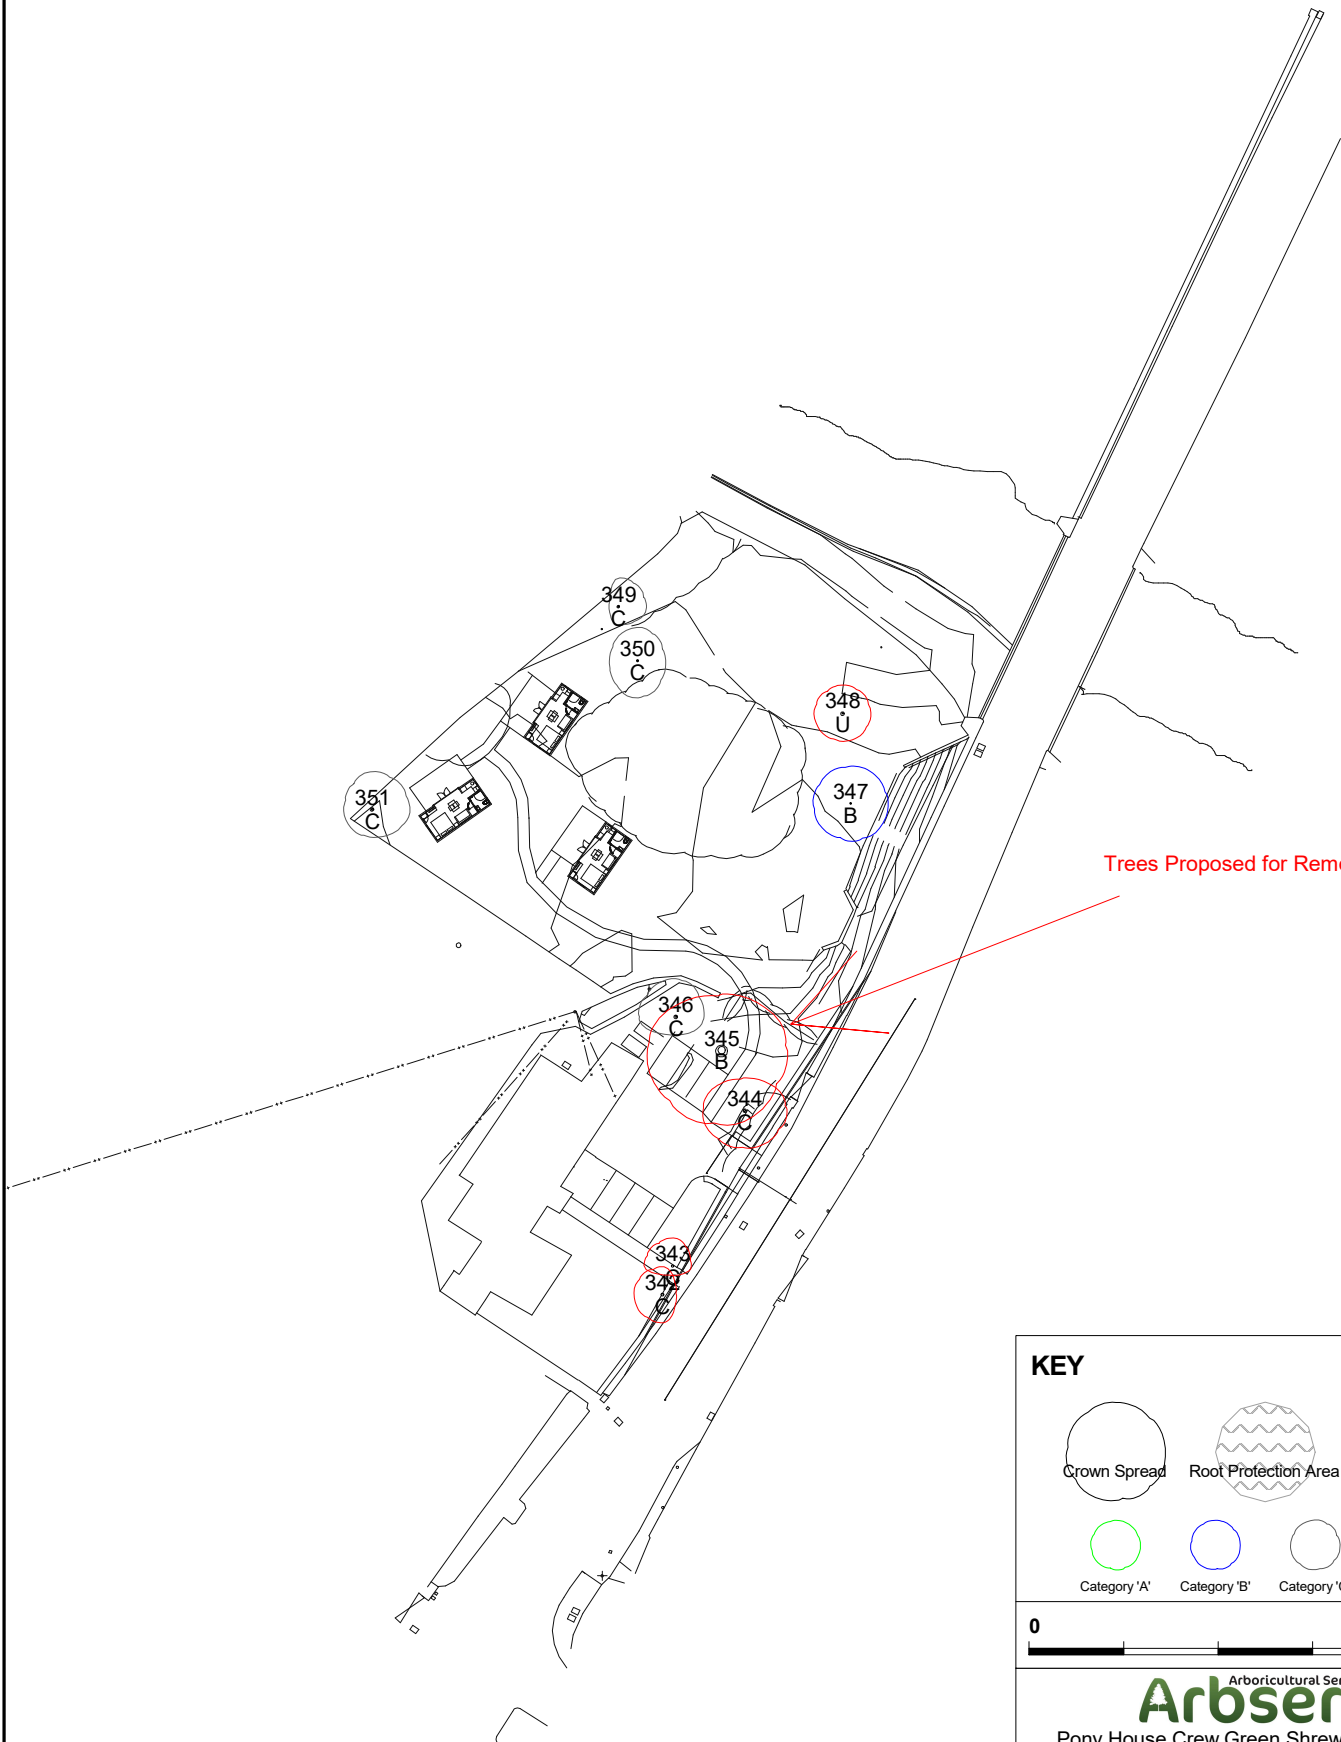
## Appendix 2 figure 2 Trees Proposed for removal.

- 8.2 Tree 348, category U unsuitable for retention and proposed for removal. Category U those in such a condition that they cannot realistically be retained as living trees in the context of the current land use for no longer than 10 years.

- 8.3 Trees 342, 343, 344 all category C are proposed for removal. The Arboricultural Impact for the proposed removal of 3 category C trees of low quality is moderate, compared to number of trees retained and protected on the proposed layout the Arboricultural impact for the whole site is low. The impact for the proposed removal of trees 342,343 2x Holly can be mitigated further by replanting 2x heavy standard Holly of similar size and location once the visibility splay wall has been rebuilt.

- 8.4 Tree 345 Category B Sycamore. Proposed for removal. Bifurcated stem with partial included bark. Root protection area falls within proposed parking area. The Arboricultural Impact for removing this tree can be mitigated by re planting 15 new standard size British native trees within open areas on the lower meadow to add amenity value to the site.

(FIG 2) Proposed removal plan

9.2 Fell and remove all category U trees and trees proposed for removal in red on figure 2.

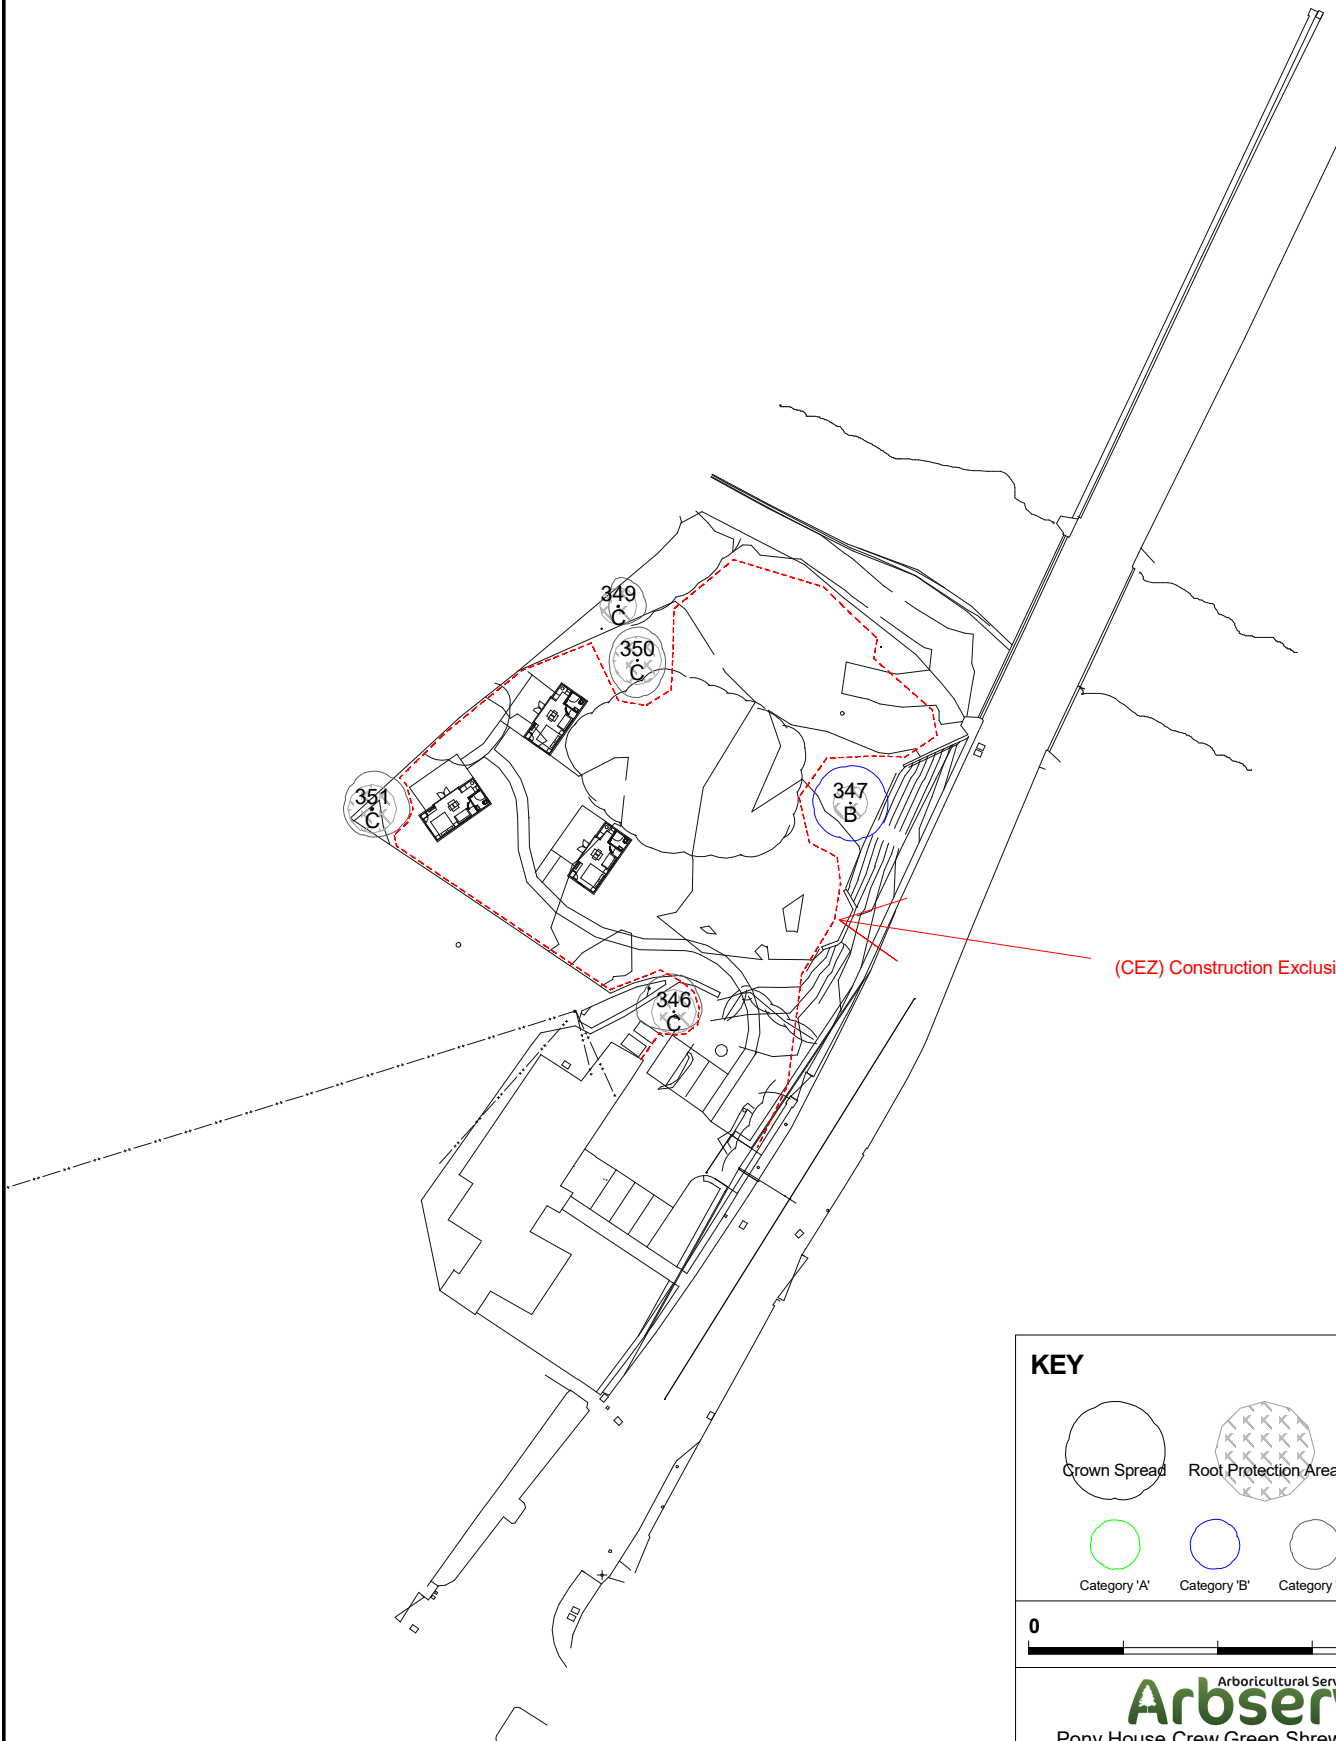
## Appendix 3 Tree Protection Plan.

- 8.5 The proposed building and parking area fall out-side the RPA'S of all other trees and hedges in the site parameter. (see figure 3 Tree Protection Plan) The Arboricultural impact on these trees can be mitigated by following the Arboricultural Method statement out-side RPA.

(CEZ) Construction Exclusion Zone

9.3 **Method out-side RPA** for all trees retained. The RPA shall be measured and clearly marked on site with the use of ground pins or marker spray. All relevant personnel should be briefed to ensure they are fully aware of the location and extent of the RPA'S Construction Exclusion Zone (CEZ). Install the section of Heras fence or similar barrier positioned as indicated on the tree protection plan to form a construction exclusion zone (CEZ).

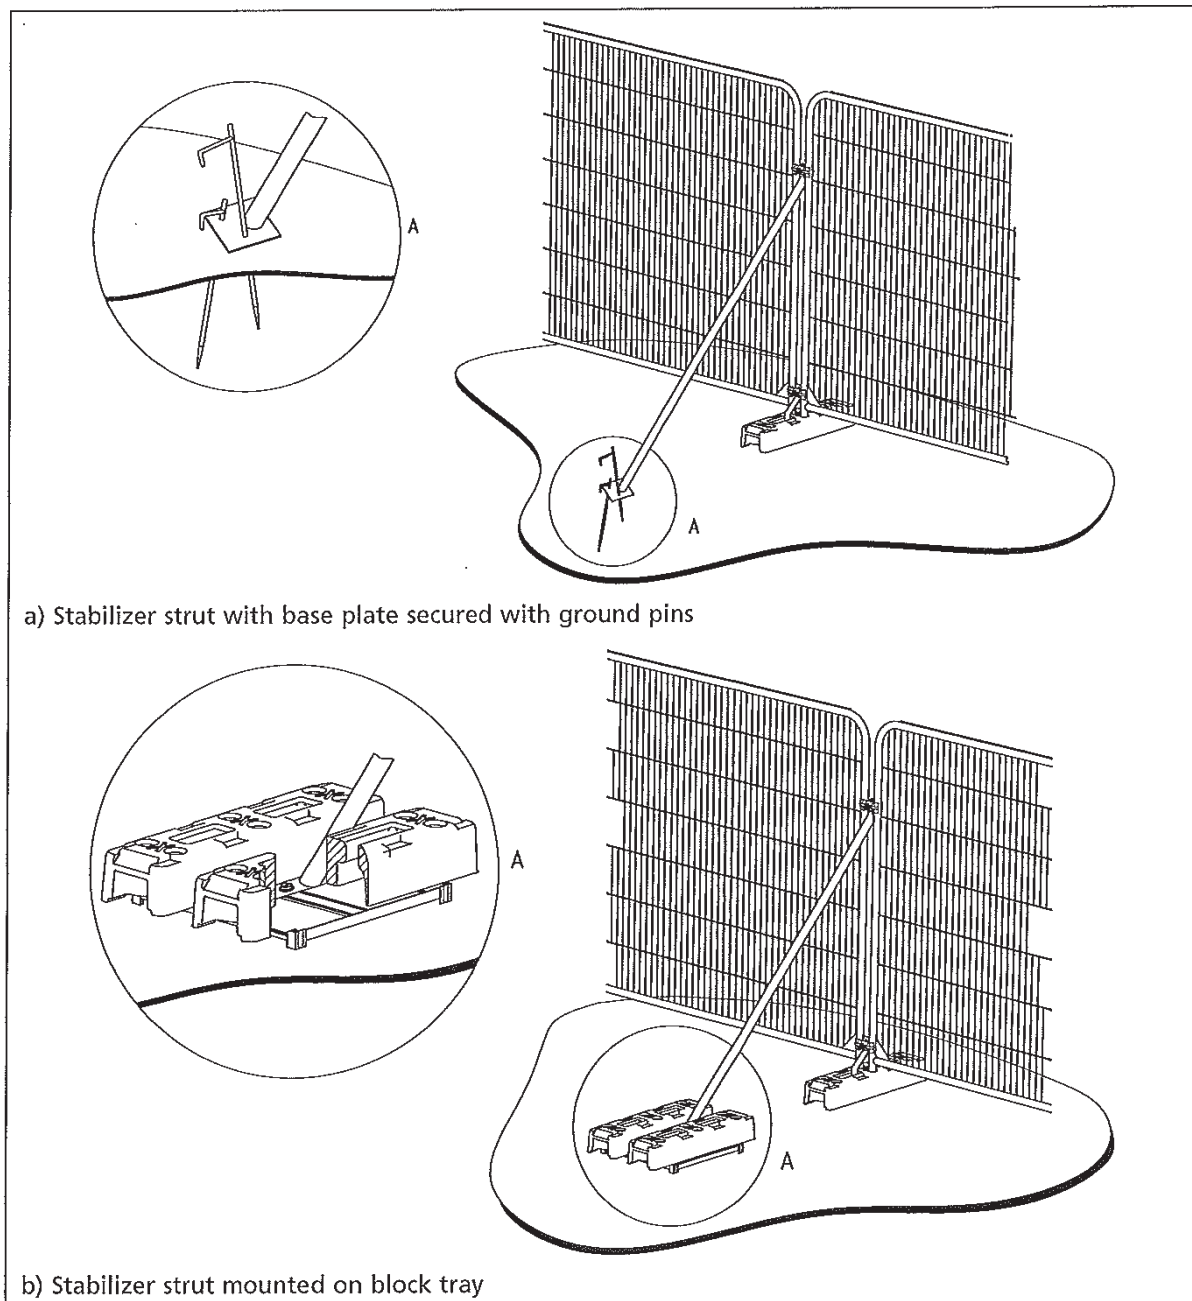
Figure 3 Examples of above-ground stabilizing systems

**6.2.2.3** Where the site circumstances and associated risk of damaging incursion into the RPA do not necessitate the default level of protection, an alternative specification should be prepared by the project arboriculturist and, where relevant, agreed with the local planning authority. For example, 2 m tall welded mesh panels on rubber or concrete feet might provide an adequate level of protection from cars, vans, pedestrians and manually operated plant. In such cases, the fence panels should be joined together using a minimum of two anti-tamper couplers, installed so that they can only be removed from inside the fence. The distance between the fence couplers should be at least 1 m and should be uniform throughout the fence. The panels should be supported on the inner side by stabilizer struts, which should normally be attached to a base plate secured with ground pins (Figure 3a). Where the fencing is to be erected

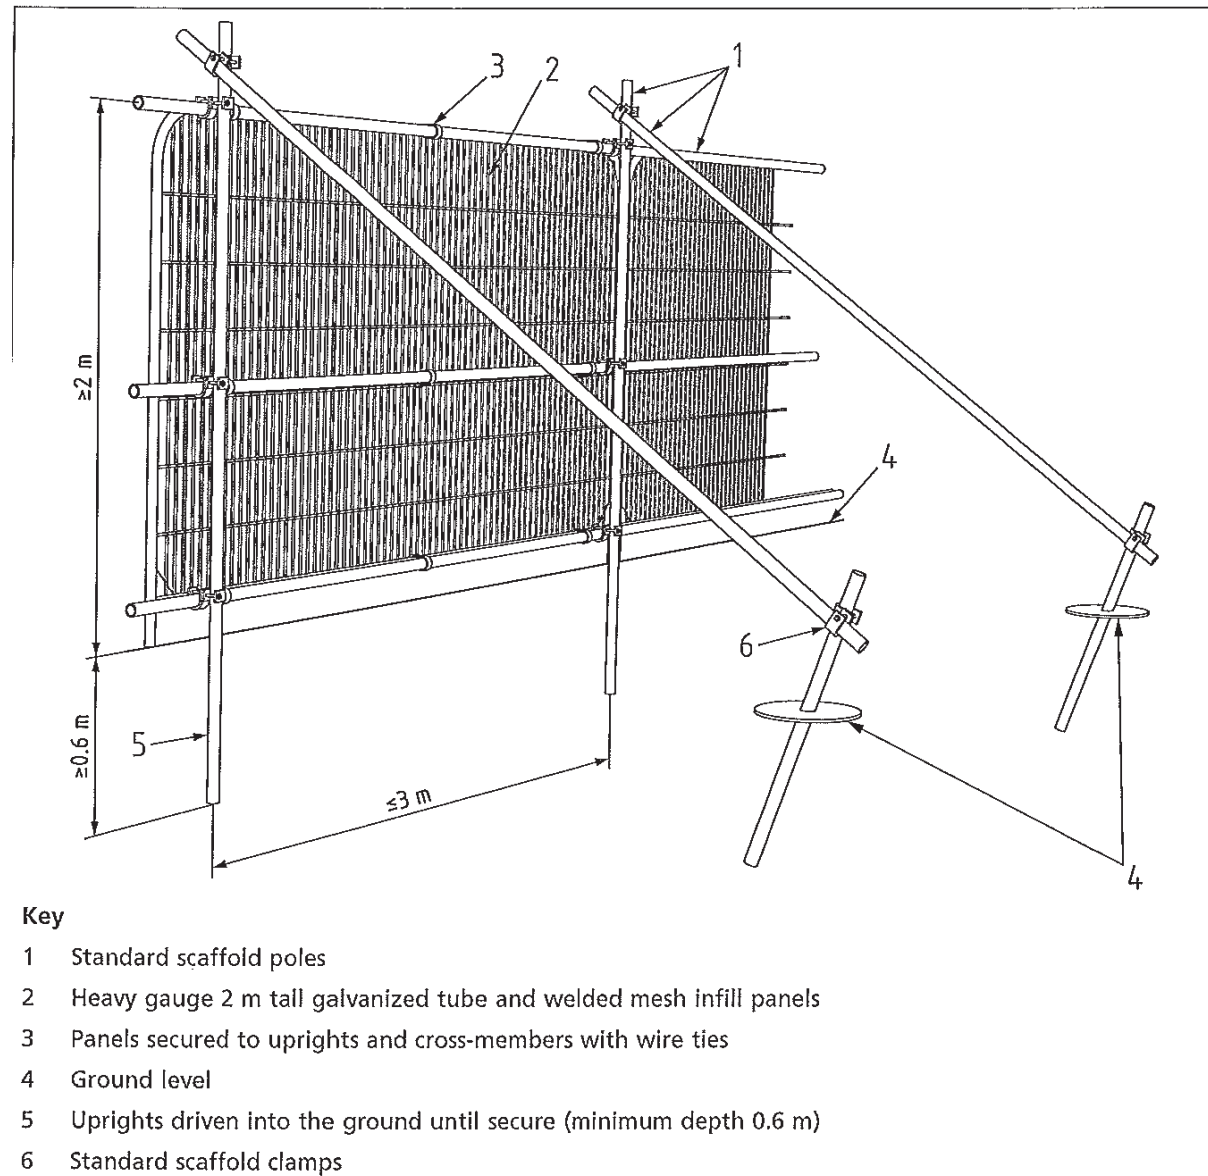
Figure 2 Default specification for protective barrier

**6.2.2.2** The default specification should consist of a vertical and horizontal scaffold framework, well braced to resist impacts, as illustrated in Figure 2. The vertical tubes should be spaced at a maximum interval of 3 m and driven securely into the ground. Onto this framework, welded mesh panels should be securely fixed. Care should be exercised when locating the vertical poles to avoid underground services and, in the case of the bracing poles, also to avoid contact with structural roots. If the presence of underground services precludes the use of driven poles, an alternative specification should be prepared in conjunction with the project arboriculturist that provides an equal level of protection. Such alternatives could include the attachment of the panels to a free-standing scaffold support framework.
