**REMEDIATION STRATEGY POLICY FOR  
GRESFORD ROAD  
LLAY, WREXHAM**

**REMEDIATION STRATEGY  
17040/REM/001/A**

### **PROPOSED RESIDENTIAL DEVELOPMENT**

#### **GRESFORD ROAD, LLAY, WREXHAM**

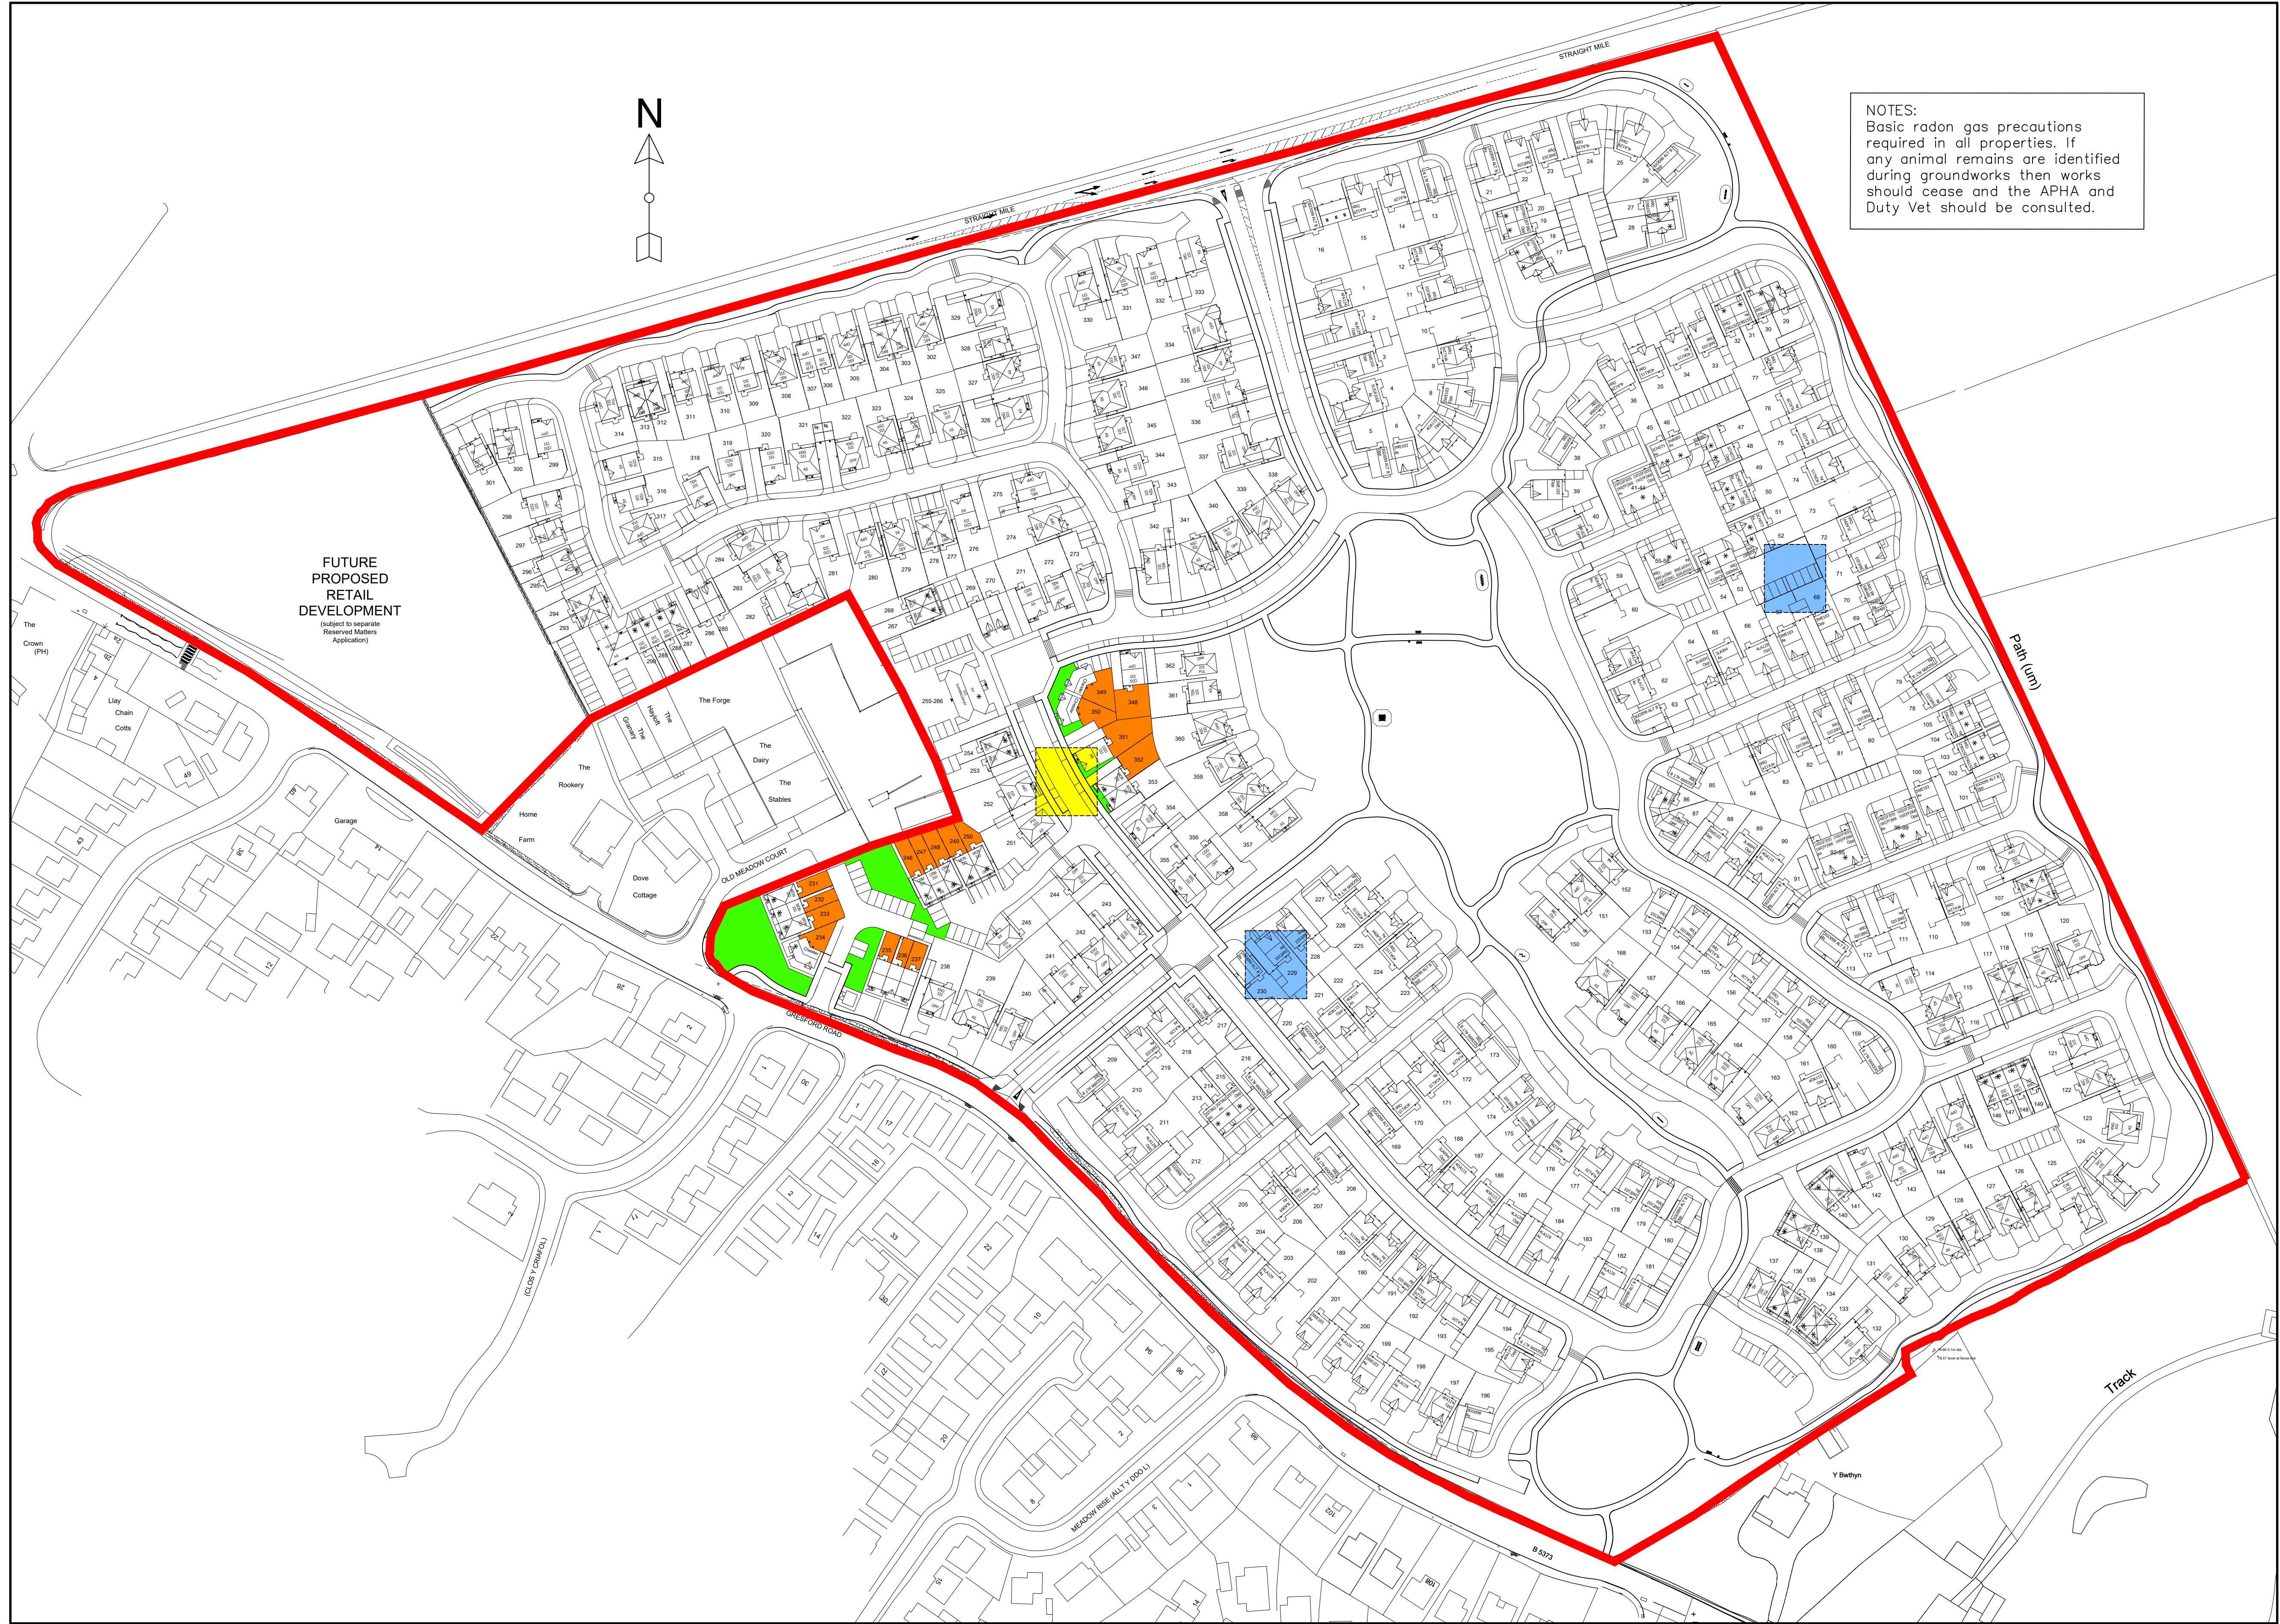
Drawing title  
Remediation Plan

NOTES:  
Basic radon gas precautions  
required in all properties. If  
any animal remains are identified  
during groundworks then works  
should cease and the APHA and  
Duty Vet should be consulted.

- KEY
- Approximate site boundary
  - Front garden landscaped areas where ground levels should be reduced or raised to accommodate 450mm of clean inert capping. Capping should consist of at least 150mm of topsoil.
  - Rear garden areas where ground levels should be raised or reduced to allow for at least 600mm of clean inert capping. Capping should consist of at least 150mm of topsoil.
  - Approximate location where animal remains have been identified and will require appropriate disposal in accordance with APHA and Duty Vet guidance.
  - Approximate areas where landowner has indicated where animal remains may be present but not identified during the site investigation.

- 2.6 Supplementary site investigation was undertaken within the rear garden areas of plots 271 – 273 in December 2019 to re-evaluate the requirement for a clean capping system within the garden areas of these plots. The topsoil had been removed during the development works to reveal natural clay strata and trial pits confirmed that no made ground deposits were present within the garden areas of plots 271 – 273 and the strata comprised solely of natural clay strata proven from ground level to at least 1.3m bgl. No visual or olfactory evidence of contamination was observed within the natural clay strata and reference to the initial desk study has confirmed no evidence to suggest naturally arising elevated concentrations of contaminants within the natural strata. It was therefore confirmed that a clean capping system is not required within the garden areas of plots 271 – 273. The full details of this investigation are provided in report reference MGD/17040/01, dated December 2019 and the remediation plan has been updated to reflect the results of the supplementary site investigation (drawing reference; 17040/25/A).

- Previous ground investigation has identified the presence of animal remains and these are identified on the appended remediation plan. Other areas of potential burial sites were indicated by the landowner but no animal remains have been identified. The ground workers should maintain a watching brief throughout the ground works across the site to identify any potential animal remains during excavation works. If animal remains are identified then excavation works should cease and they should be backfilled immediately and contact should be made with the APHA and the duty vet to arrange appropriate disposal.

- 4.4 Where garden levels are to be raised, natural clean uncontaminated site arising material can be utilised for these purposes, or where unavailable, clean inert material may be imported to the site from a certified source. Where any materials are imported to site it will be necessary for these materials to be sampled and tested in accordance with the procedures detailed below to confirm their suitability for use within a residential environment.
- 4.5 Details of the remediation measures are shown upon appended drawing number 17040/25/A for reference.
