## HERITAGE IMPACT ASSESSMENT -

**The conservation-led redevelopment of the Patternmakers & Carpenters Workshop, including reinstatement of the roof structure, extensive fabric repairs and new visitor interpretation facilities.**

# Sketch Design Proposals - Pattern Shop Existing Photographic Record and Reconstruction Notes

**Brymbo Heritage Trust - Proposed Regeneration Project**

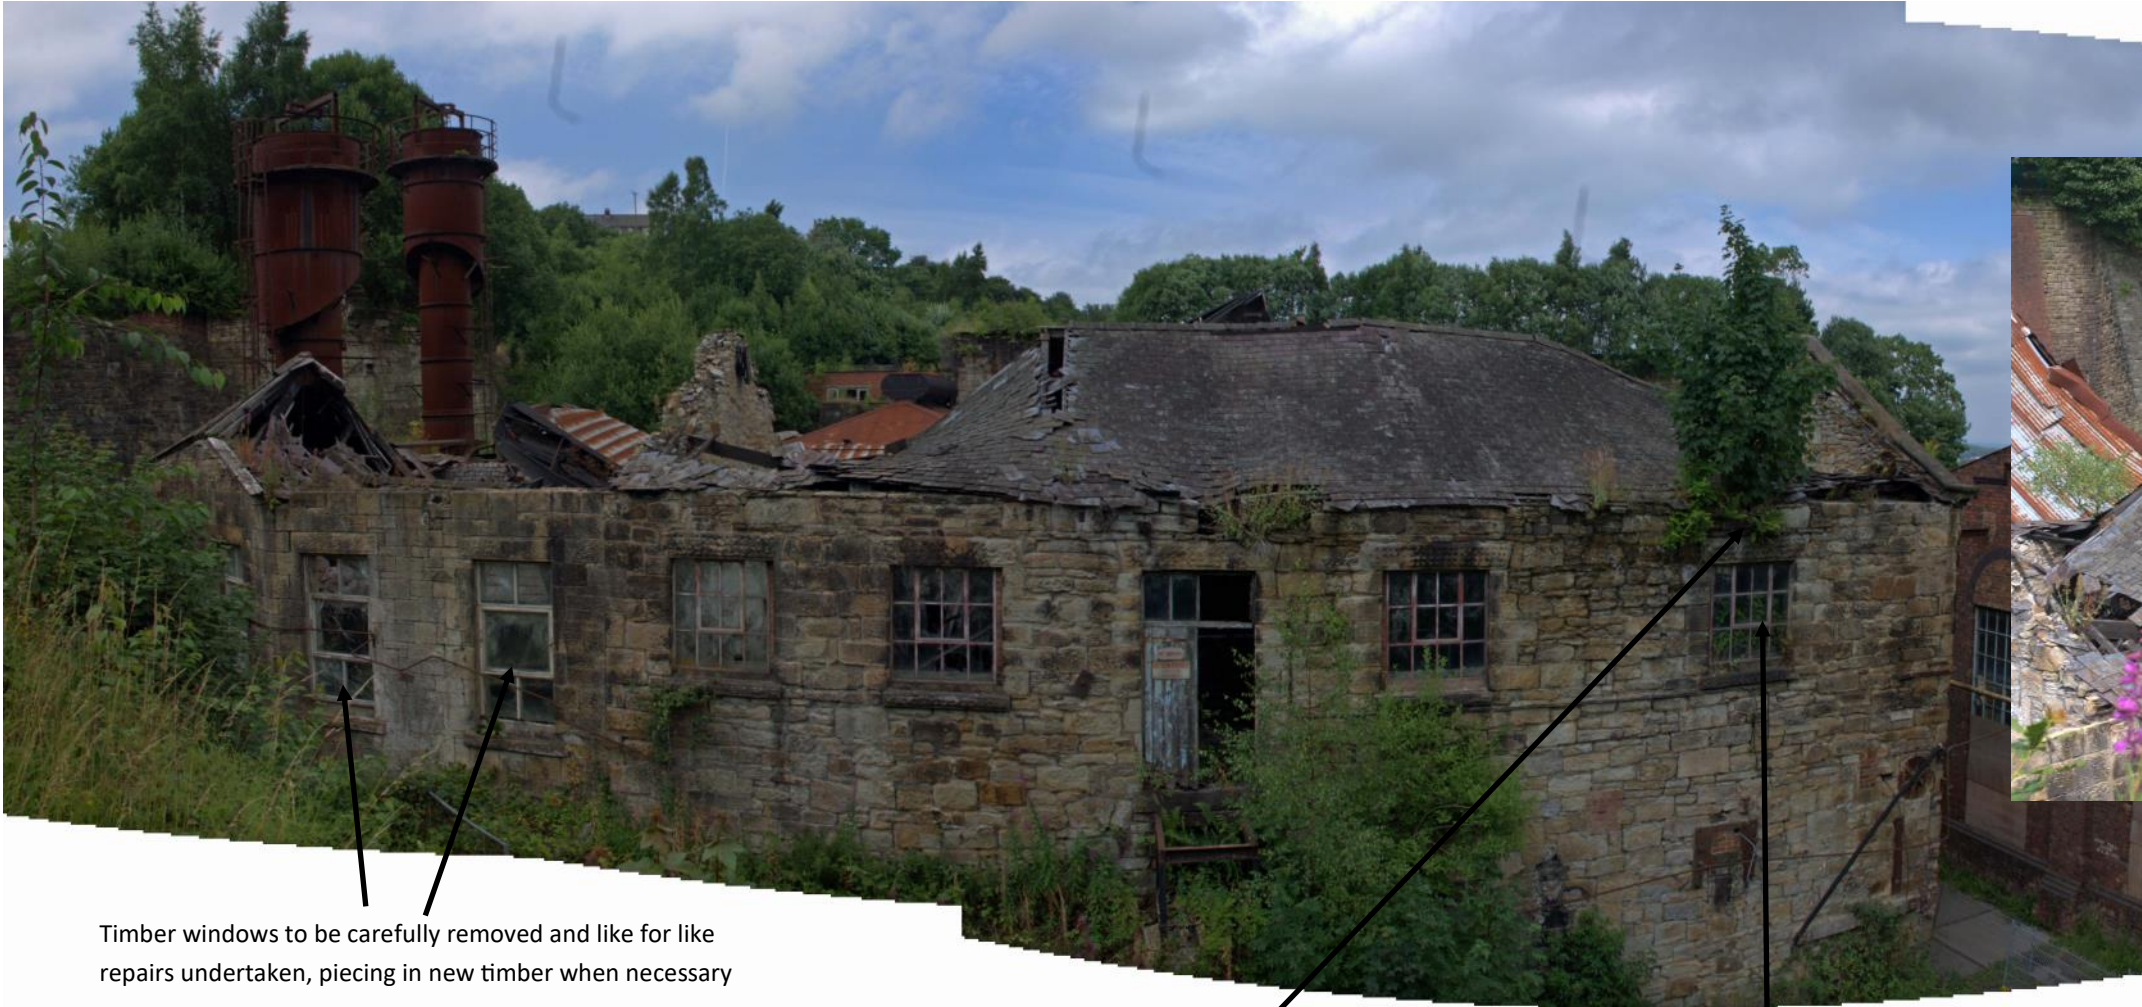
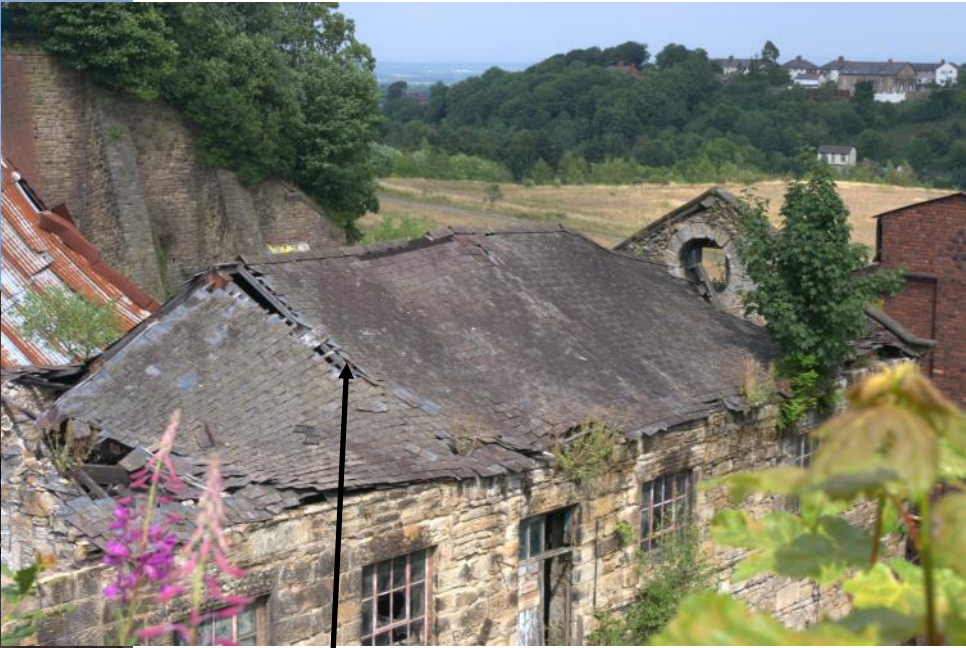
Timber windows to be carefully removed and like for like repairs undertaken, piecing in new timber when necessary

Note truss position

Metal windows to be deglazed, removed and overhauled before being refixed on a like for like basis

Between 4-5 additional courses of stonework need to be rebuilt over the head of the existing windows to realign with the gable and the rest of the elevation

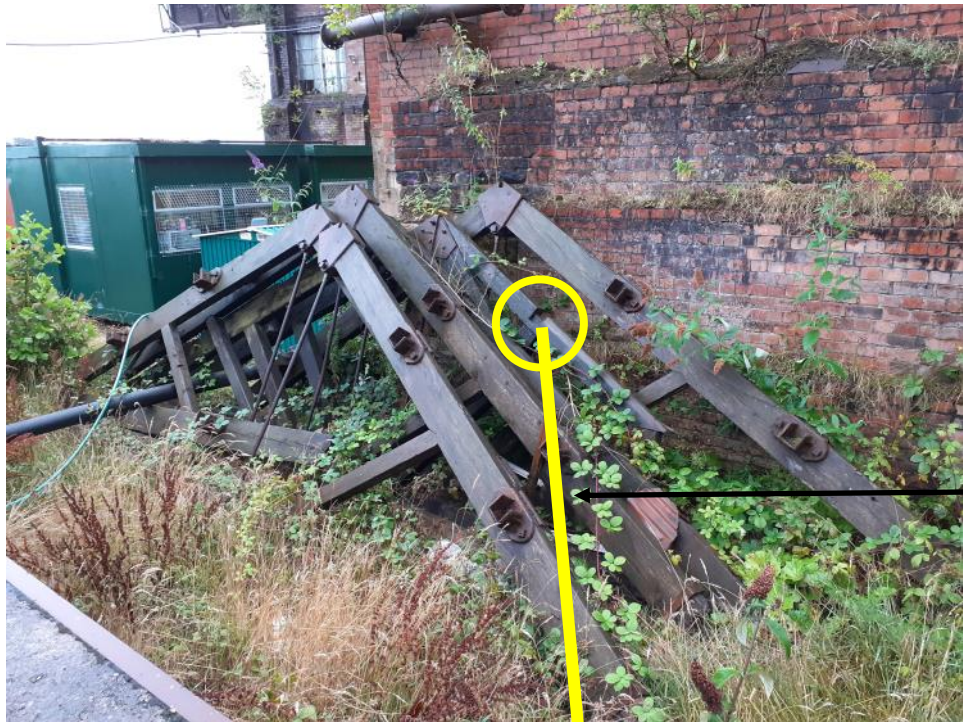
This is the same modified roof truss and runs parallel with all other roof tresses, though it will be picking up the hips to the adjacent pitches

Intermediate wall to be rebuilt fully in two faces of uncoursed random stone-work and core material

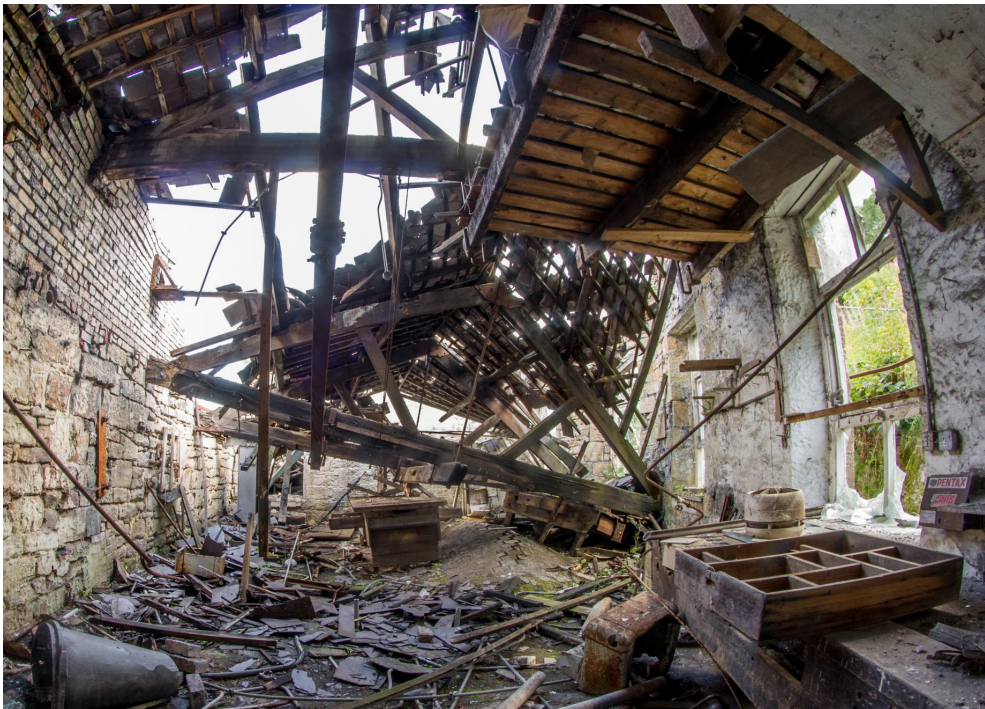
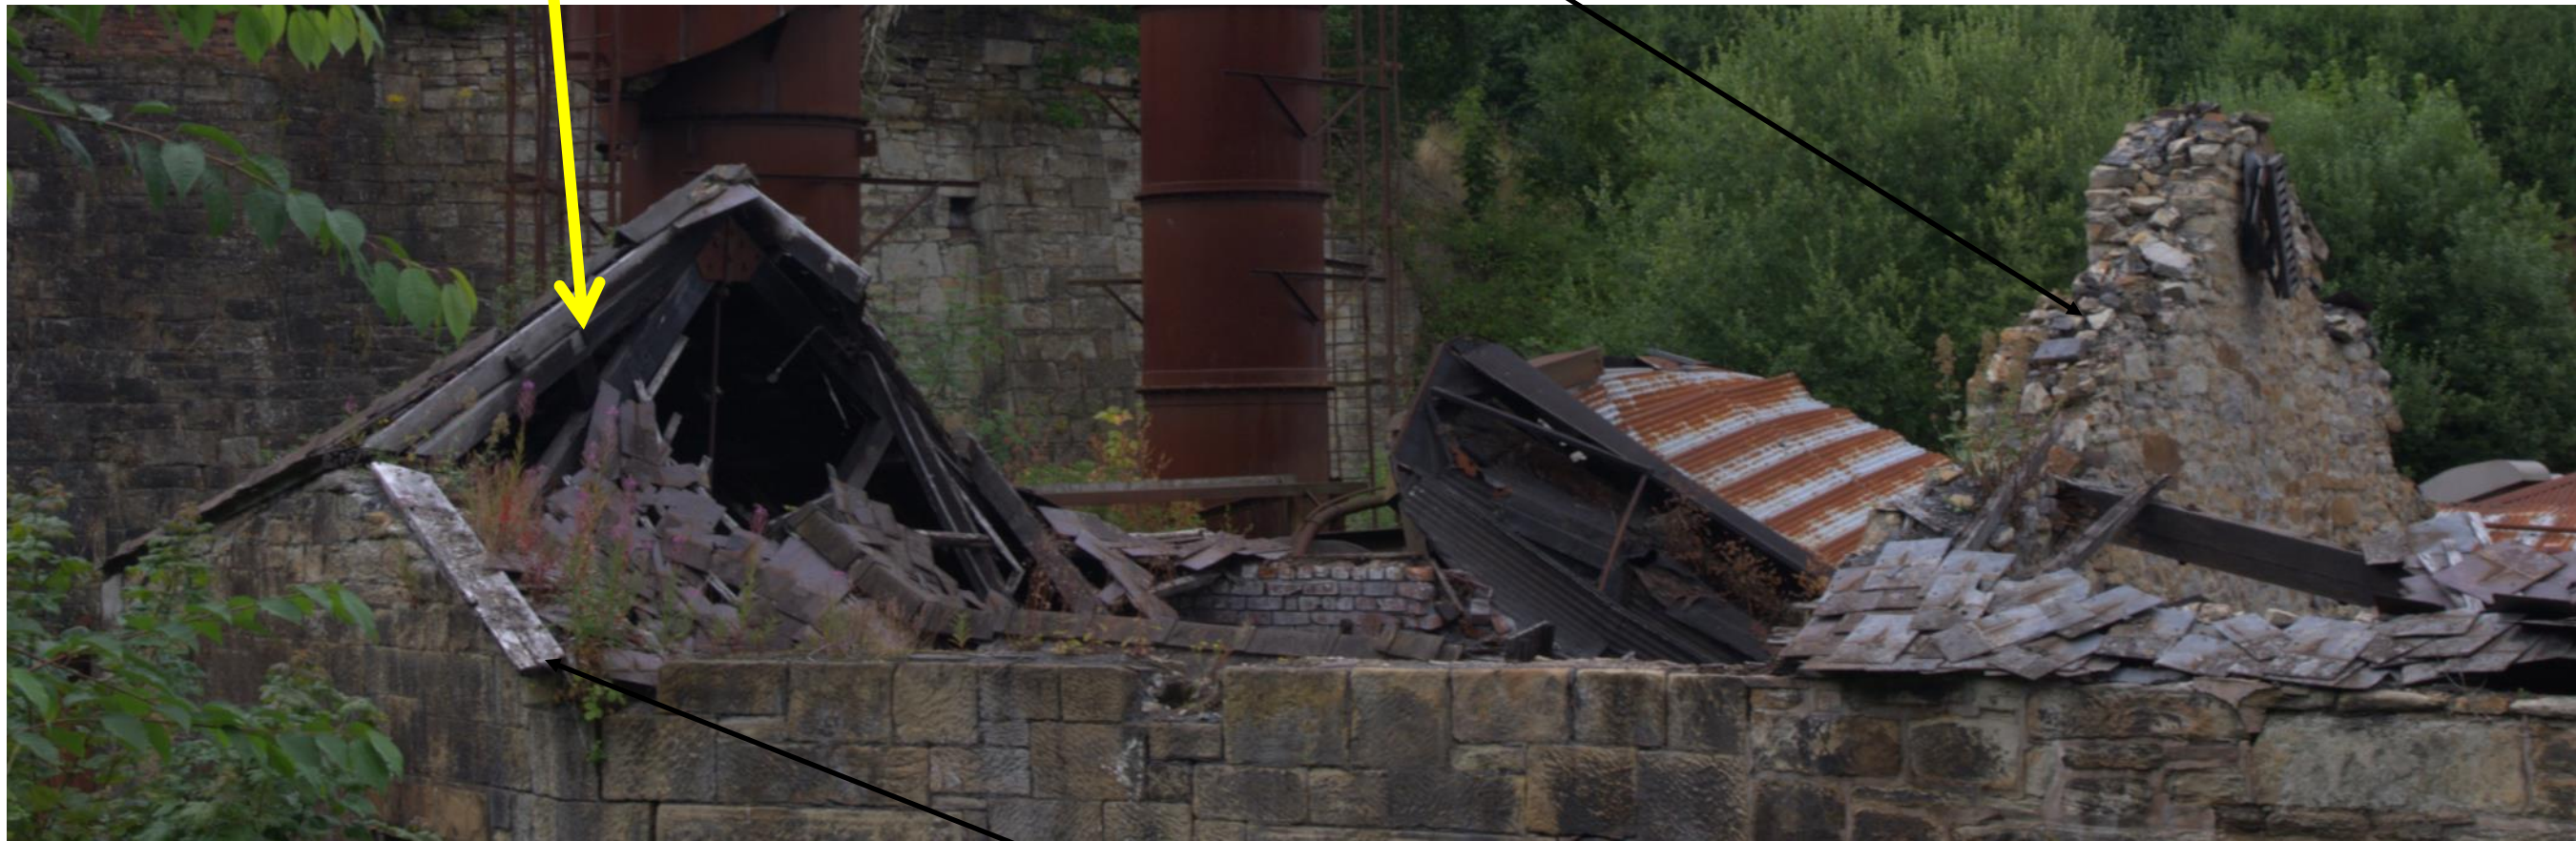
Note triangular shape of wall plate here

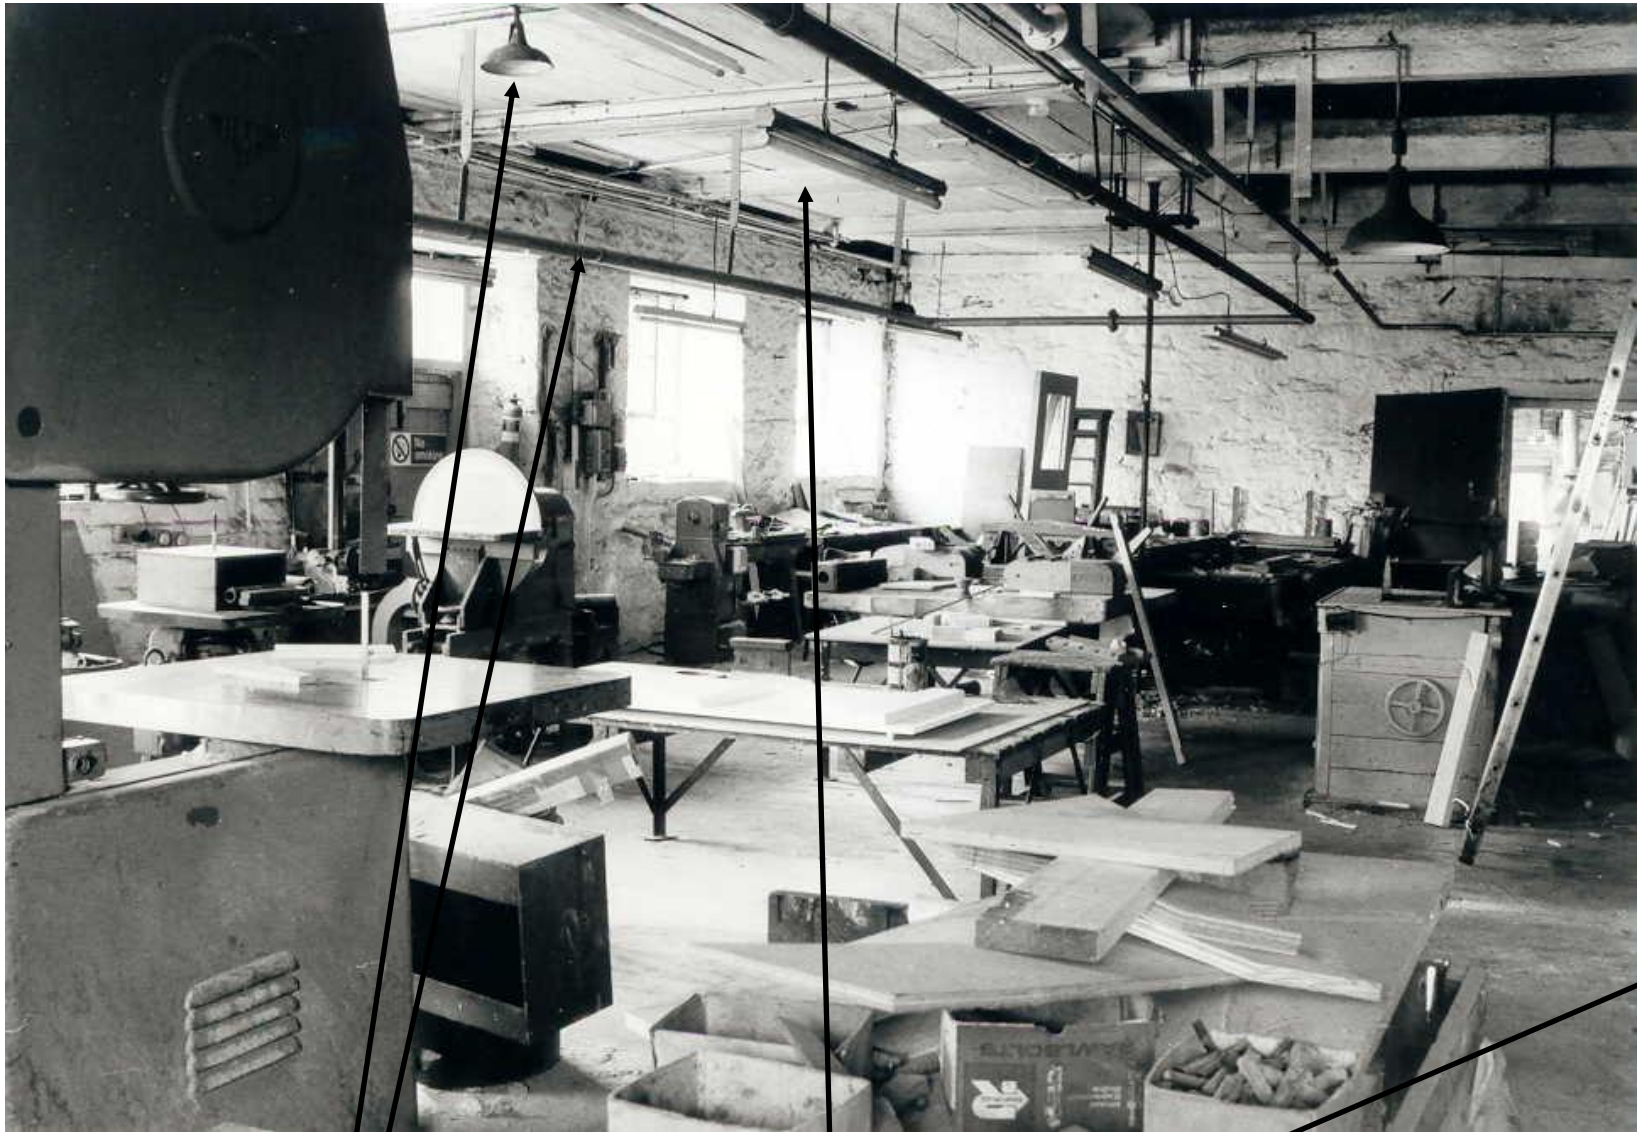
Note heating pipework and light fittings used originally

Note ceiling fitted between the cords to the trusses

Design detail and extent of existing shelving for reinstatement could be indicated on the drawings for SMC purposes

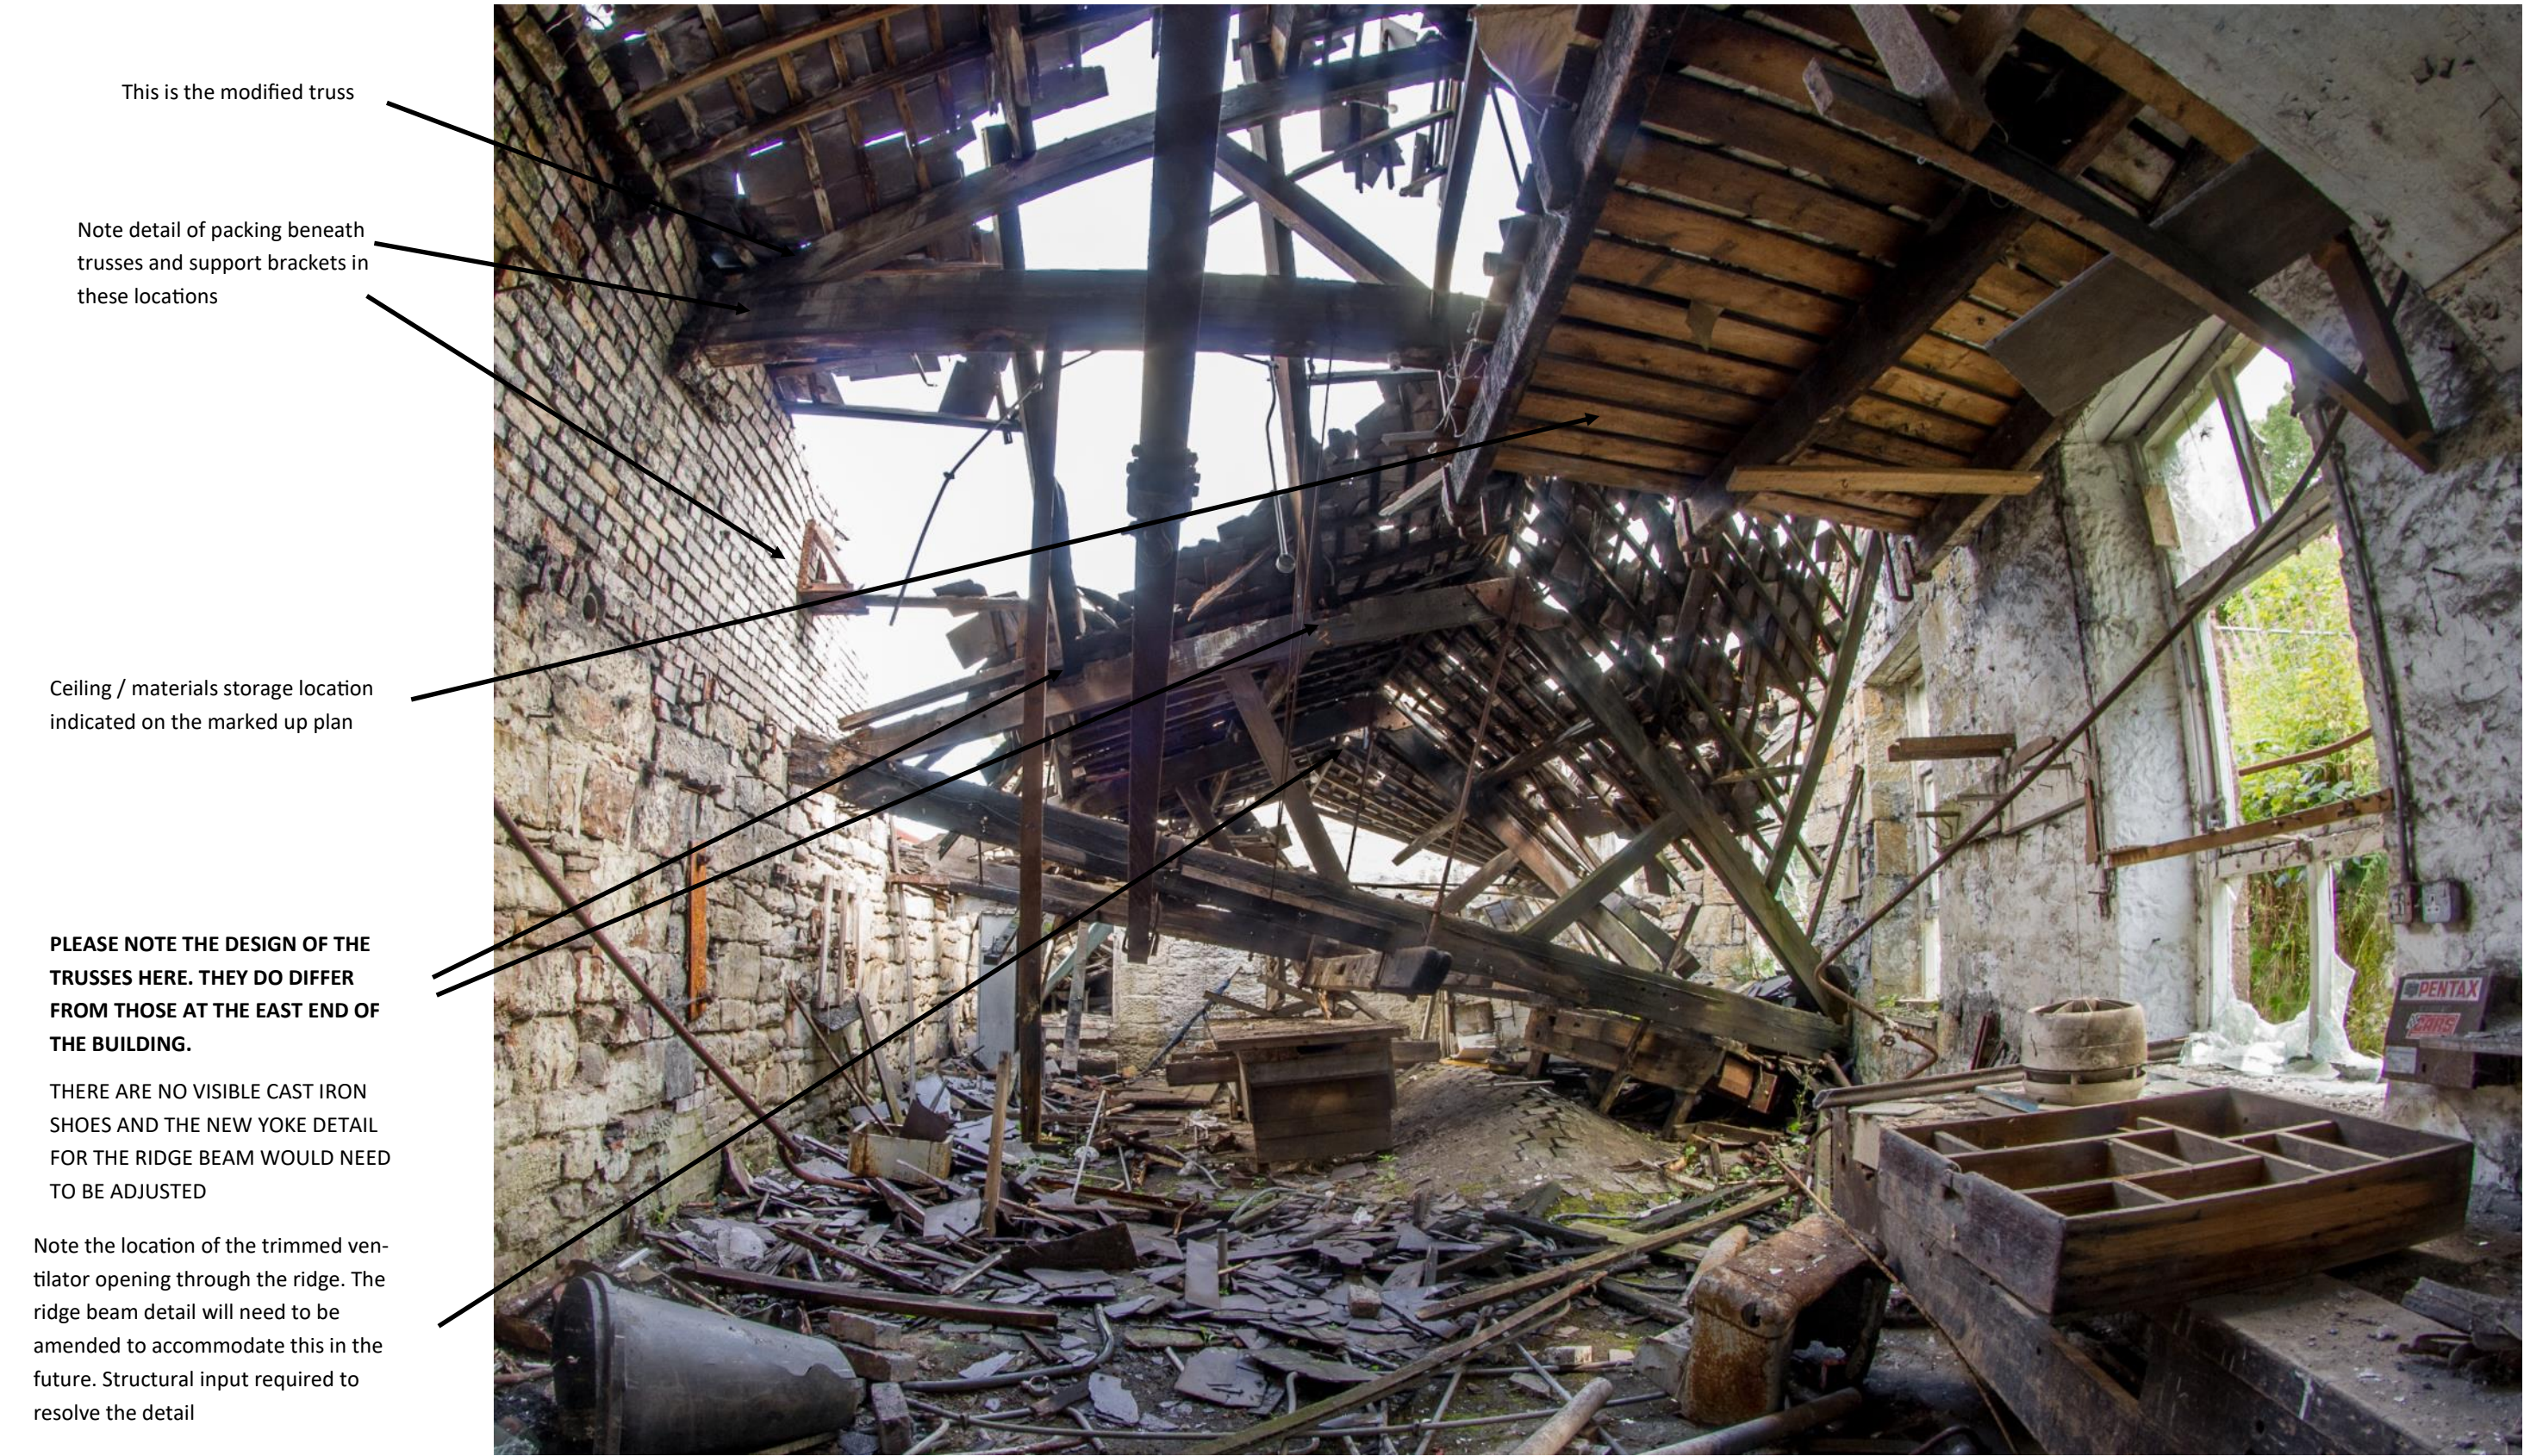
Ref: SK-01 Scale: +/- 1:20 Date: 14.09.19

# Sketch Design Proposals - Pattern Shop Existing Photographic Record and Reconstruction Notes

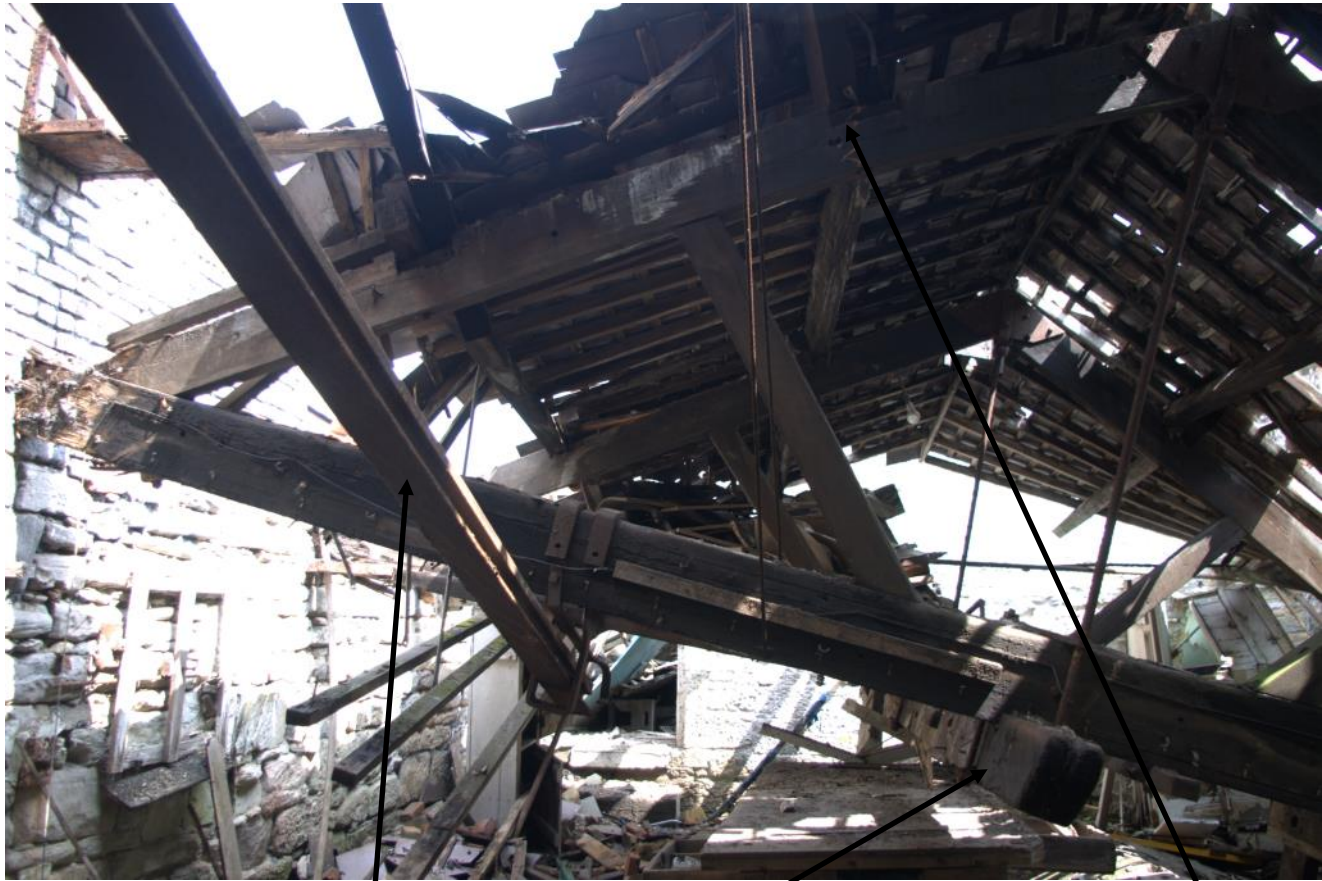
Note lifting beam and fixing details of elements that should be reintroduced under the SMC as the evidential information is available to do so.

Note side by side positioning of the purlins at this end of the building

Strategy to be developed for the recording, lifting and air drying of the existing timber block floor. Floor to be lifter and palletised before cleaning and air drying. Floor to be re-laid on like for like basis on completion of the structural repair works.

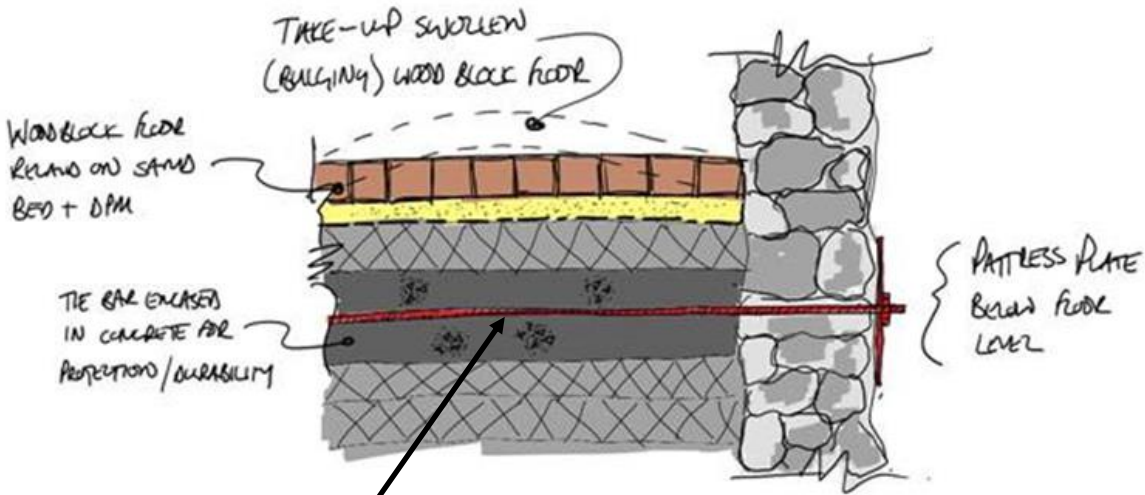
See floor plan for the insertion of ties beneath the existing floor construction. See above WSP details

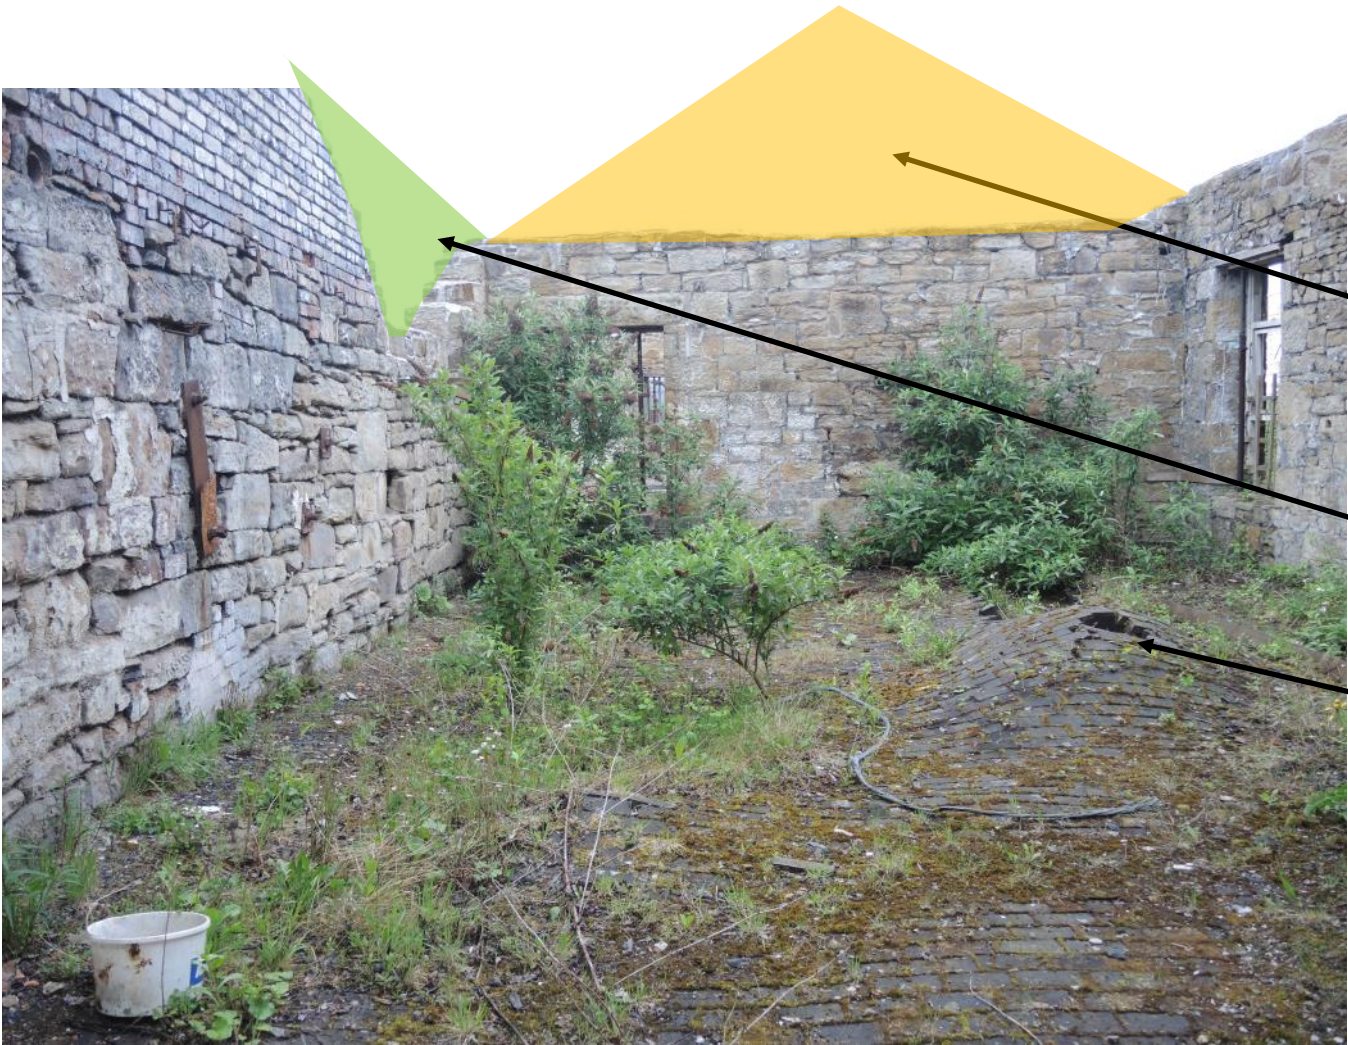
Stonework to be rebuilt to the underside of the roof construction

Walls to be rebuilt in panels of facing brickwork and stonework to match existing

Nature and composition of the block floor is yet to be determined as access has not been permissible for Health and Safety reasons

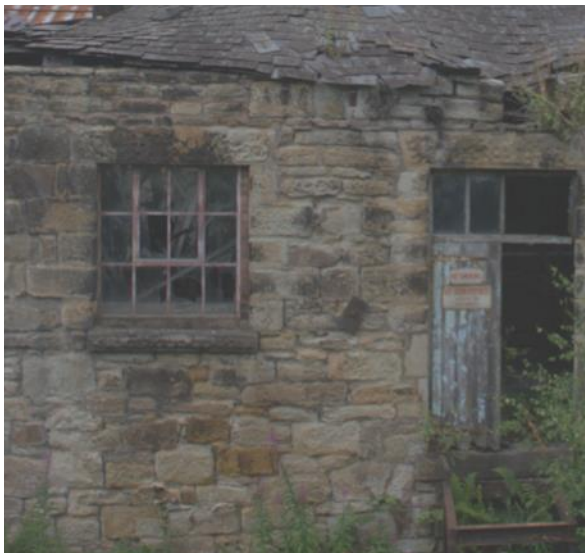
Detail of the existing metal and timber windows

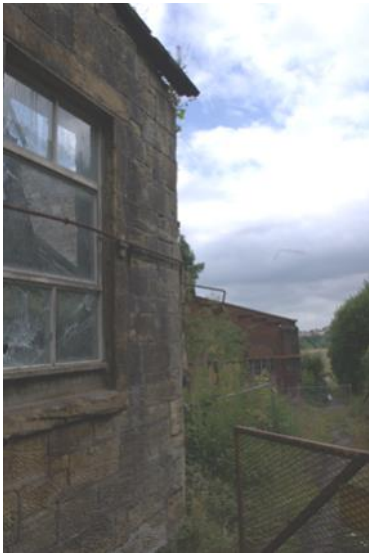
Simple timber balustrade could be considered to replicate the existing

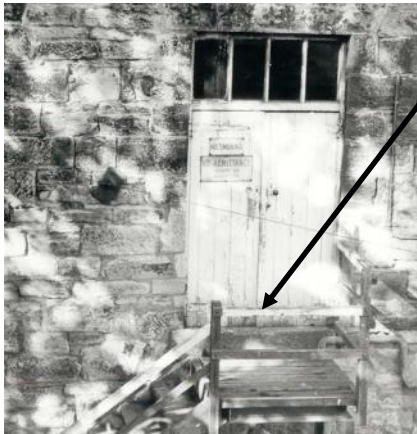
Reinstatement of the outward opening door detail.

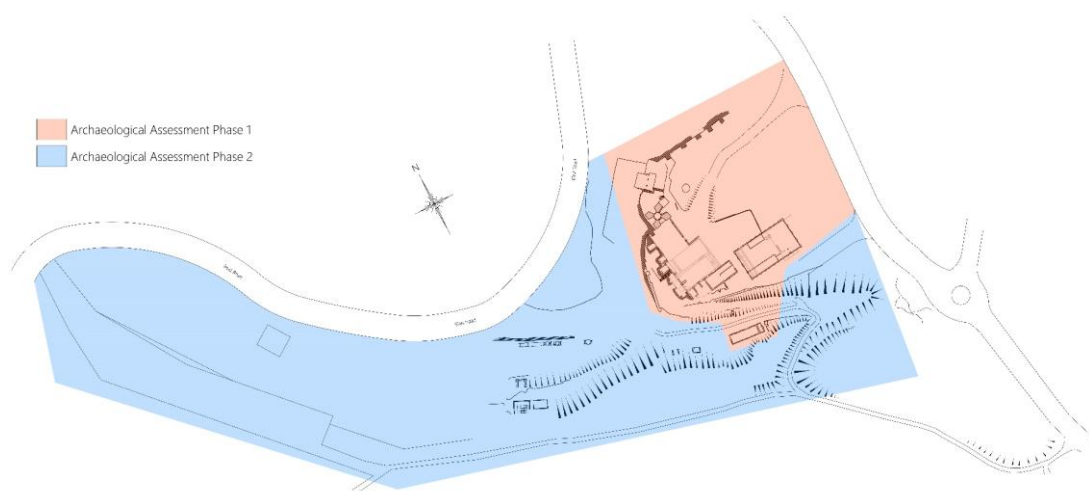
*Fig. 1 – Brymbo Ironwork Archaeological Assessment Phase 1 and 2 Areas.*

- 1.2 The production of the Archaeological Assessment will be undertaken in two phases (Fig. 1 & 4). Phase 1 (red) will focus on the lower site, up to the Agents House. Phase 2 (blue) will cover the upper end of the site, from the Agents house onward.

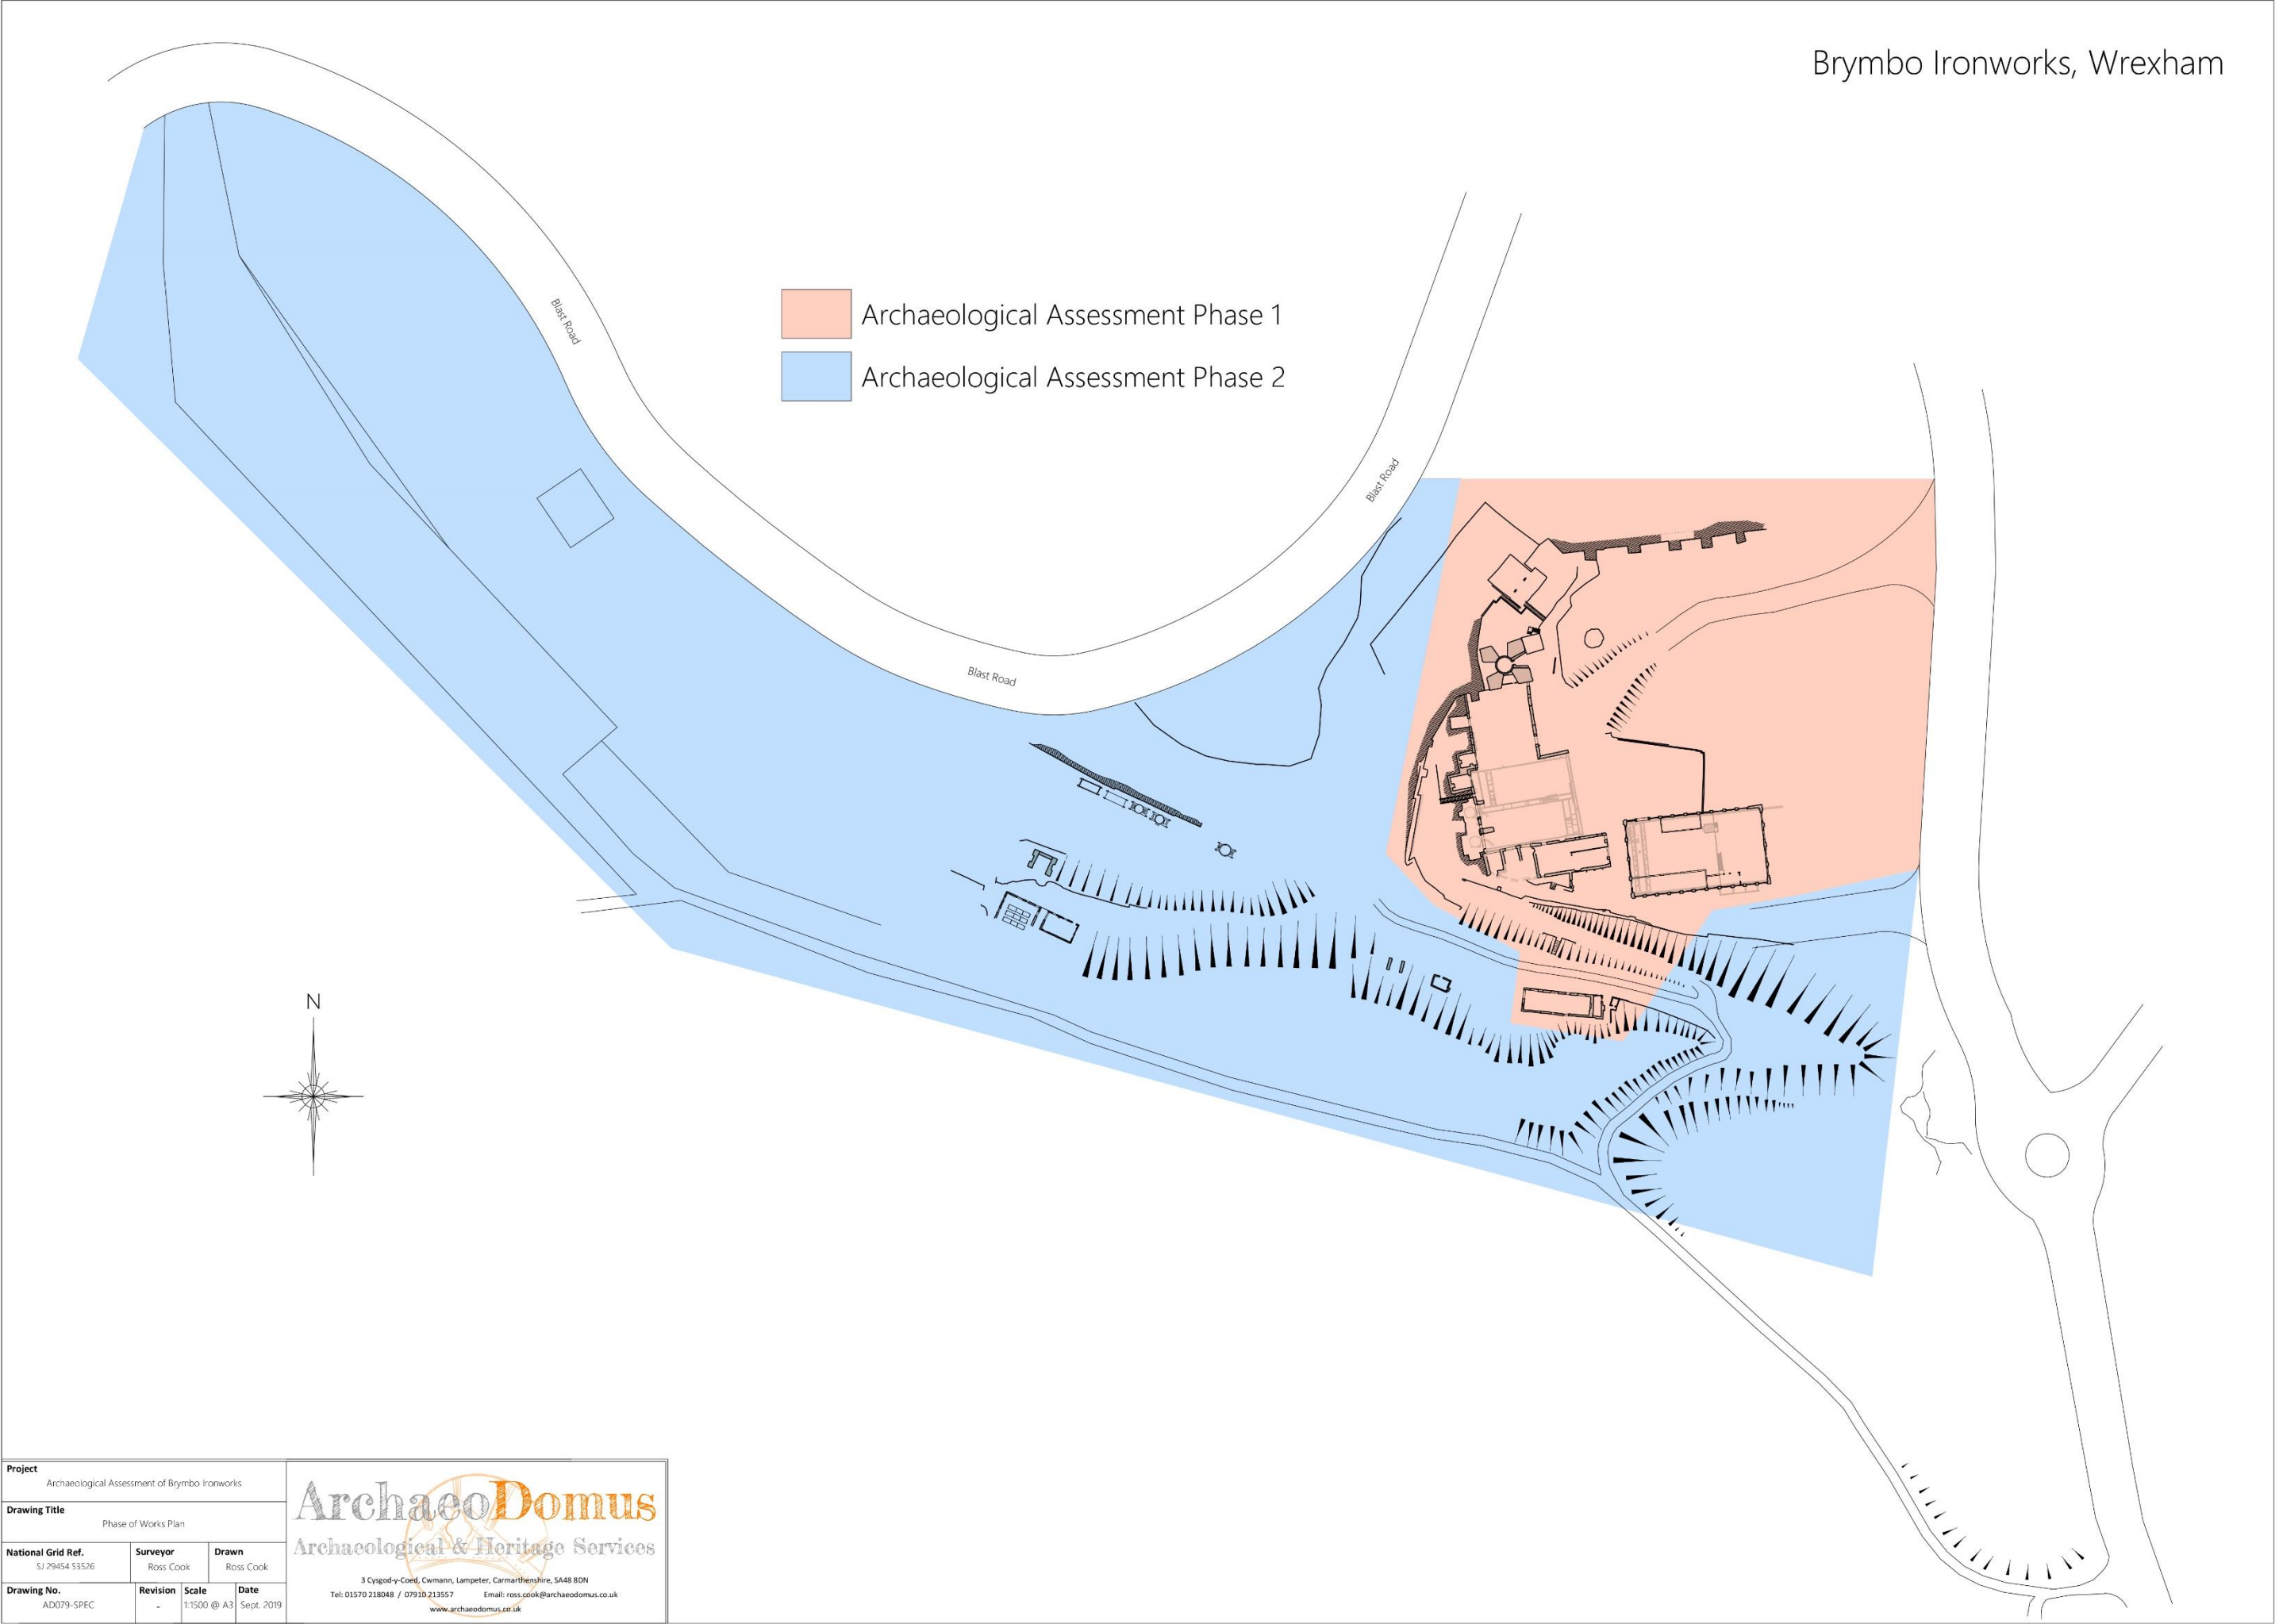
Fig. 4 – Archaeological Assessment Phase 1 and Phase 2 Areas.
