## REMEDIATION STRATEGY

### JACQUES WAY, WREXHAM

REC REFERENCE: 108157P3R3

REPORT PREPARED FOR: CASTLEMEAD GROUP LIMITED

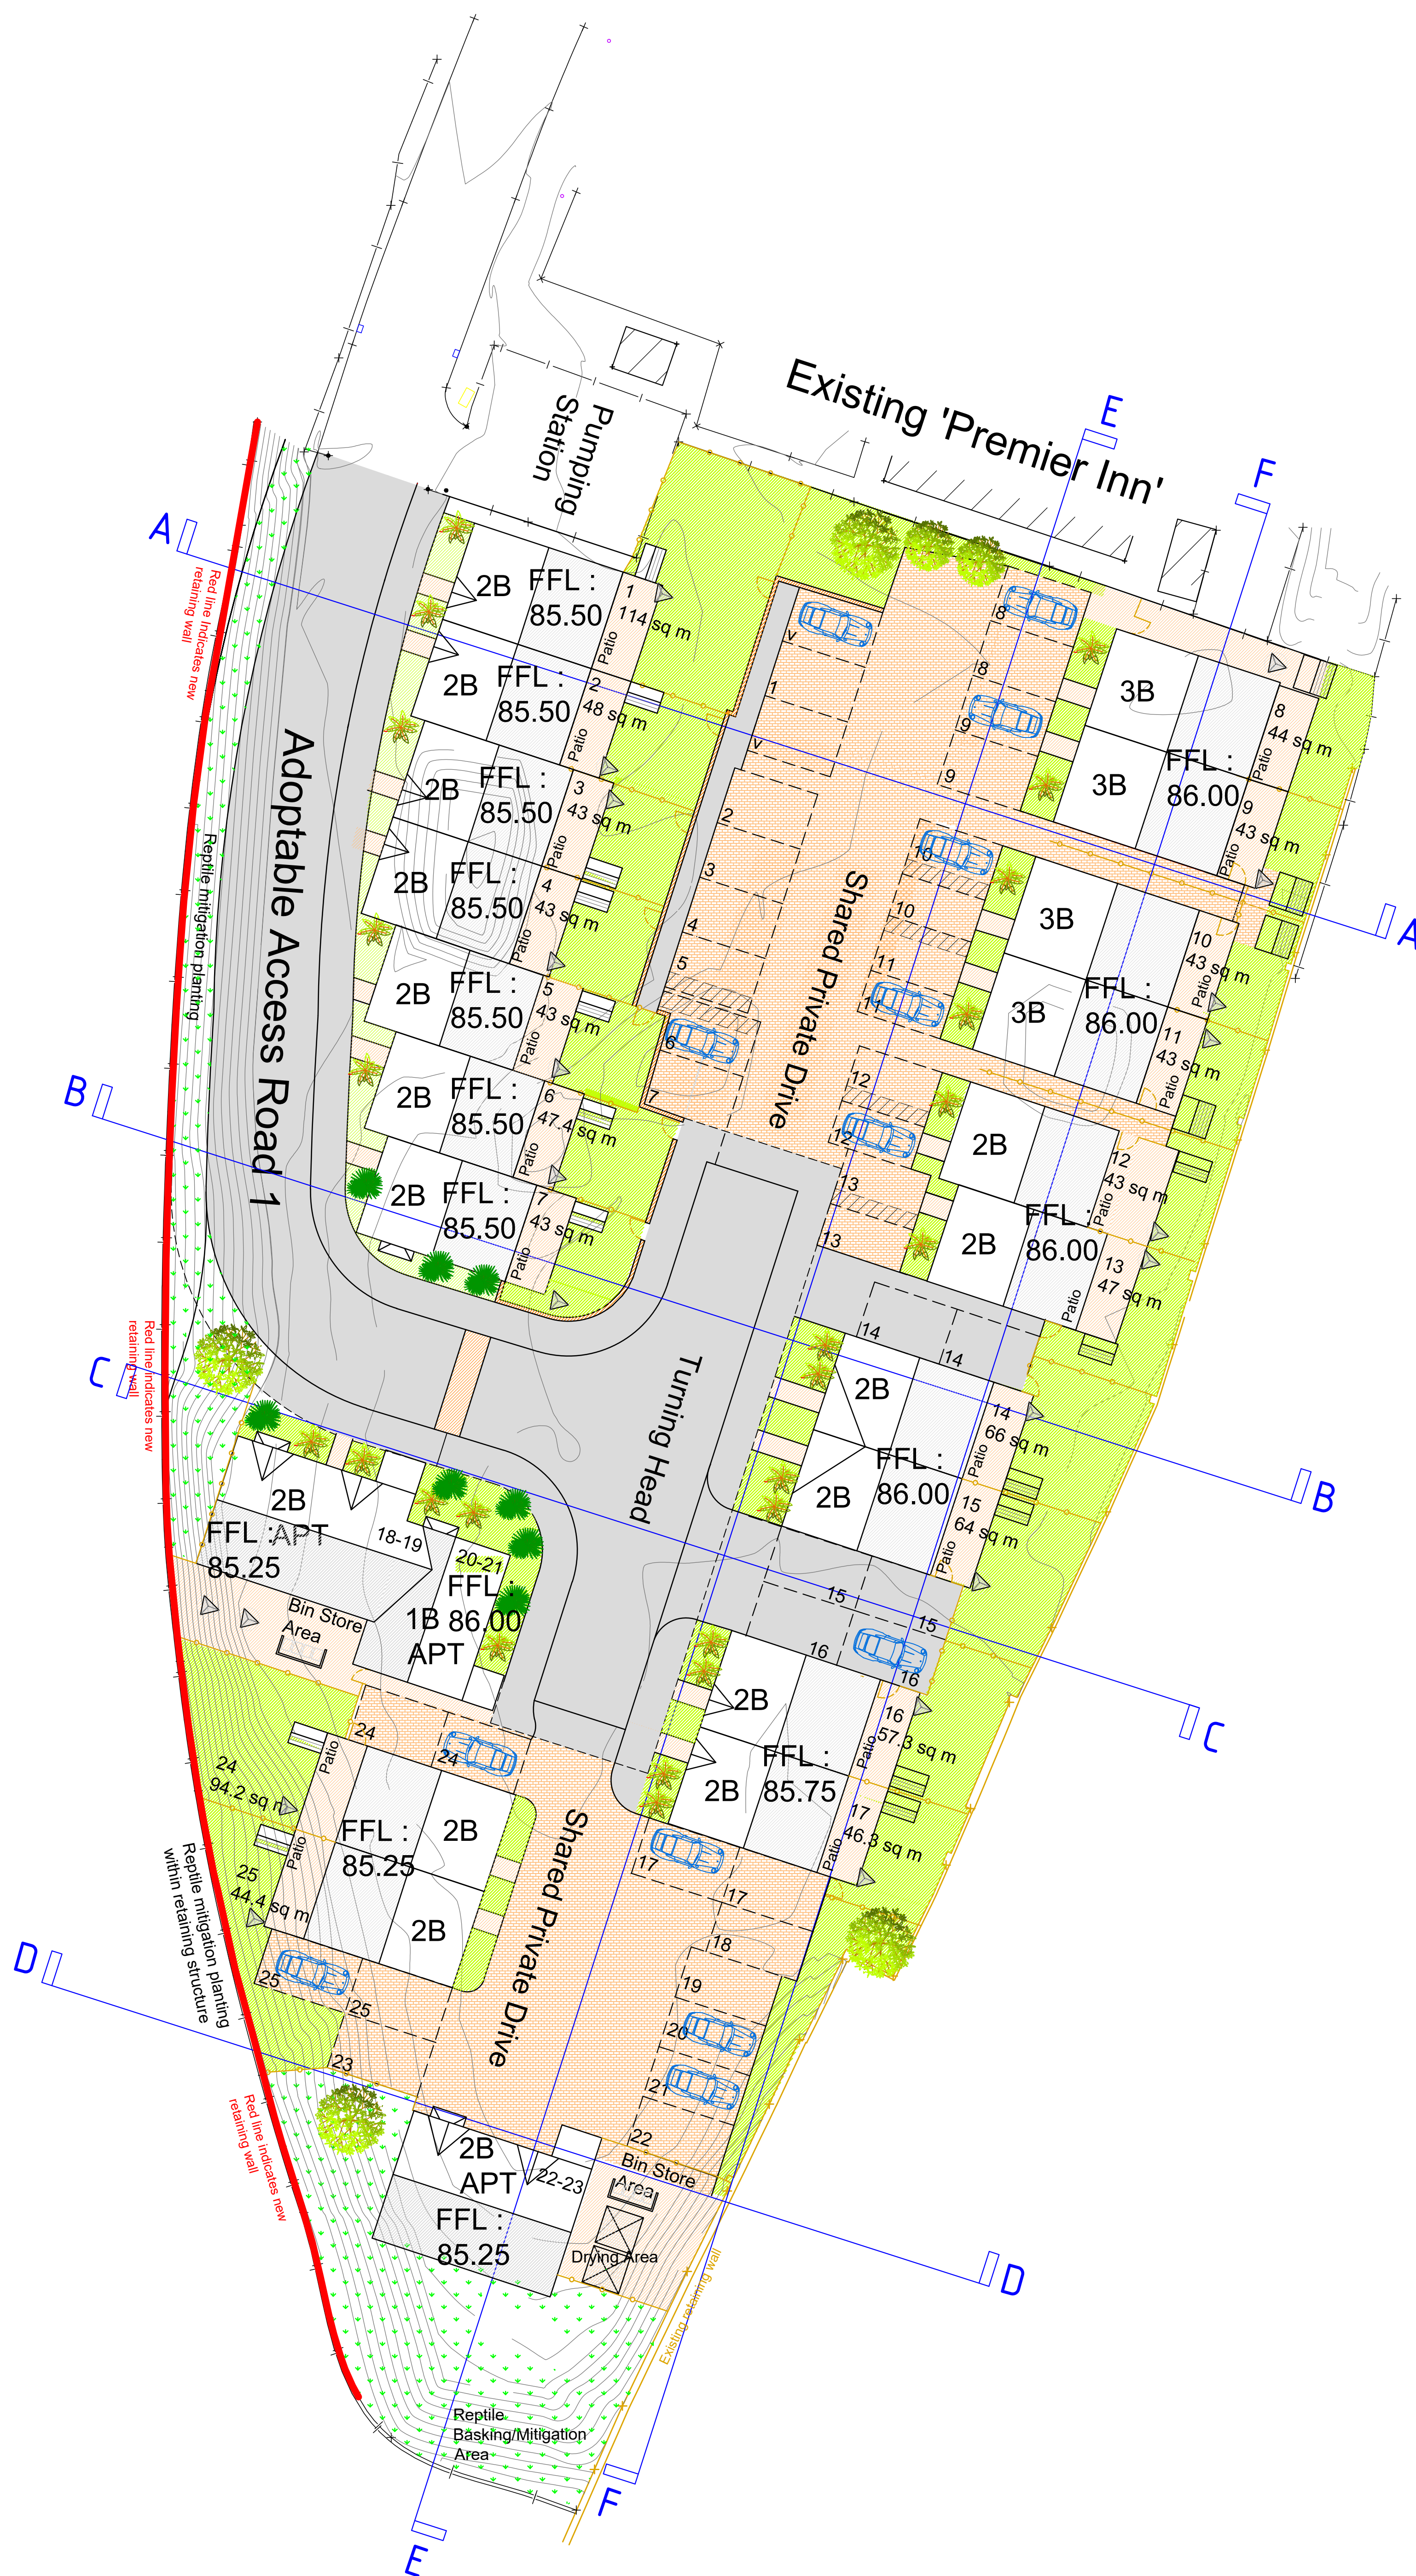
The proposed development at the site comprises the construction of residential dwellings. A proposed development plan (HDS Architectural Services – Site Plan as Proposed – JWA/PD/00 revision I) is shown in Appendix III.

| | HDS Architectural Services – Site Plan as Proposed – JWA/PD/00 revision I | |

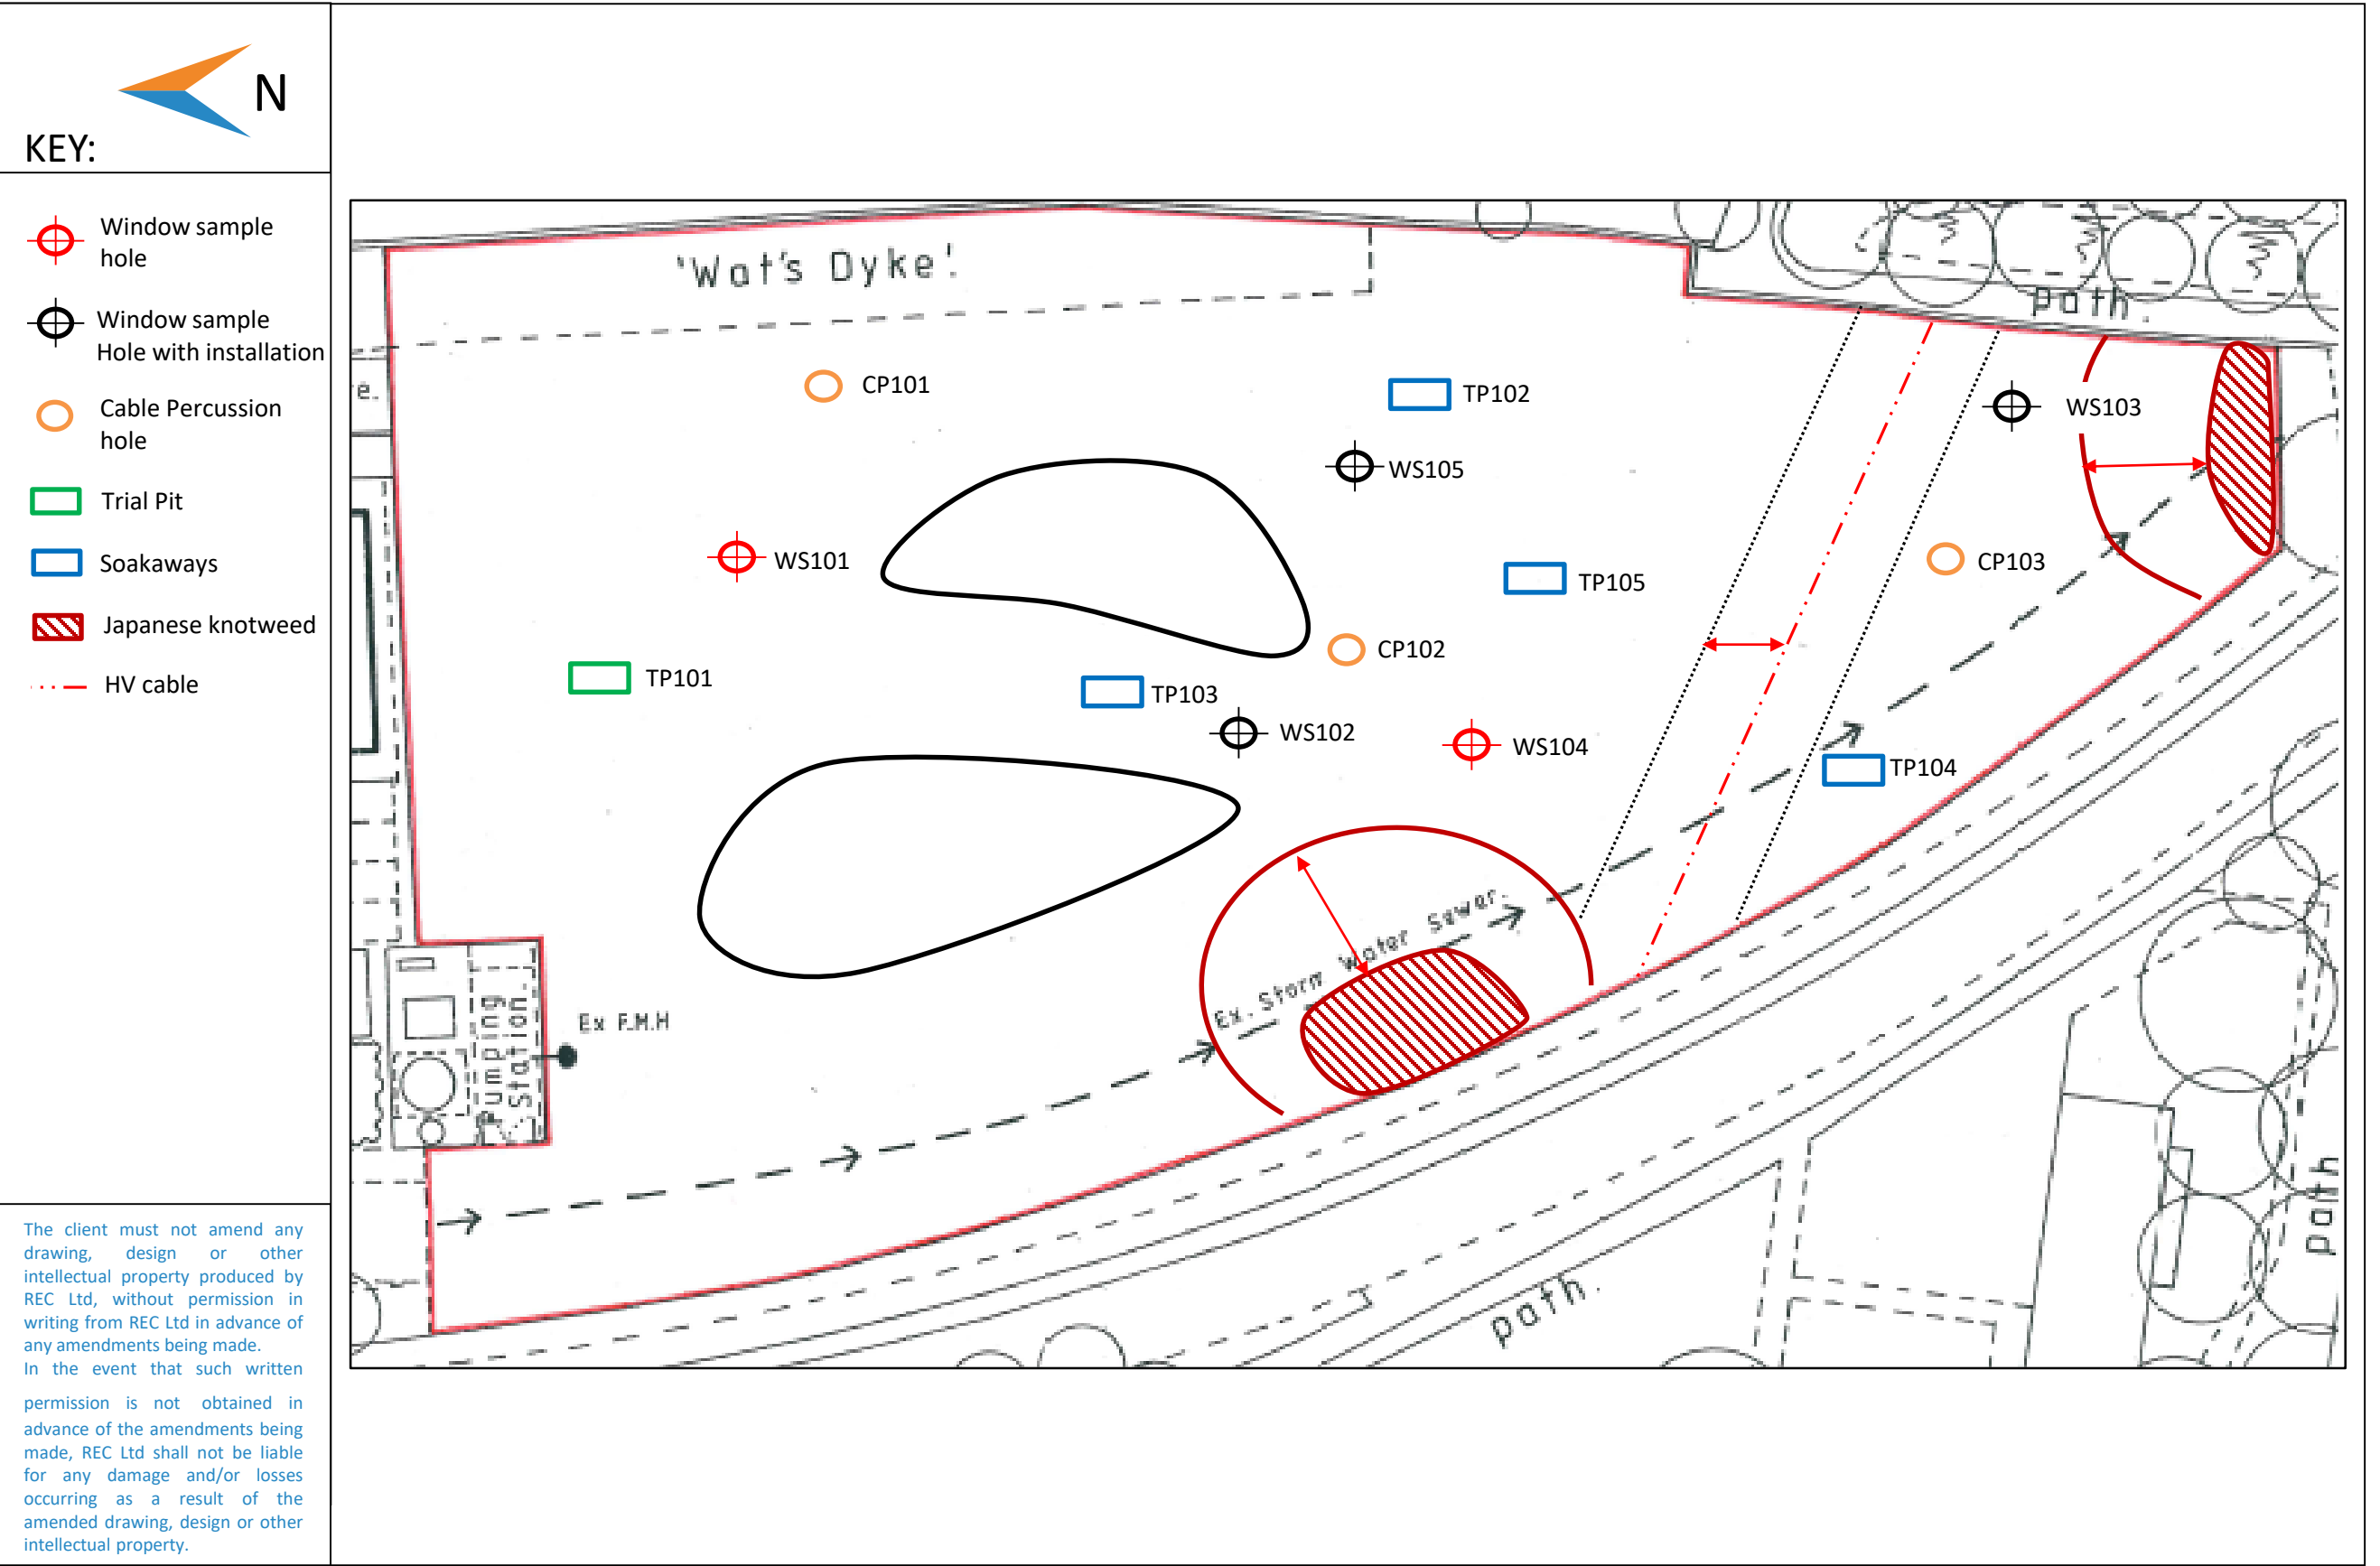
| | Drawing No 108157-003 Exploratory Hole Location Plan (trial pitting) | |
