Computer generated images for proposed development at  
the Oak Tree Inn, Ruabon Road, Wrexham.

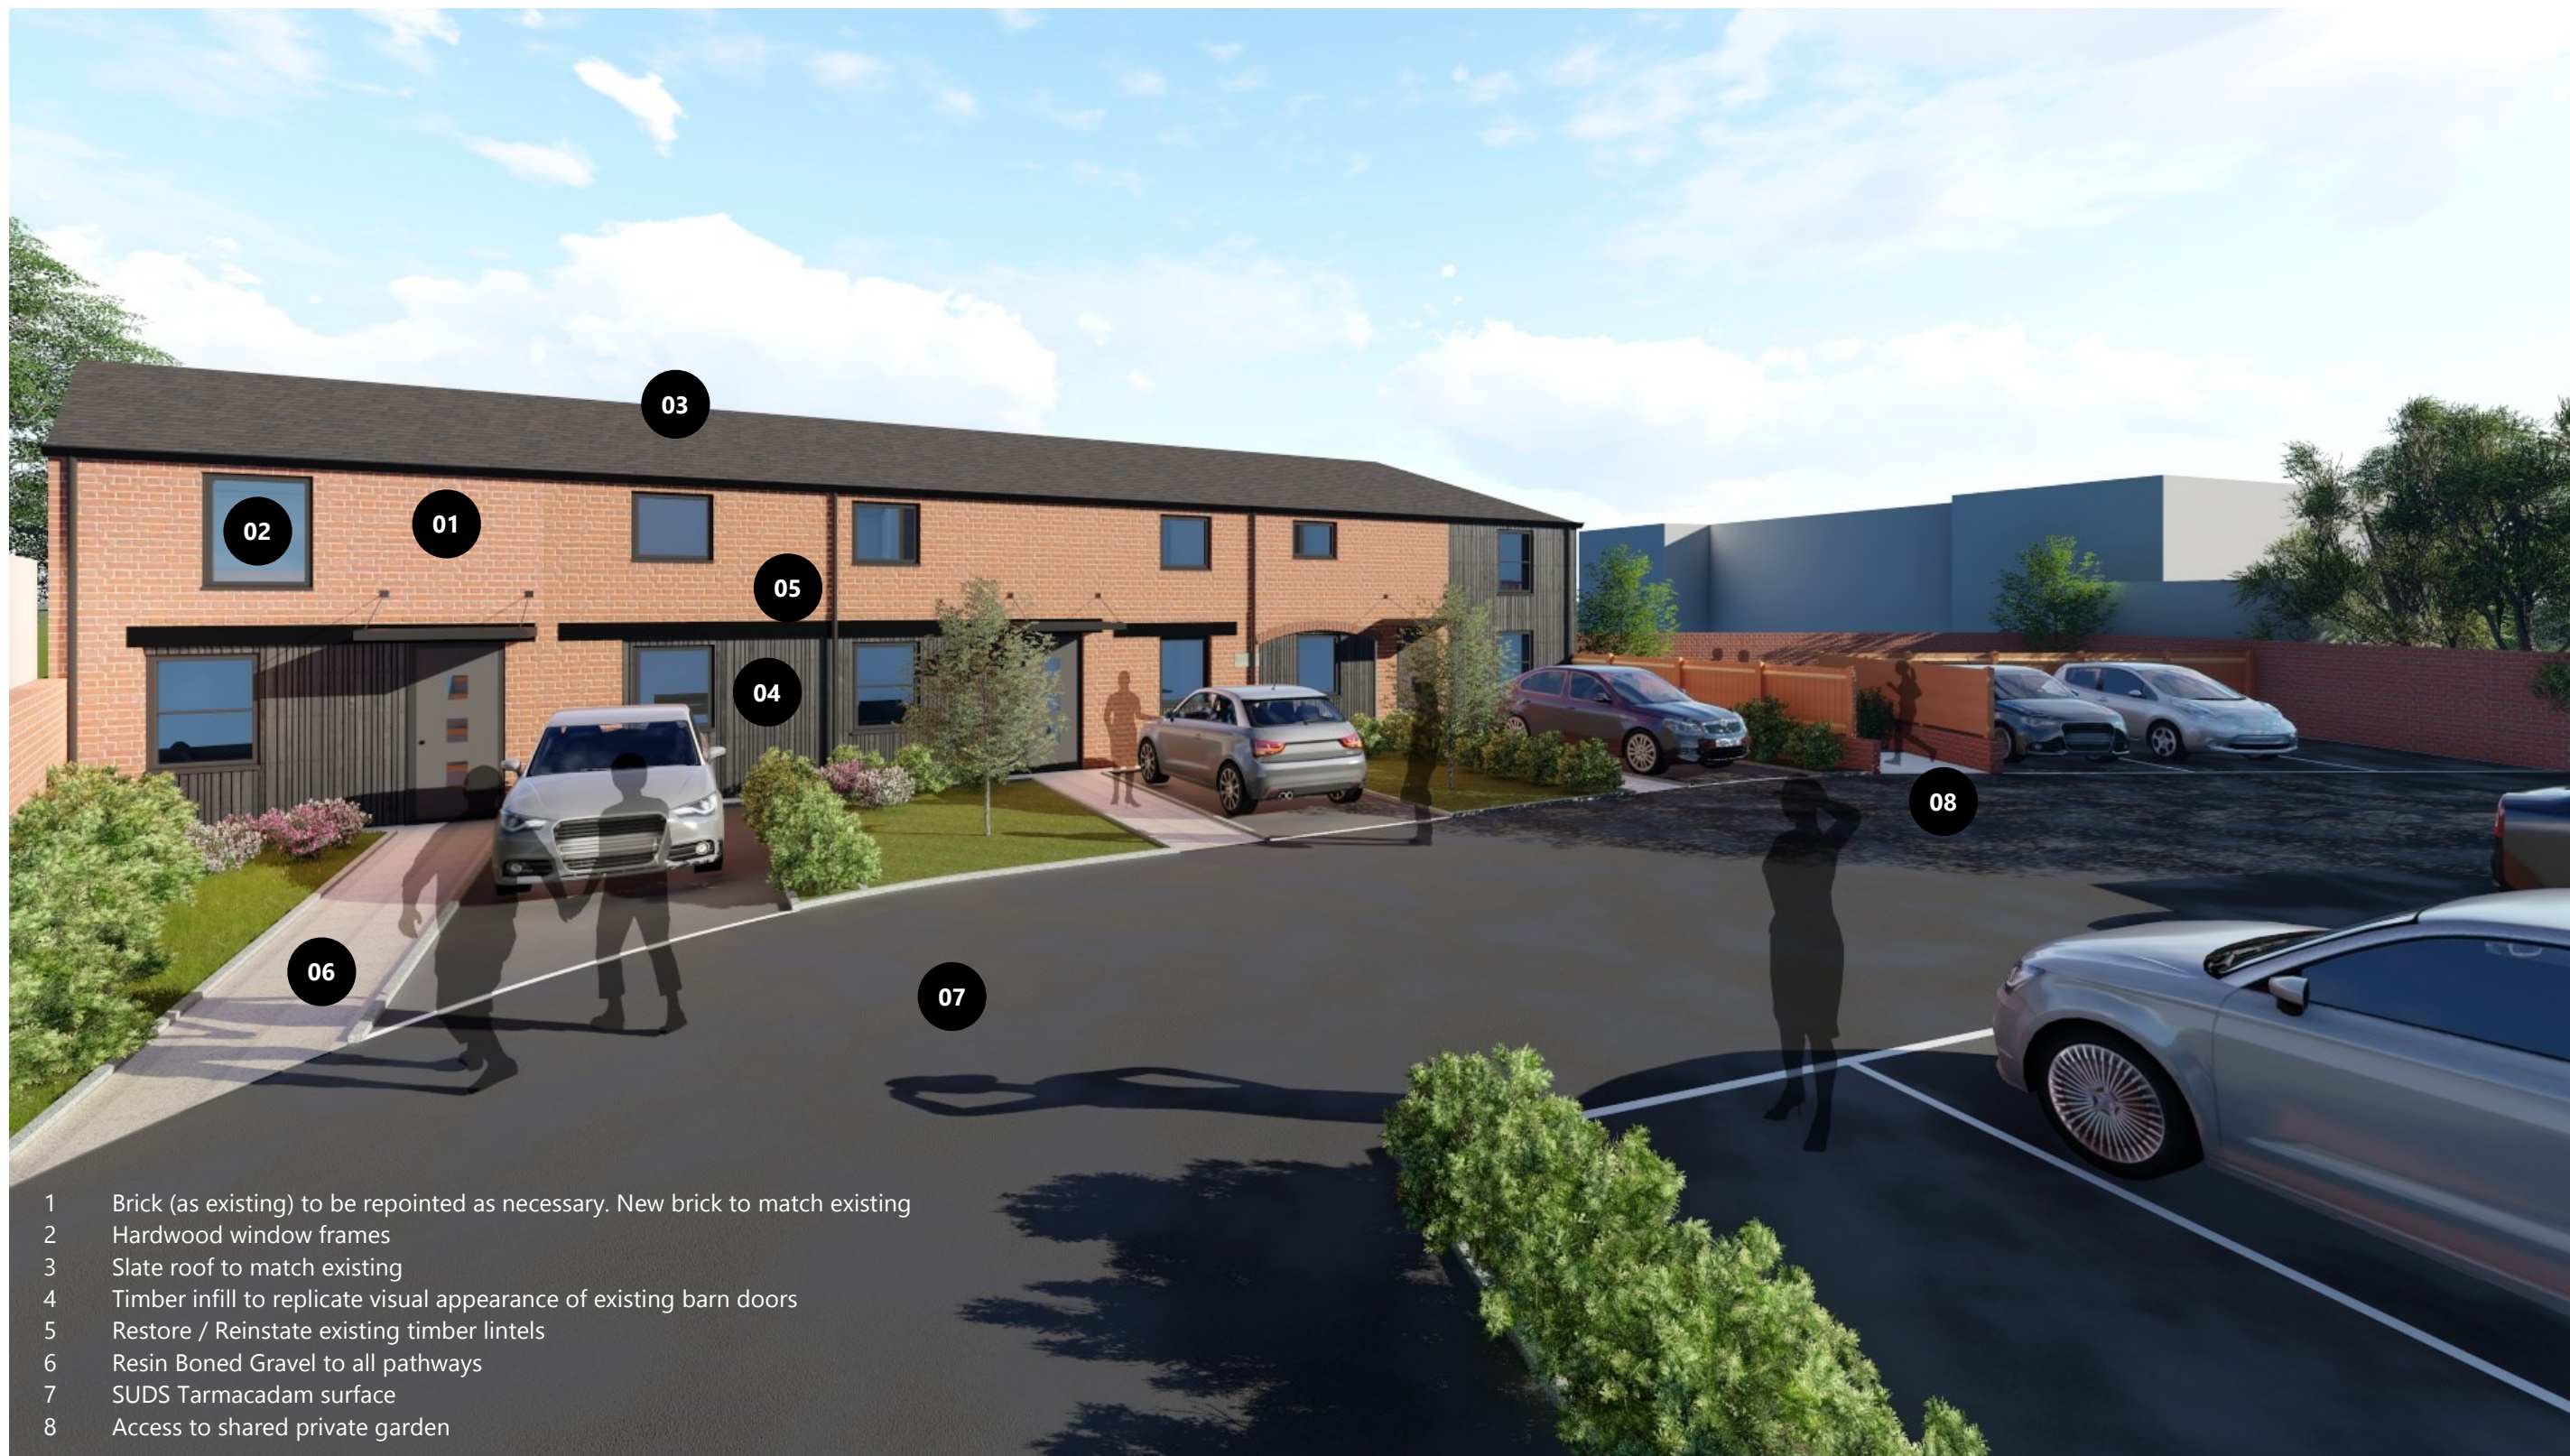
- 1 Brick (as existing) to be repointed as necessary. New brick to match existing
- 2 Hardwood window frames
- 3 Slate roof to match existing
- 4 Timber infill to replicate visual appearance of existing barn doors
- 5 Restore / Reinstall existing timber lintels
- 6 Resin Banded Gravel to all pathways
- 7 SUDS Tarmac surface
- 8 Access to shared private garden

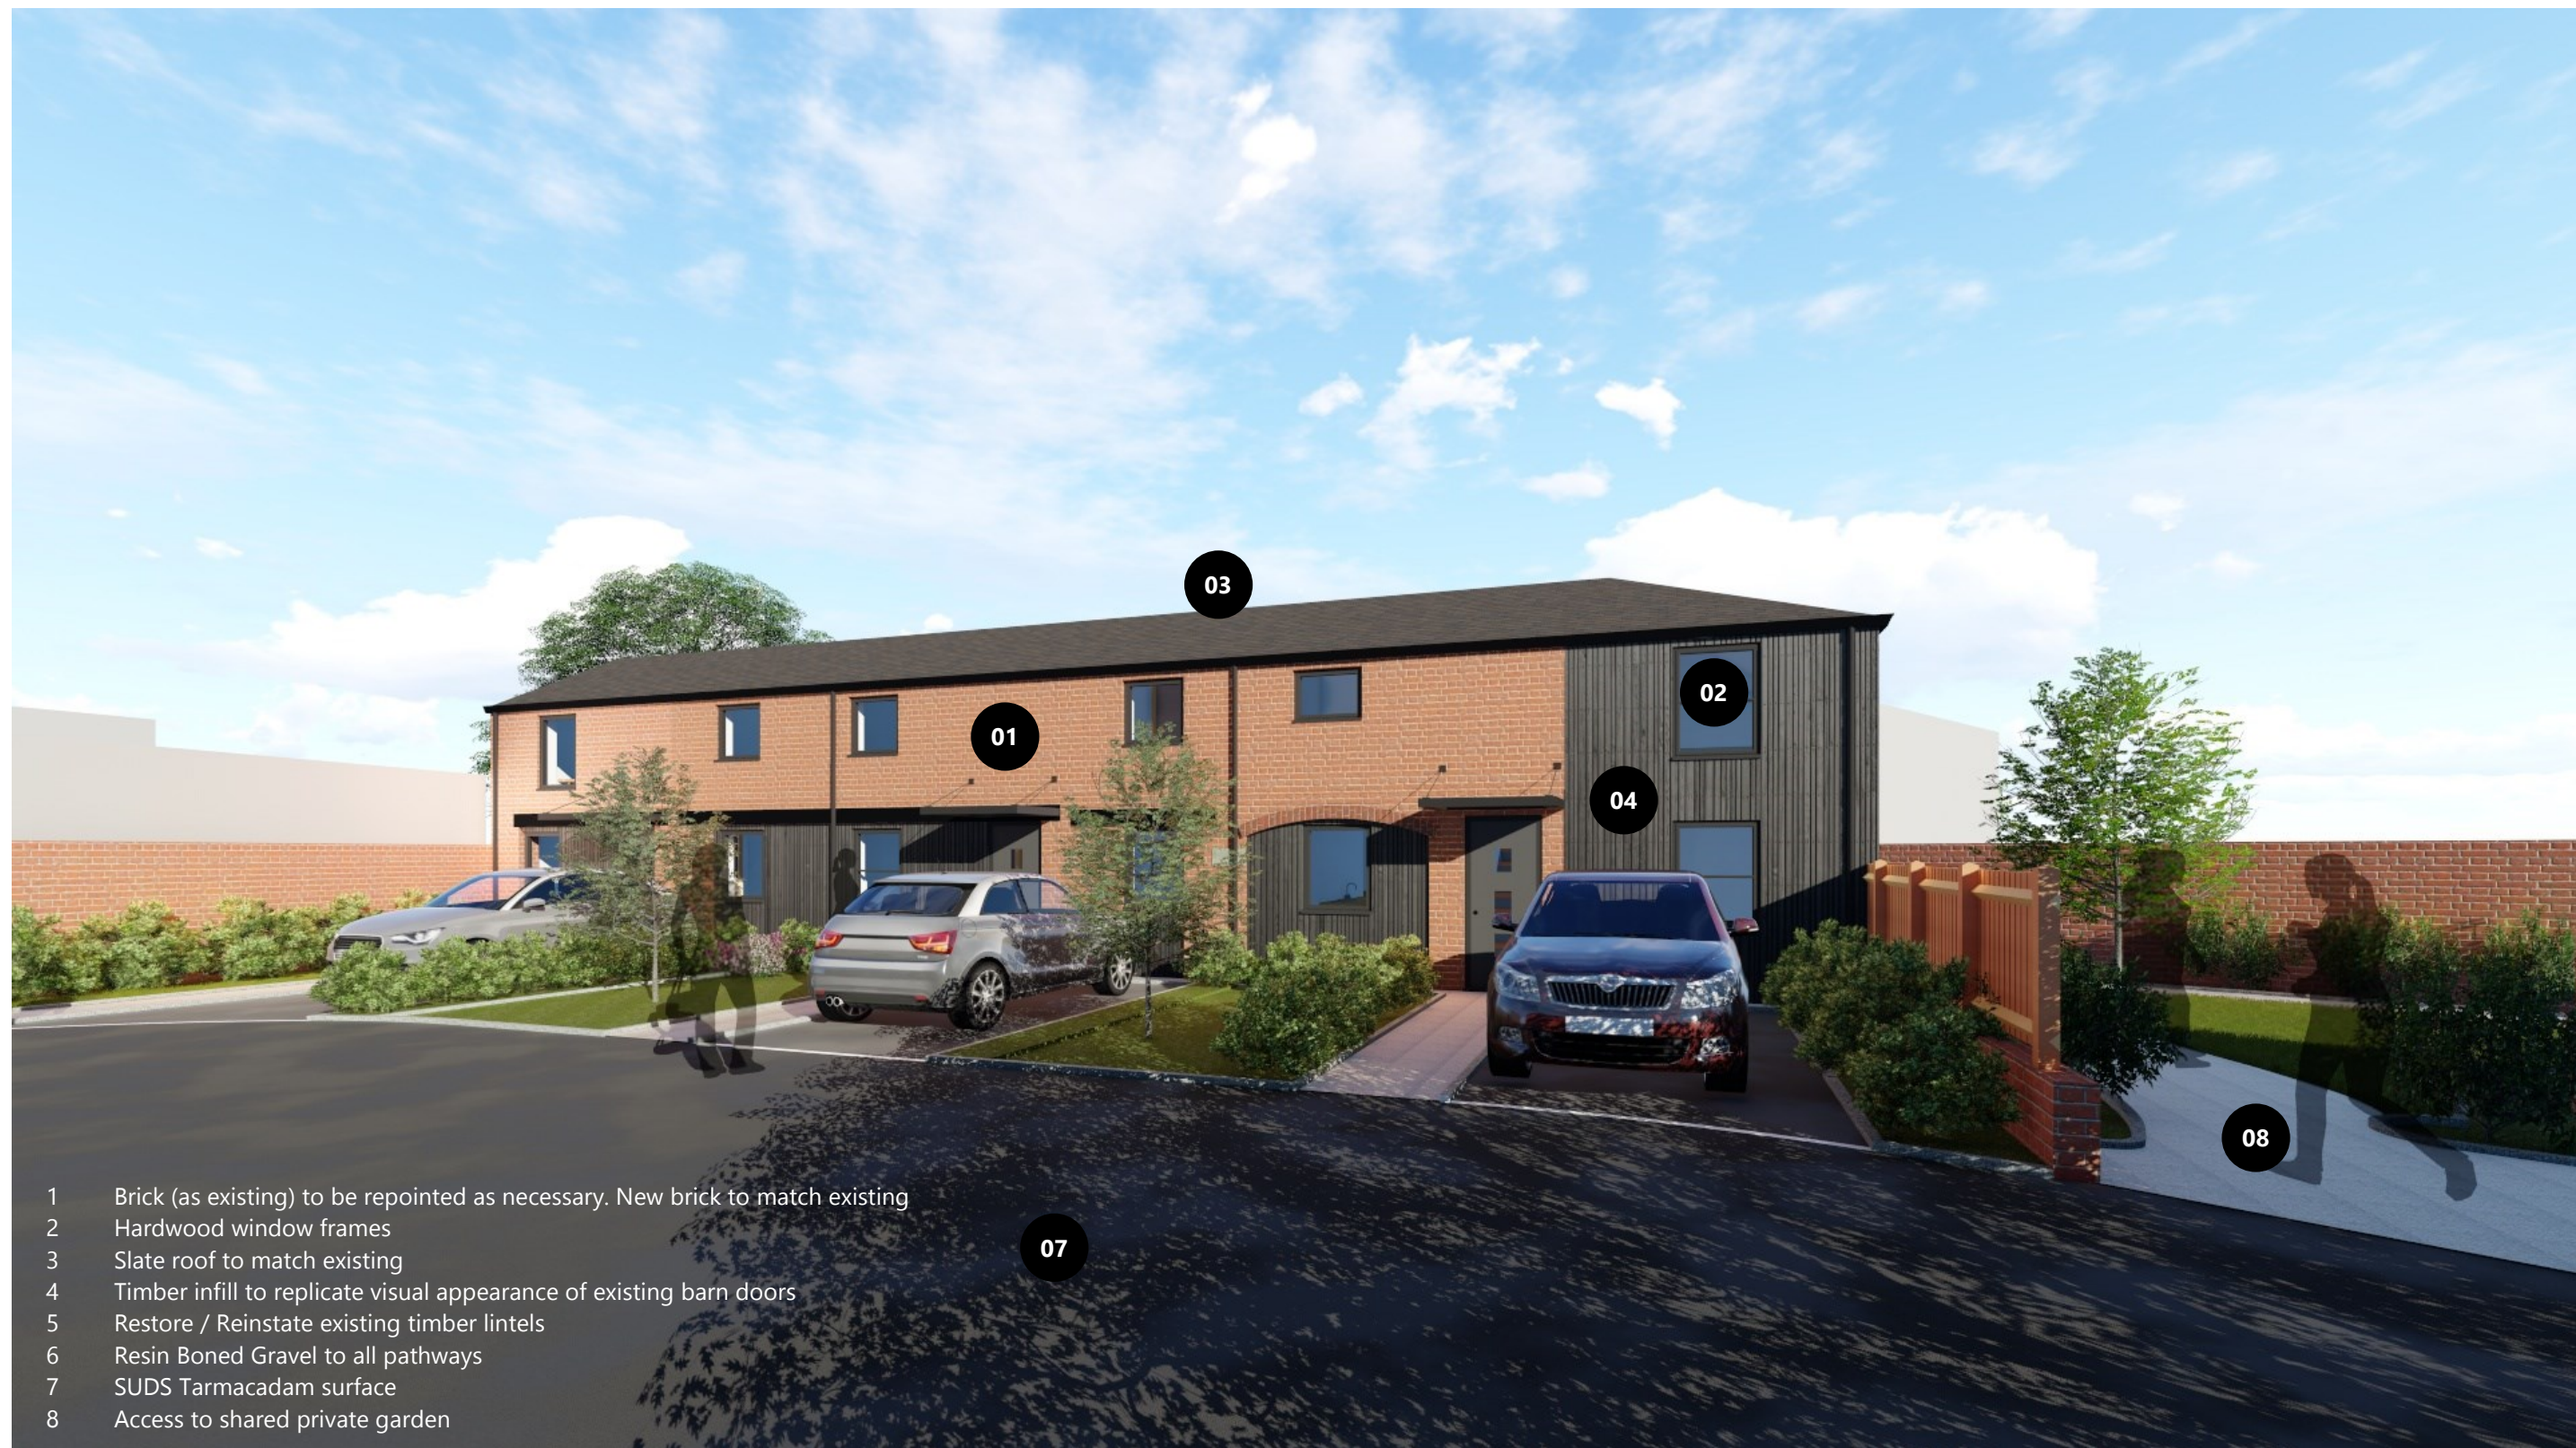
- 1 Brick (as existing) to be repointed as necessary. New brick to match existing
- 2 Hardwood window frames
- 3 Slate roof to match existing
- 4 Timber infill to replicate visual appearance of existing barn doors
- 5 Restore / Reinstall existing timber lintels
- 6 Resin Boned Gravel to all pathways
- 7 SUDS Tarmacadam surface
- 8 Access to shared private garden

Computer generated images for proposed development at  
the Oak Tree Inn, Ruabon Road, Wrexham.

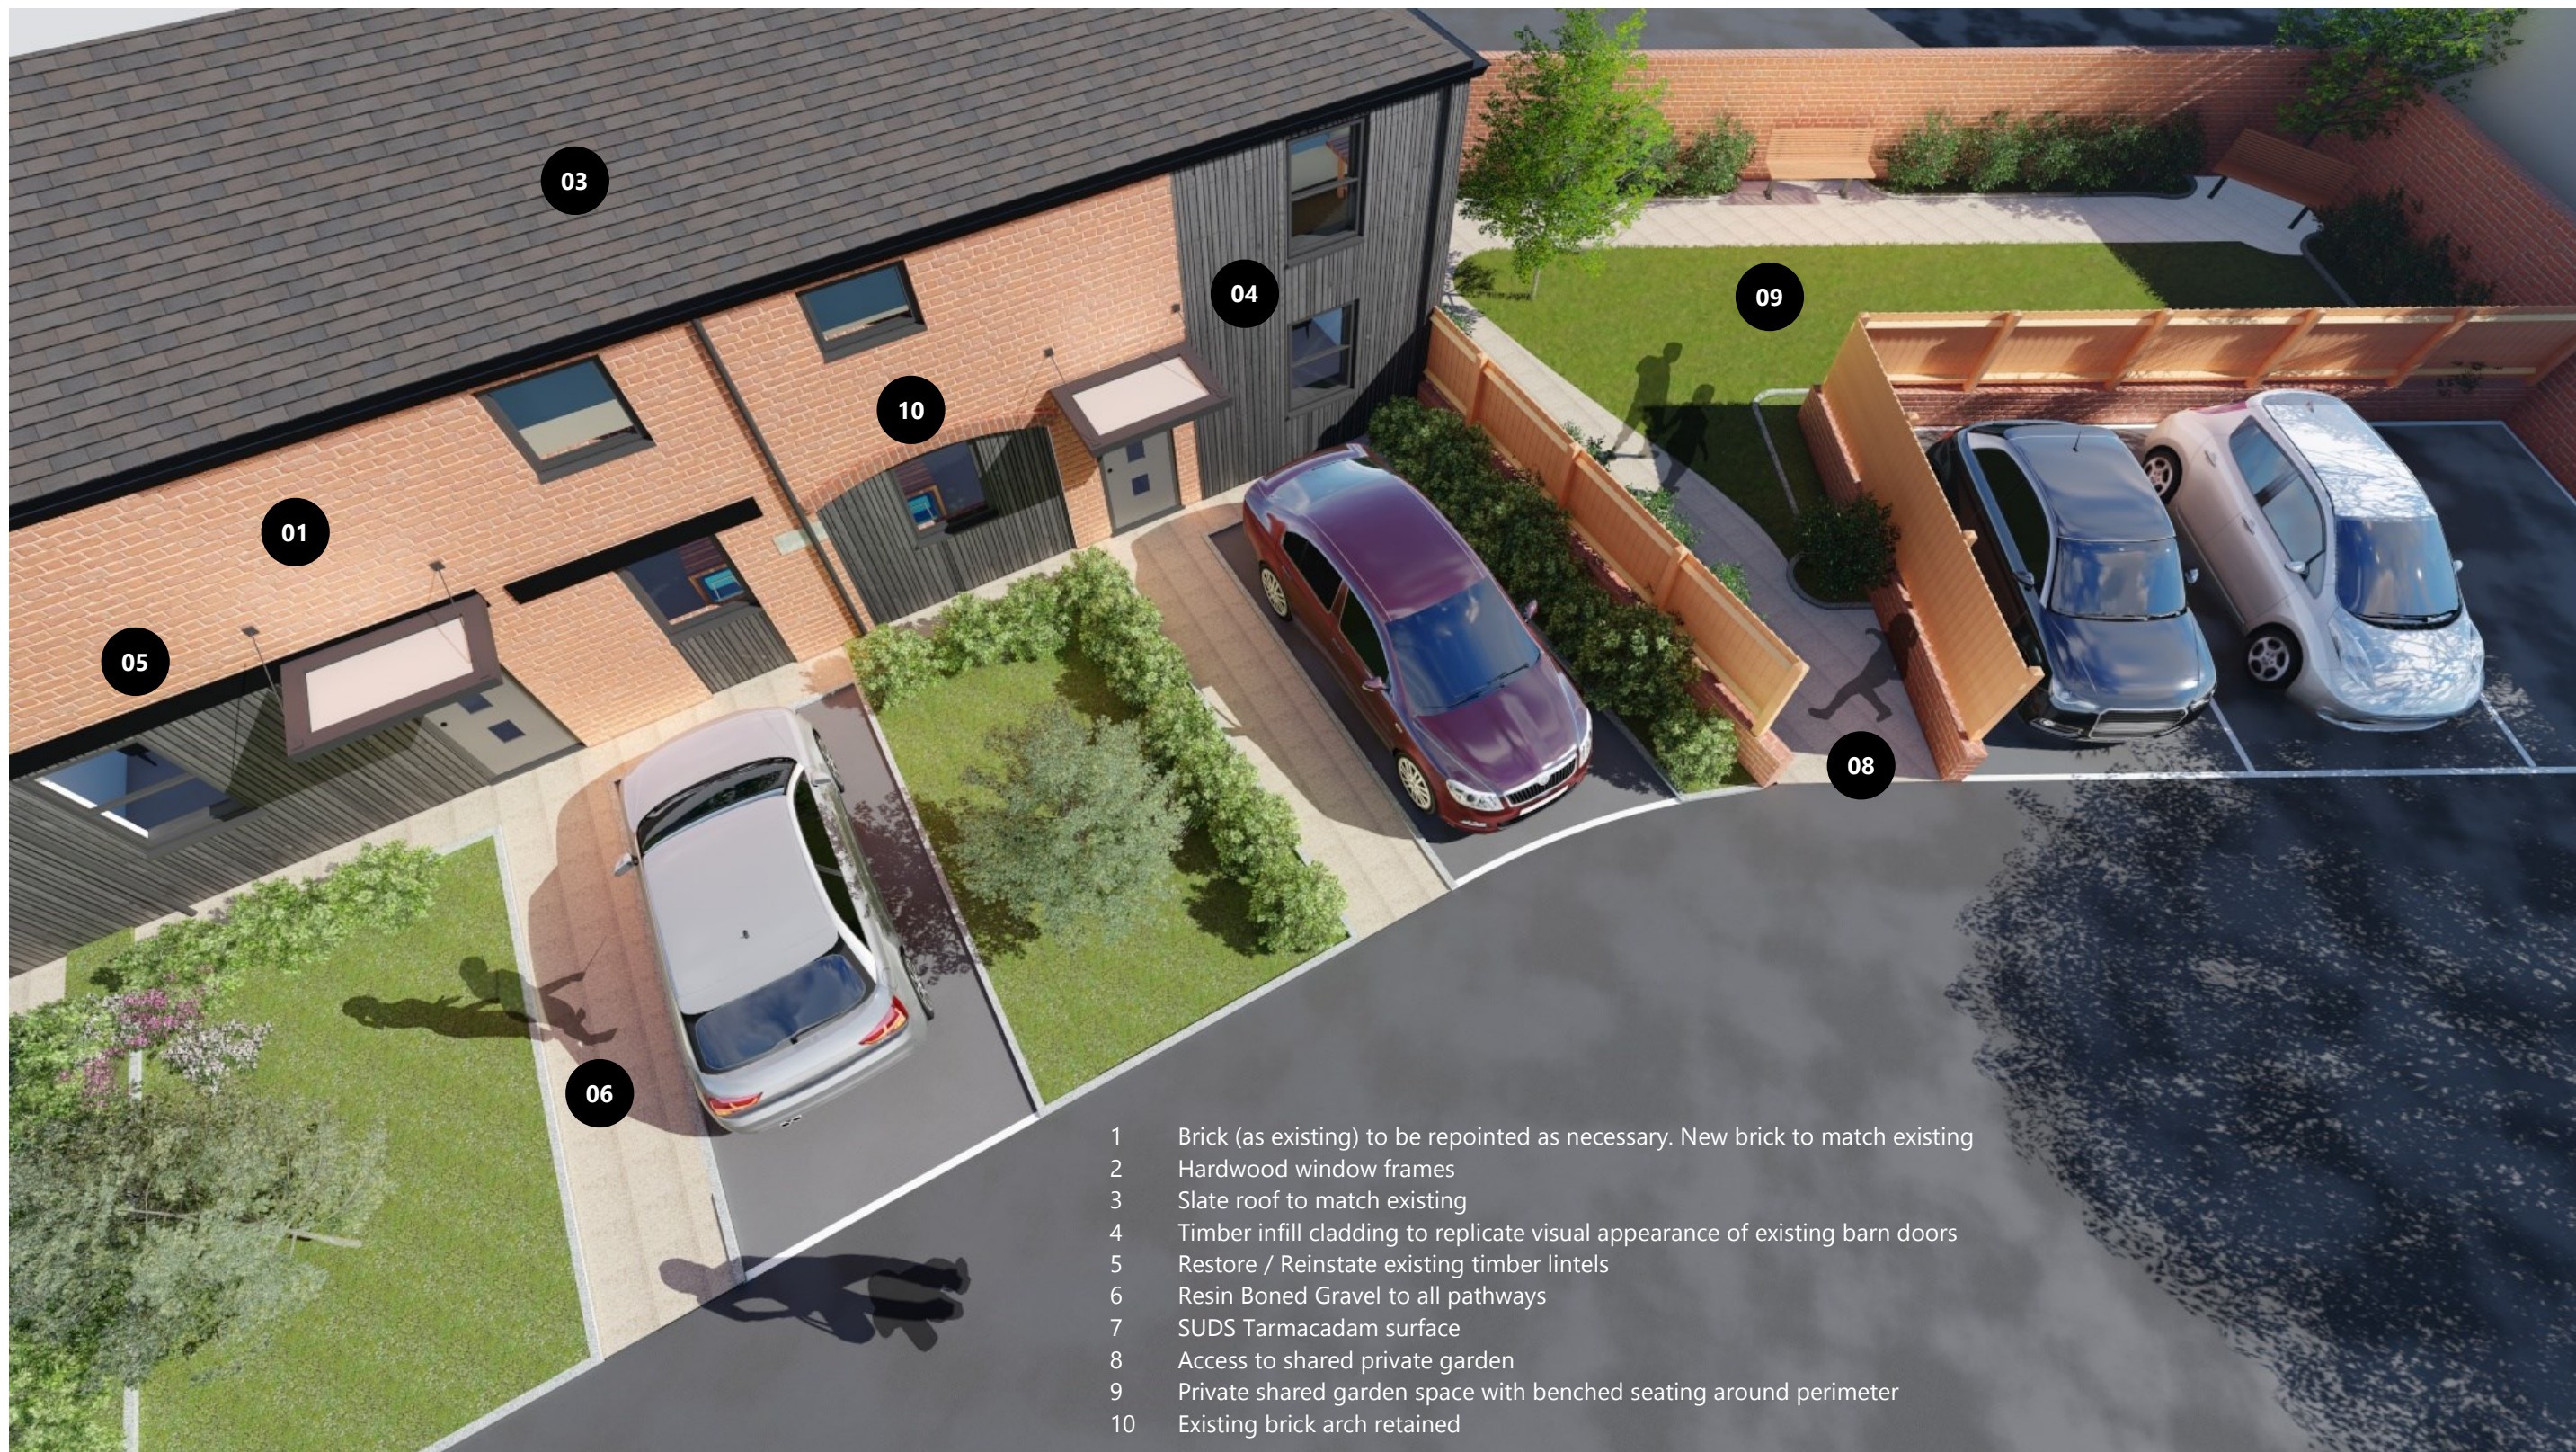
- 1 Brick (as existing) to be repointed as necessary. New brick to match existing
- 2 Hardwood window frames
- 3 Slate roof to match existing
- 4 Timber infill cladding to replicate visual appearance of existing barn doors
- 5 Restore / Reinstall existing timber lintels
- 6 Resin Boned Gravel to all pathways
- 7 SUDS Tarmacadam surface
- 8 Access to shared private garden
- 9 Private shared garden space with benched seating around perimeter
- 10 Existing brick arch retained

Computer generated images for proposed development at  
the Oak Tree Inn, Ruabon Road, Wrexham.
