**Address:** WREXHAM INDUSTRIAL ESTATE, WREXHAM, LL13 9RG  
**Date:** 12 Aug 2019  
**Reference:** GS-6237862  
**Client:** SOCOTEC UK Limited

| Project | Wrexham SI | Project No. | F9042-19 | Carried out for | Conrad Energy | Plate<br><br><b>1</b> |
| Project | Wrexham SI | | | | | | | |
| Project No. | F9042-19 | | | | | | | |
| Carried out for | Conrad Energy | | | | | | | |

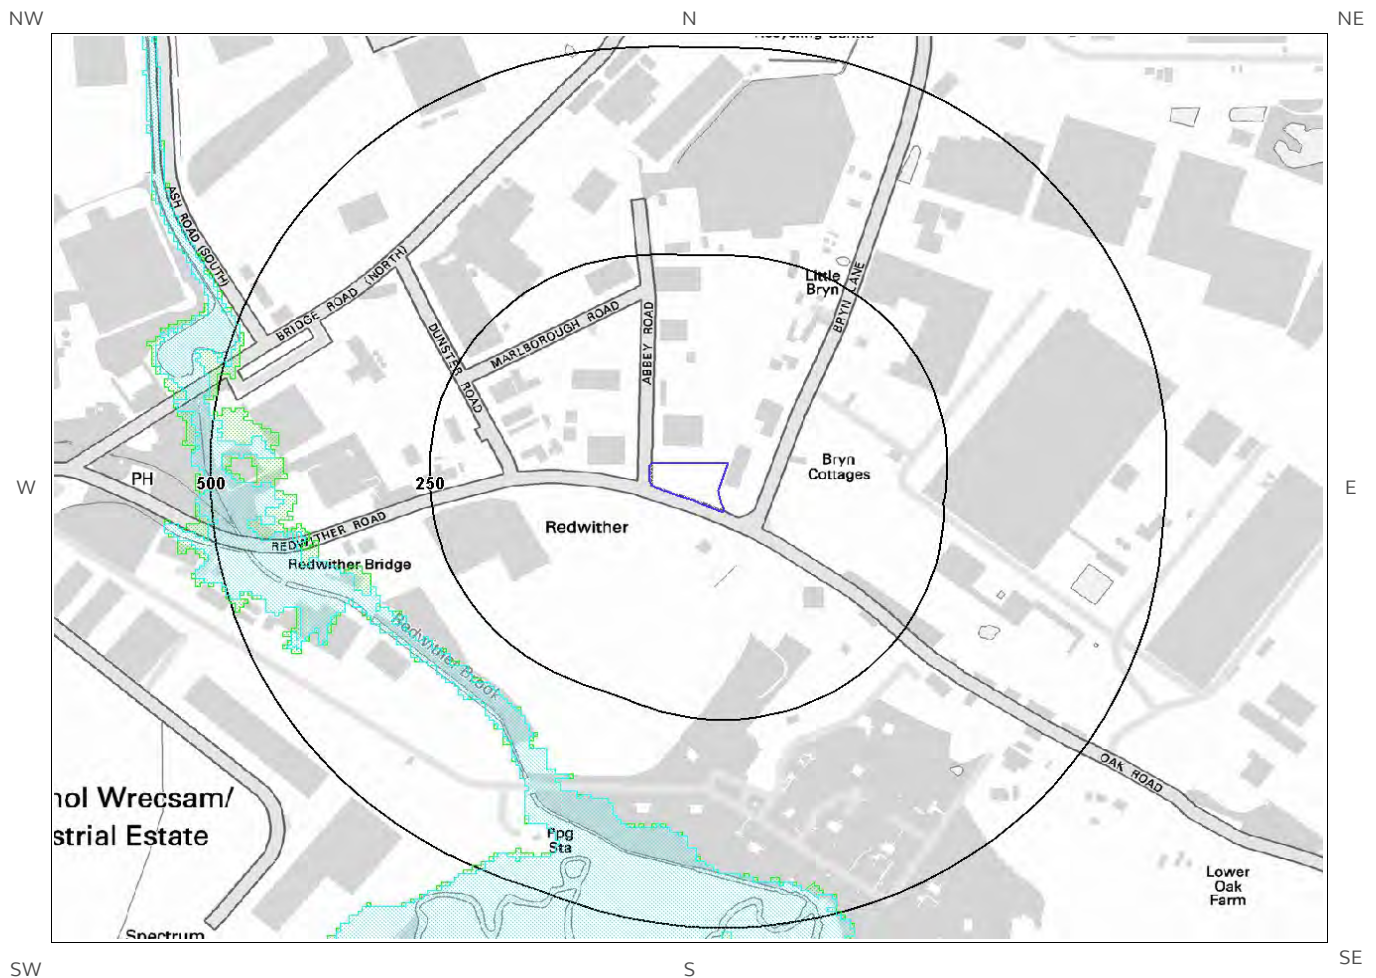
# 7a. Environment Agency/Natural Resources Wales Flood Map for Planning (from rivers and the sea)

Environment Agency/Natural Resources Wales Zone 2 floodplains estimate the annual probability of flooding as between 1 in 1000 (0.1%) and 1 in 100 (1%) from rivers and between 1 in 1000 (0.1%) and 1 in 200 (0.5%) from the sea. Any relevant data is represented on Map 7a – Flood Map for Planning:

Zone 3 shows the extent of a river flood with a 1 in 100 (1%) or greater chance of occurring in any year or a sea flood with a 1 in 200 (0.5%) or greater chance of occurring in any year. Any relevant data is represented on Map 7a – Flood Map for Planning.

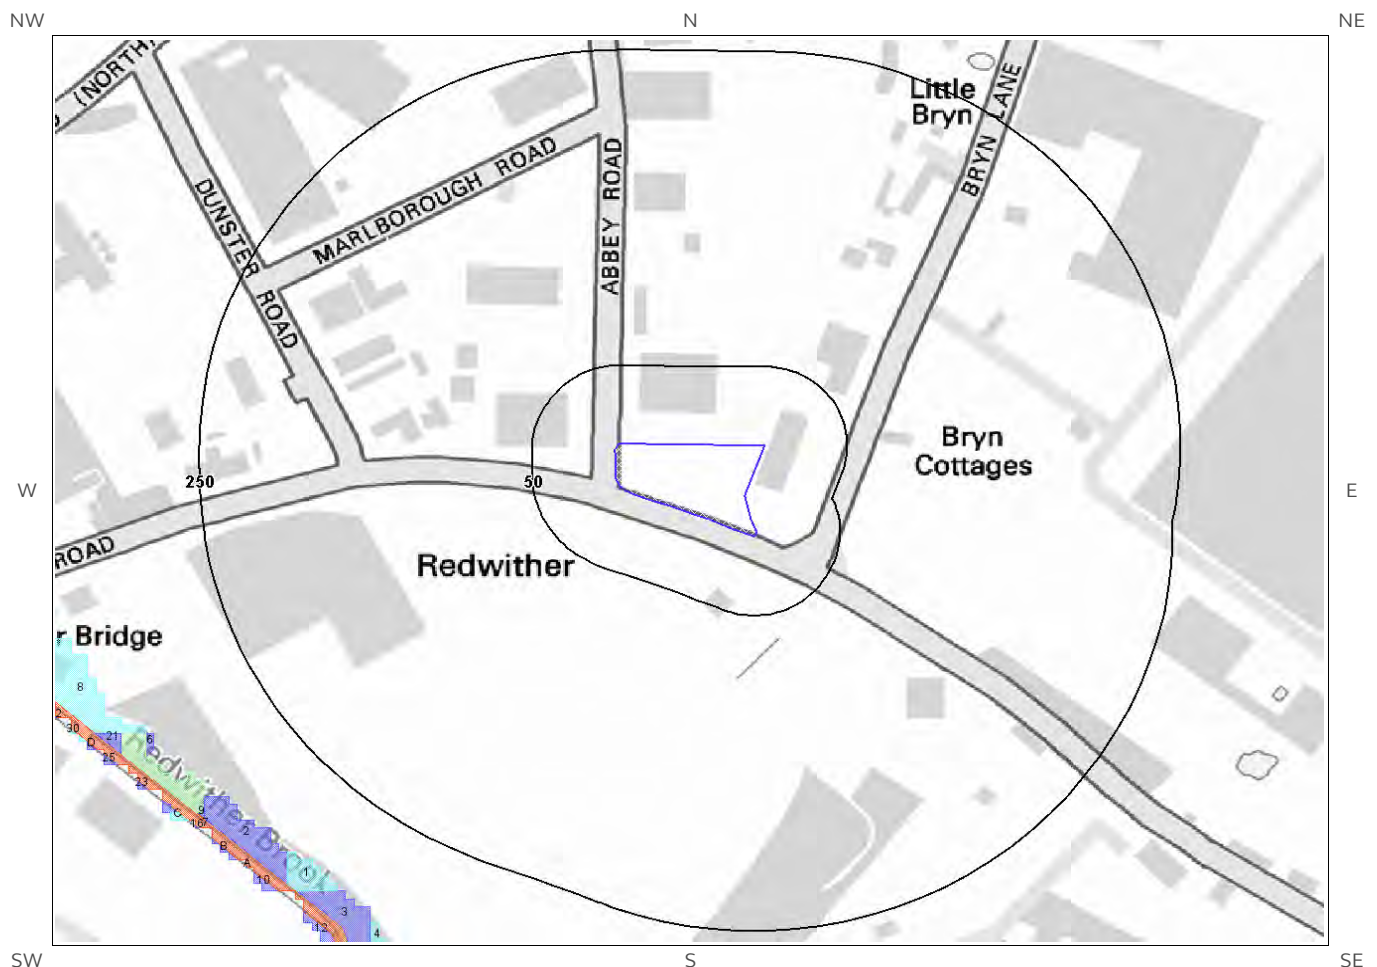
# 7b. Environment Agency/Natural Resources Wales Risk of Flooding from Rivers and the Sea (RoFRaS) Map

RoFRaS data for the study site indicates the property is in an area with a Very Low (less than 1 in 1000) chance of flooding in any given year.

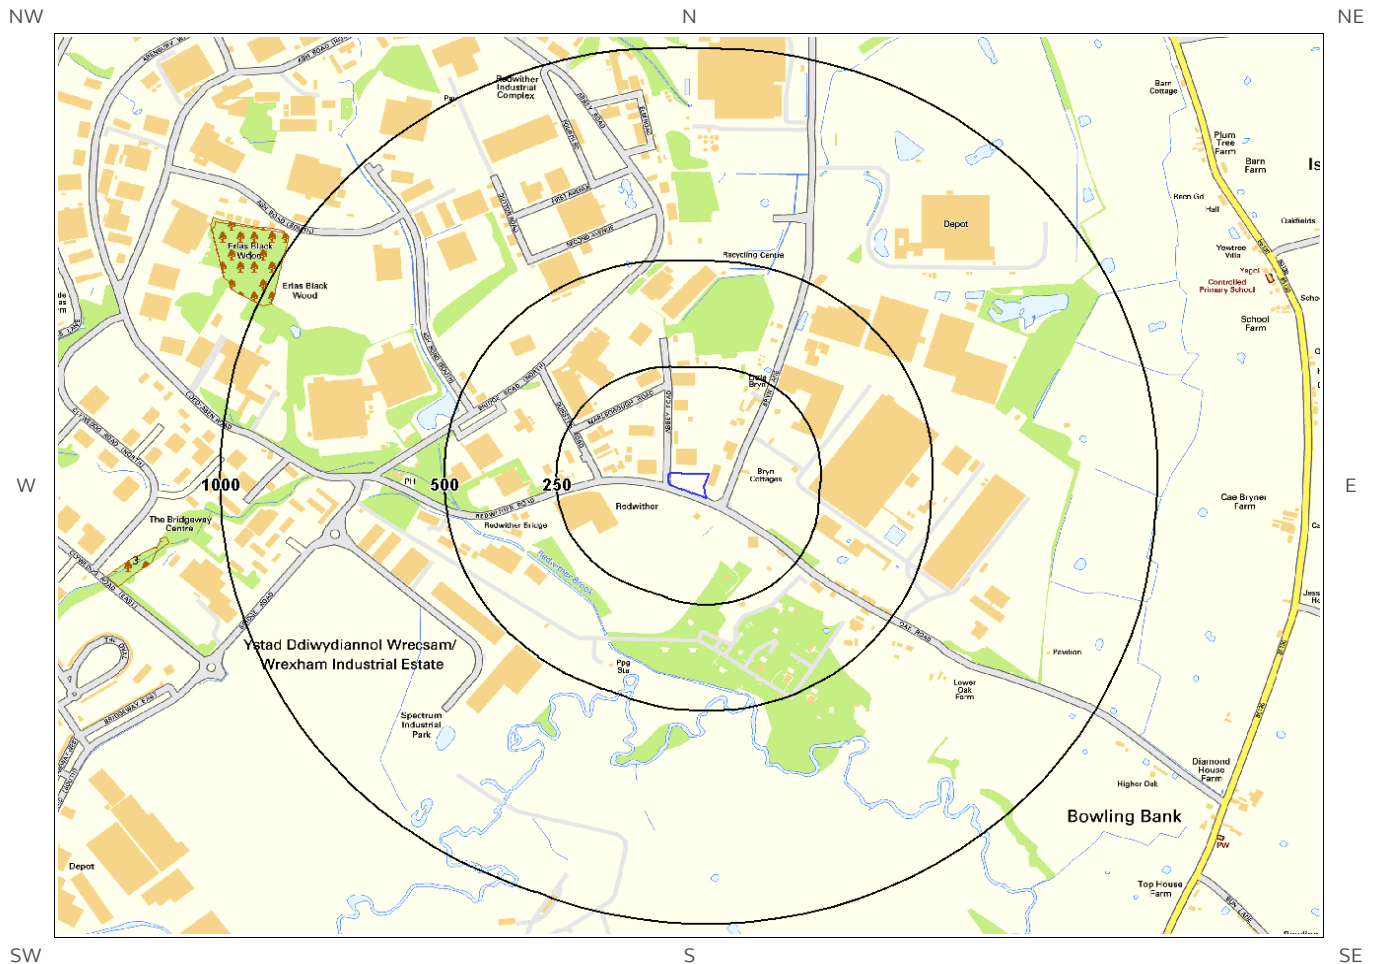
# 8. Designated Environmentally Sensitive Sites Map

| Designated Environmentally Sensitive Sites within 2000m of the study site | Identified |

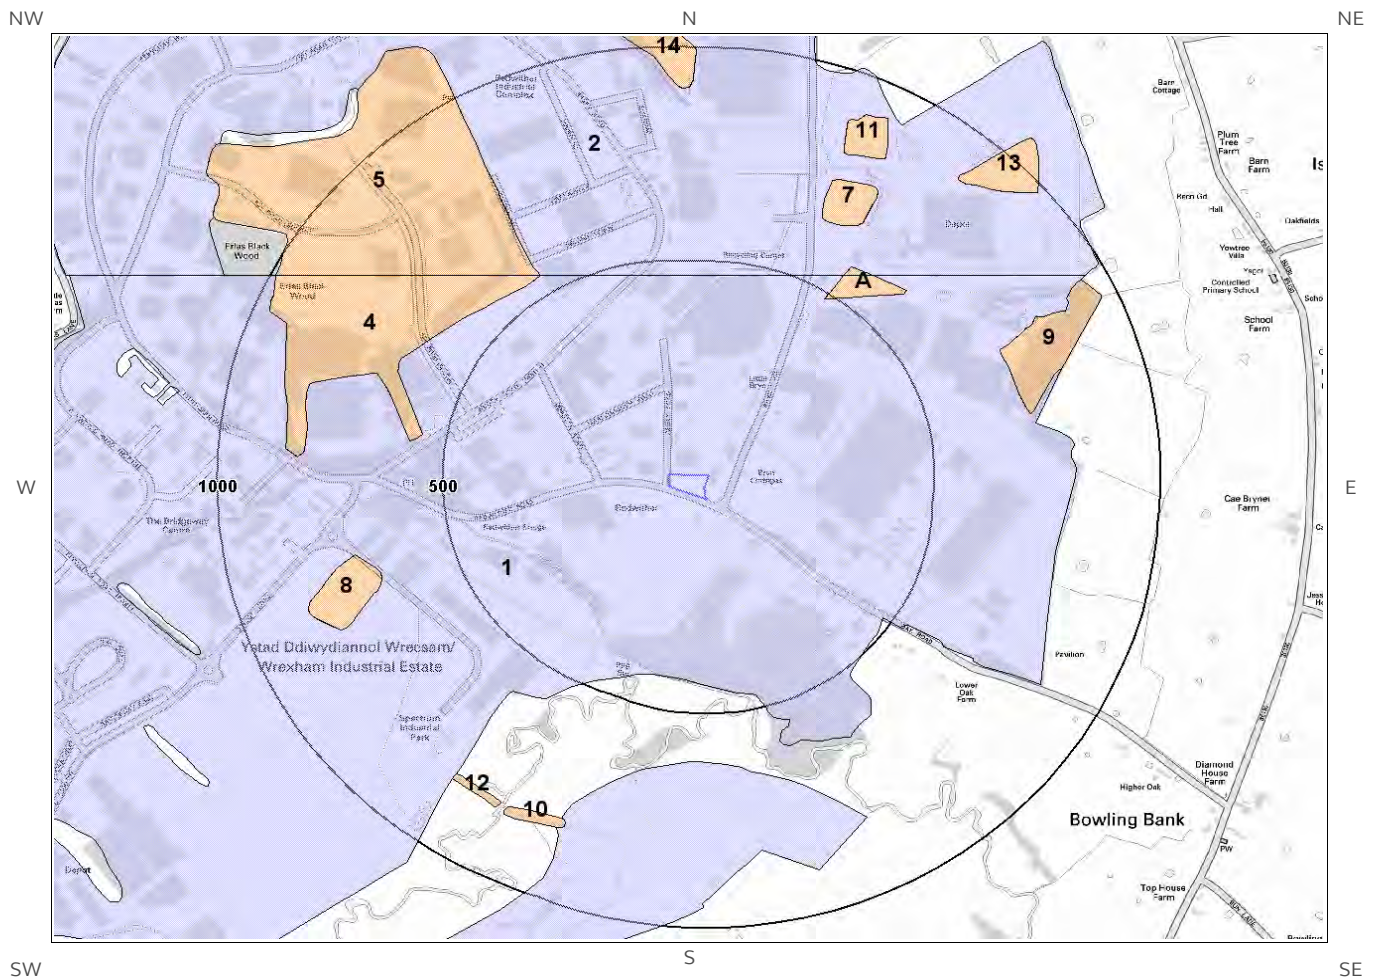
## 1.1 Artificial Ground map (1:10,000 scale)

| ID | Distance | Direction | LEX Code | Description | Rock Description |
|---|---|---|---|---|---|
| 3A | 485.0 | NE | MGR-ARTDP | Made Ground (Undivided) | Artificial Deposit |

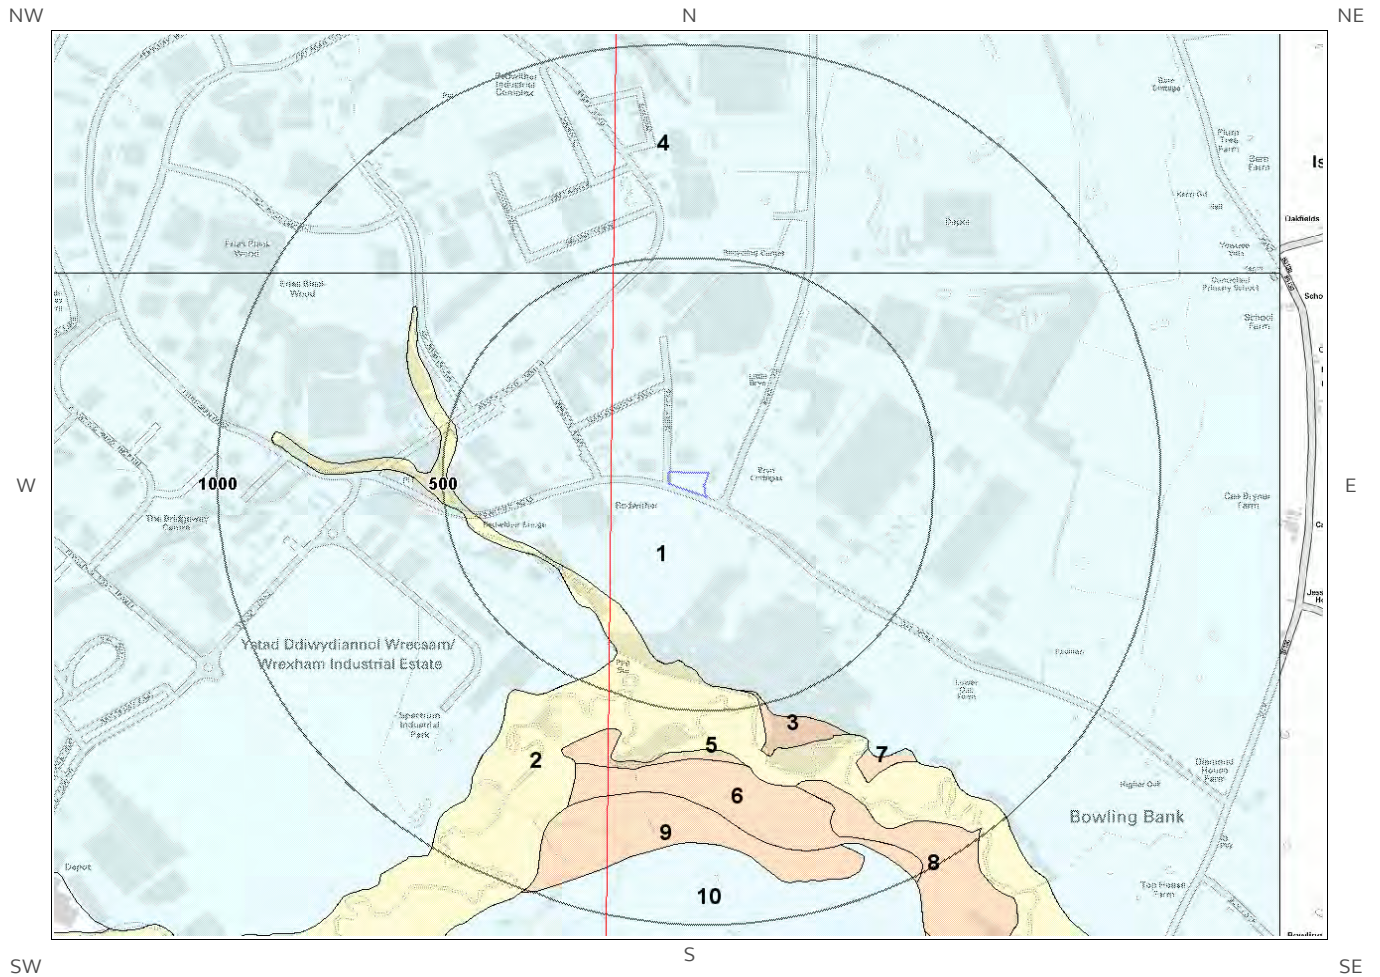
## 1.2 Superficial Deposits and Landslips map (1:10,000 scale)

This Geology shows the main components as discrete layers, these are: Artificial / Made Ground, Superficial / Drift Geology and Landslips. These are all displayed with the BGS Lexicon code for the rock unit and BGS sheet number. Not all of the main geological components have nationwide coverage.

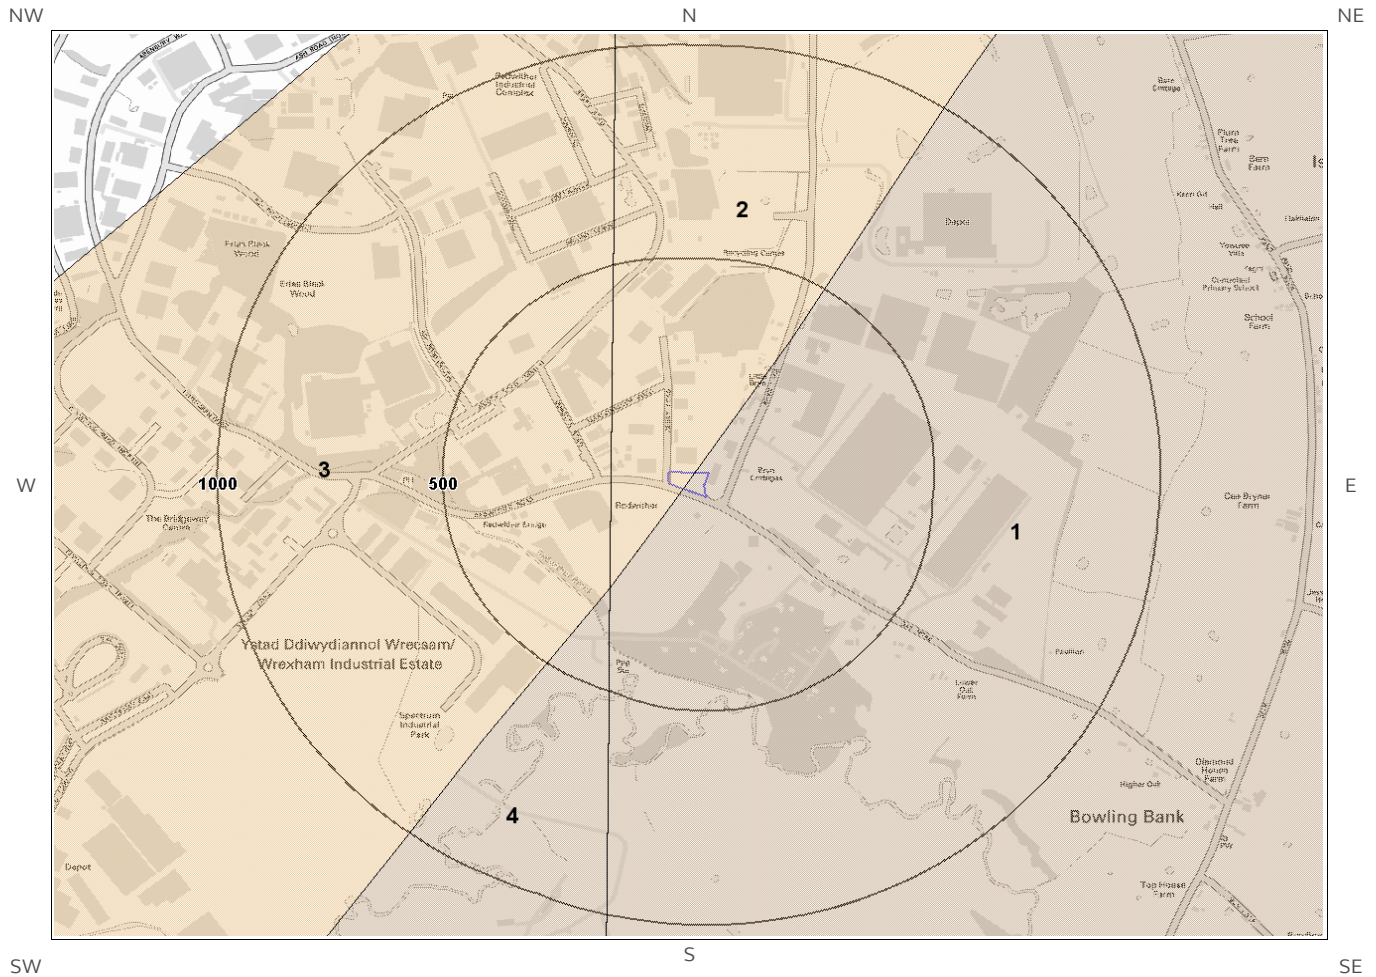
## 2.3 Bedrock and linear features map (1:50,000 scale)

| Distance | Direction | Flow Type | Maximum Permeability | Minimum Permeability |
|---|---|---|---|---|
| 0.0 | On Site | Fracture | Moderate | Low |

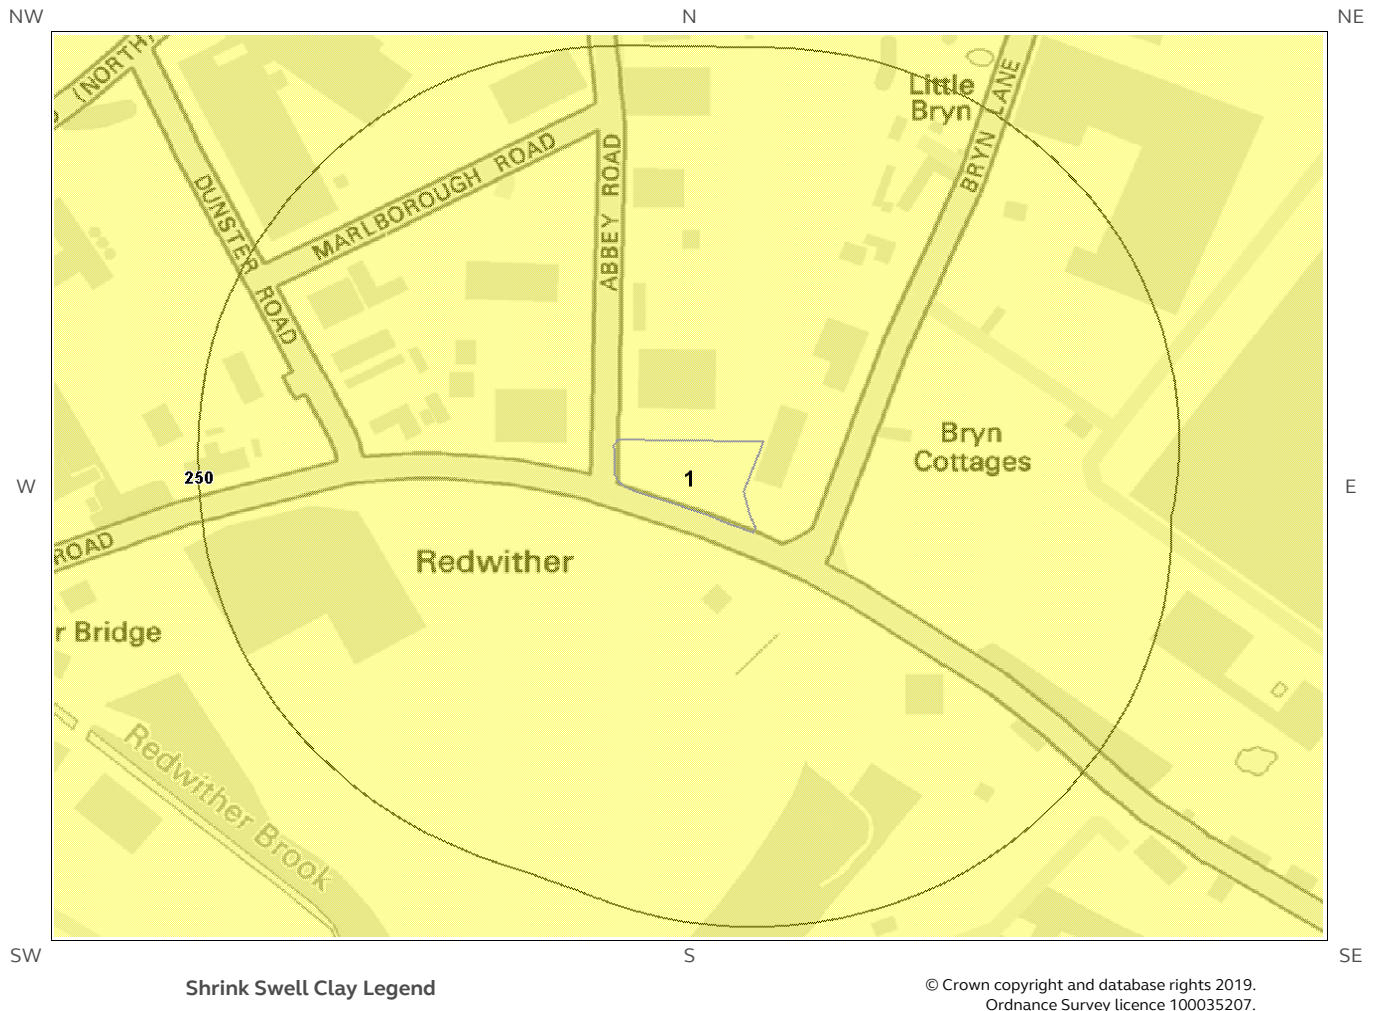
## 6.1 Shrink-Swell Clay map

| ID | Distance (m) | Direction | Hazard Rating | Details |
|---|---|---|---|---|
| 1 | 0.0 | On Site | Very Low | Ground conditions predominantly low plasticity. No special actions required to avoid problems due to shrink-swell clays. No special ground investigation required, and increased construction costs or increased financial risks are unlikely due to potential problems with shrink-swell clays. |

Maximum Shrink-Swell\*\* hazard rating identified on the study site Very Low

| Hazard |
|---|
| Ground conditions predominantly low plasticity. No special actions required to avoid problems due to shrink-swell clays. No special ground investigation required, and increased construction costs or increased financial risks are unlikely due to potential problems with shrink-swell clays. |

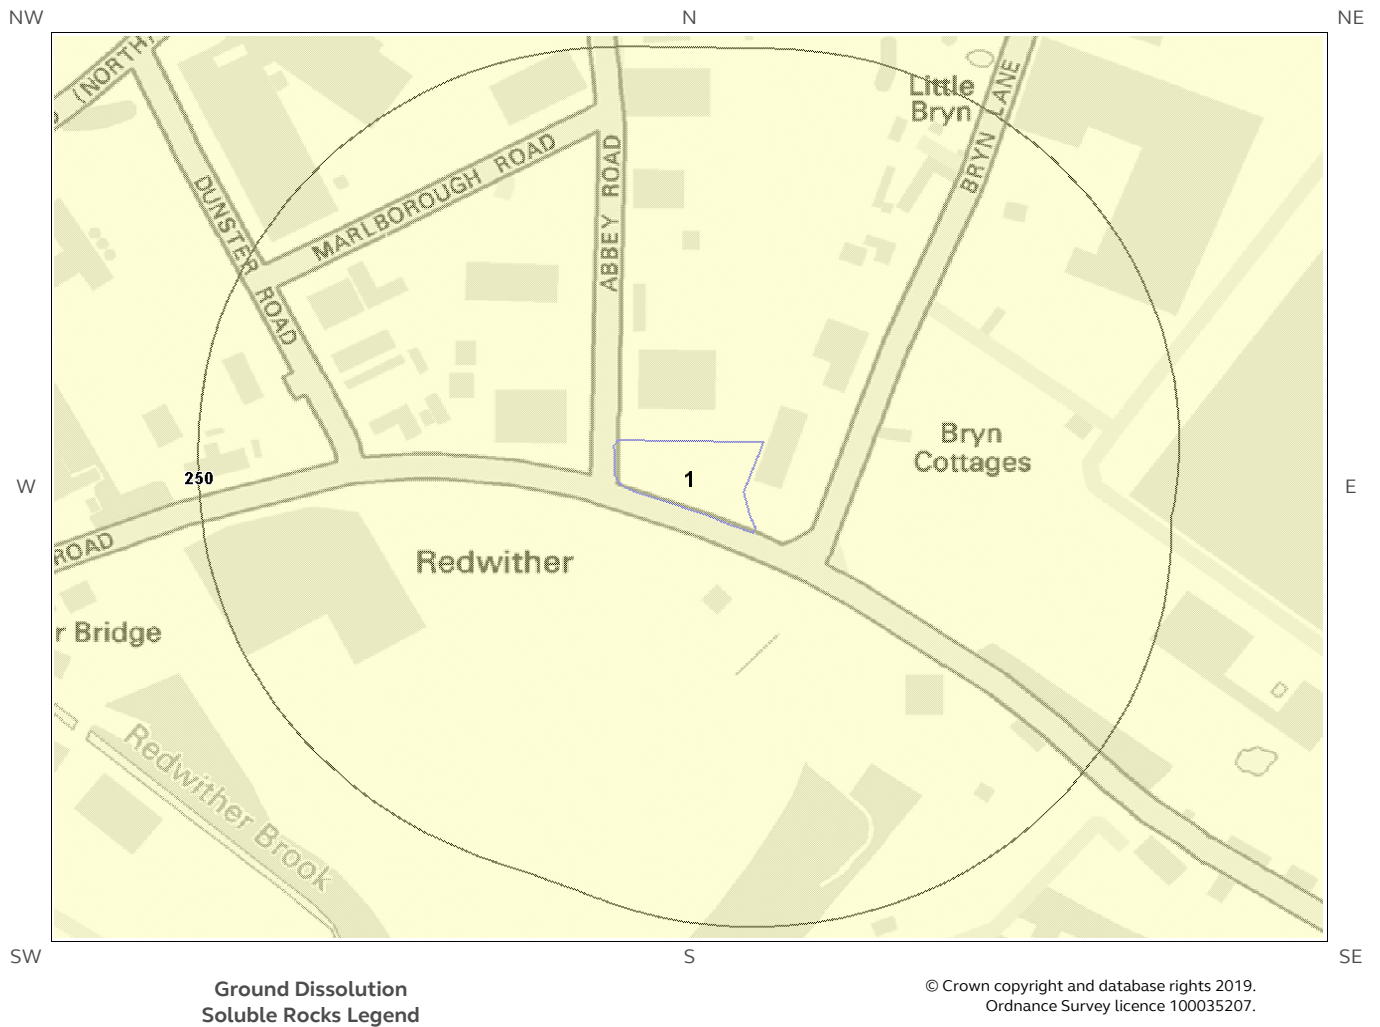
## 6.3 Ground Dissolution of Soluble Rocks map

| Hazard |
|---|
| Soluble rocks are present, but unlikely to cause problems except under exceptional conditions. No special actions required to avoid problems due to soluble rocks. No special ground investigation required, and increased construction costs or increased financial risks are unlikely due to potential problems with soluble rocks. |

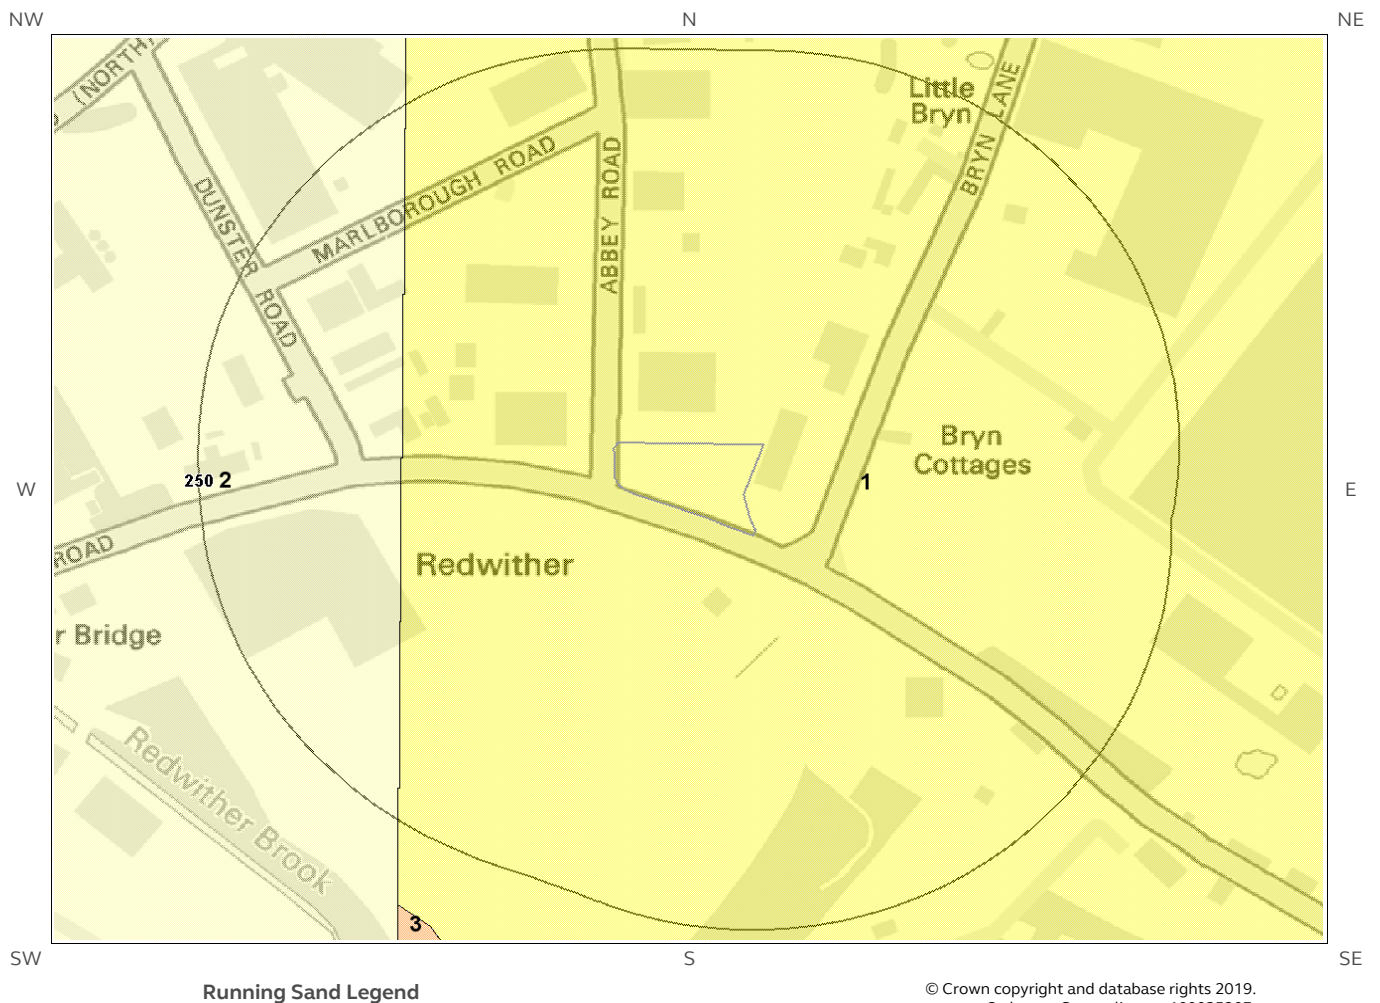
## 6.6 Running Sand map

| ID | Distance (m) | Direction | Hazard Rating | Details |
|---|---|---|---|---|
| 1 | 0.0 | On Site | Very Low | Very low potential for running sand problems if water table rises or if sandy strata are exposed to water. No special actions required, to avoid problems due to running sand. No special ground investigation required, and increased construction costs or increased financial risks are unlikely due to potential problems with running sand. |

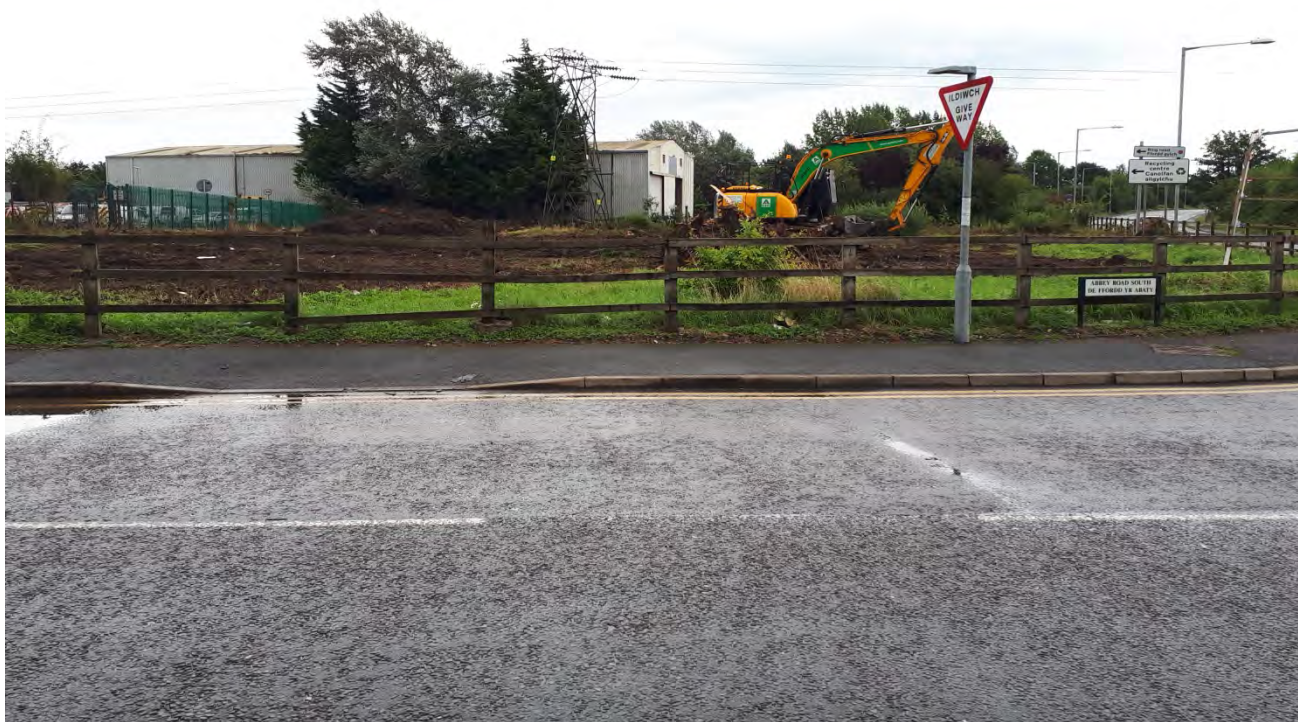
View East from Abbey Road South towards site. Excavator on site – not operating at time of walkover.

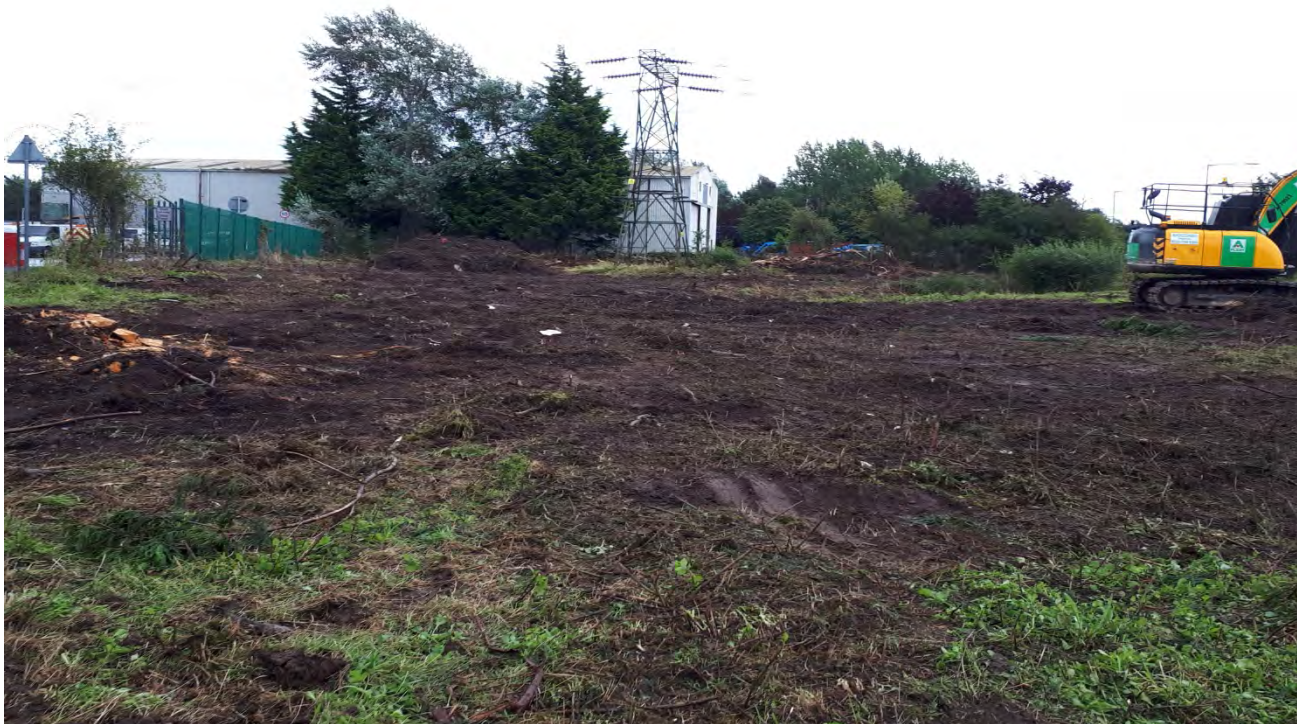
View East along northern boundary towards OHL tower

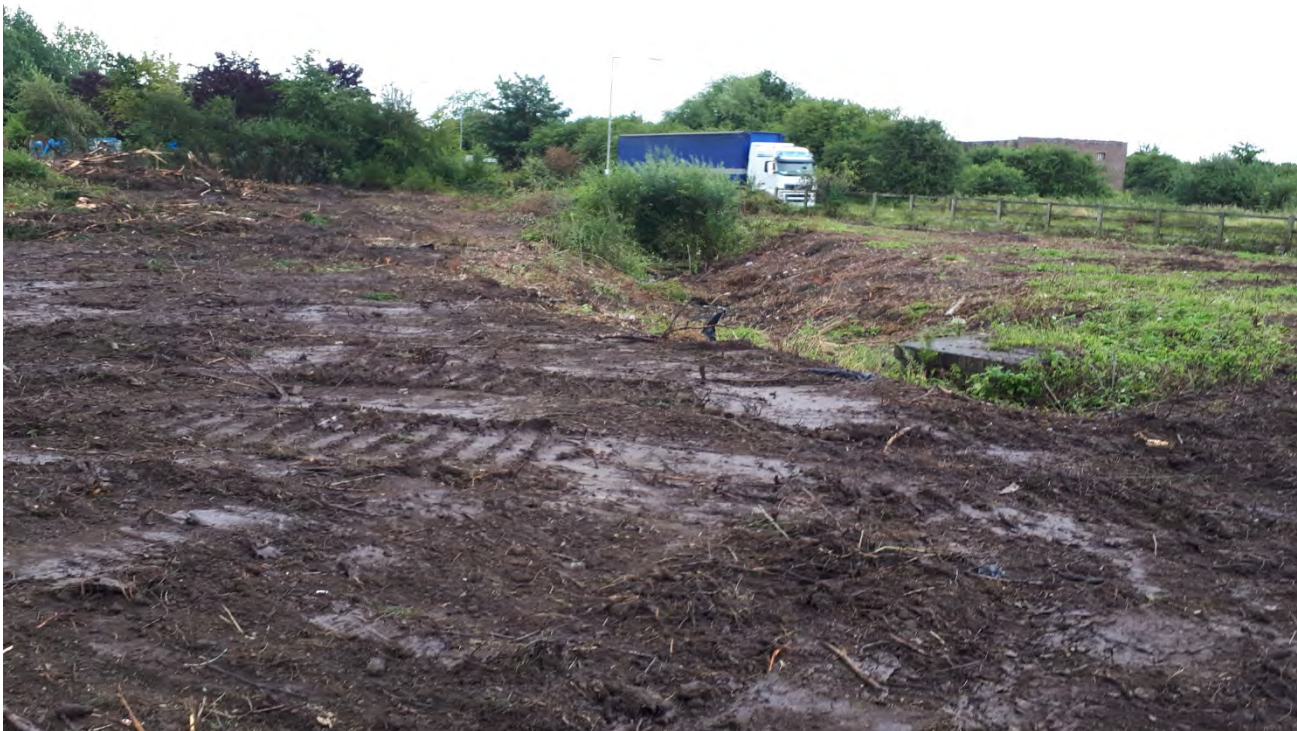
| Sloping ground – any indication of instability (cracks in ground, bulges, leaning trees, walls or poles), rotational slip scars. | Gully central to site. Approx. 1.5m deep. Running NW-SE towards SE of site. Steep sides though no obvious cracks |

View East along centre of site showing concrete service cover and gully feature

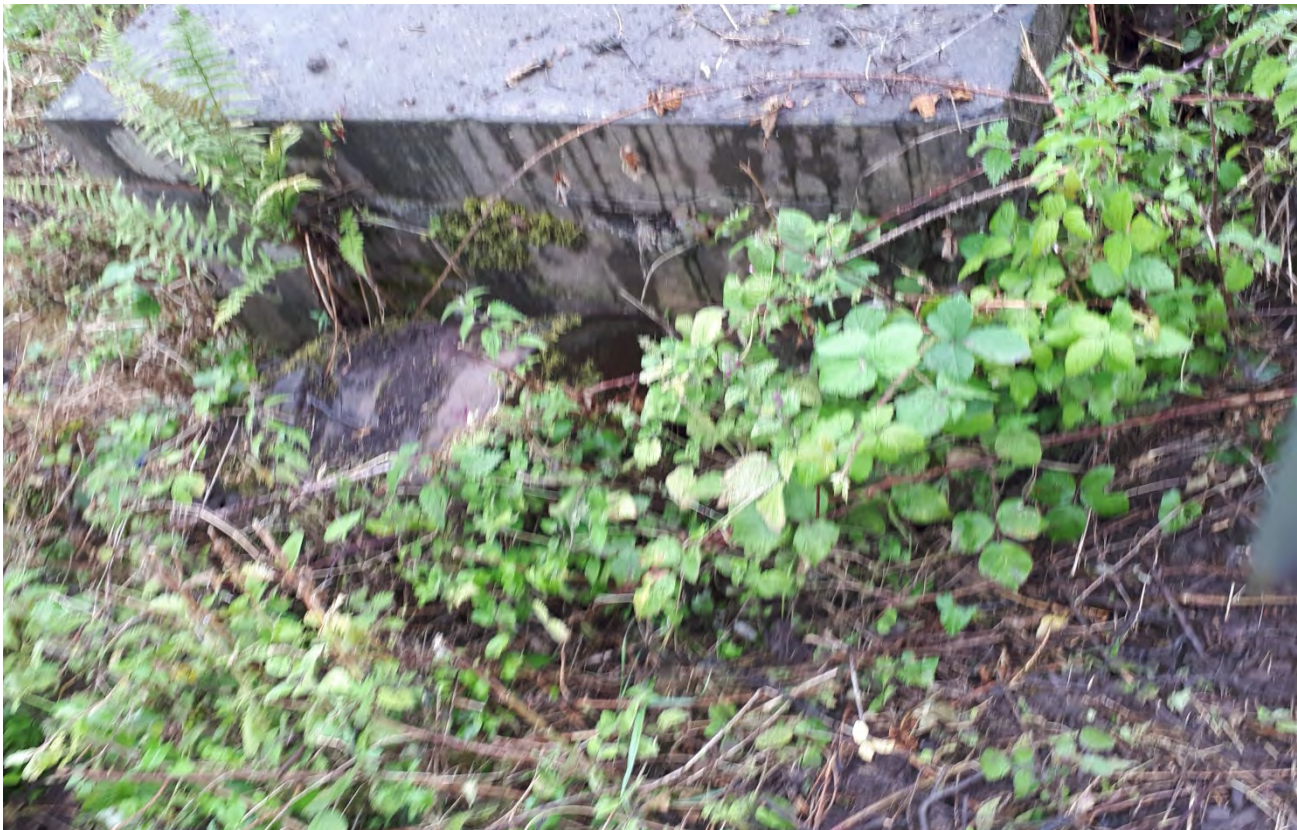
| Chemical storage : drums, other chemical stores | Rusted drum of unknown origin [photo 4] |

Unknown drum adjacent to north of concrete service cover
