**REMEDIATION STRATEGY POLICY FOR  
GRESFORD ROAD  
LLAY, WREXHAM**

**ANWYL HOMES &  
BELLWAY HOMES LTD**

**NOVEMBER 2018**

**REMEDIATION STRATEGY  
17040/REM/001**

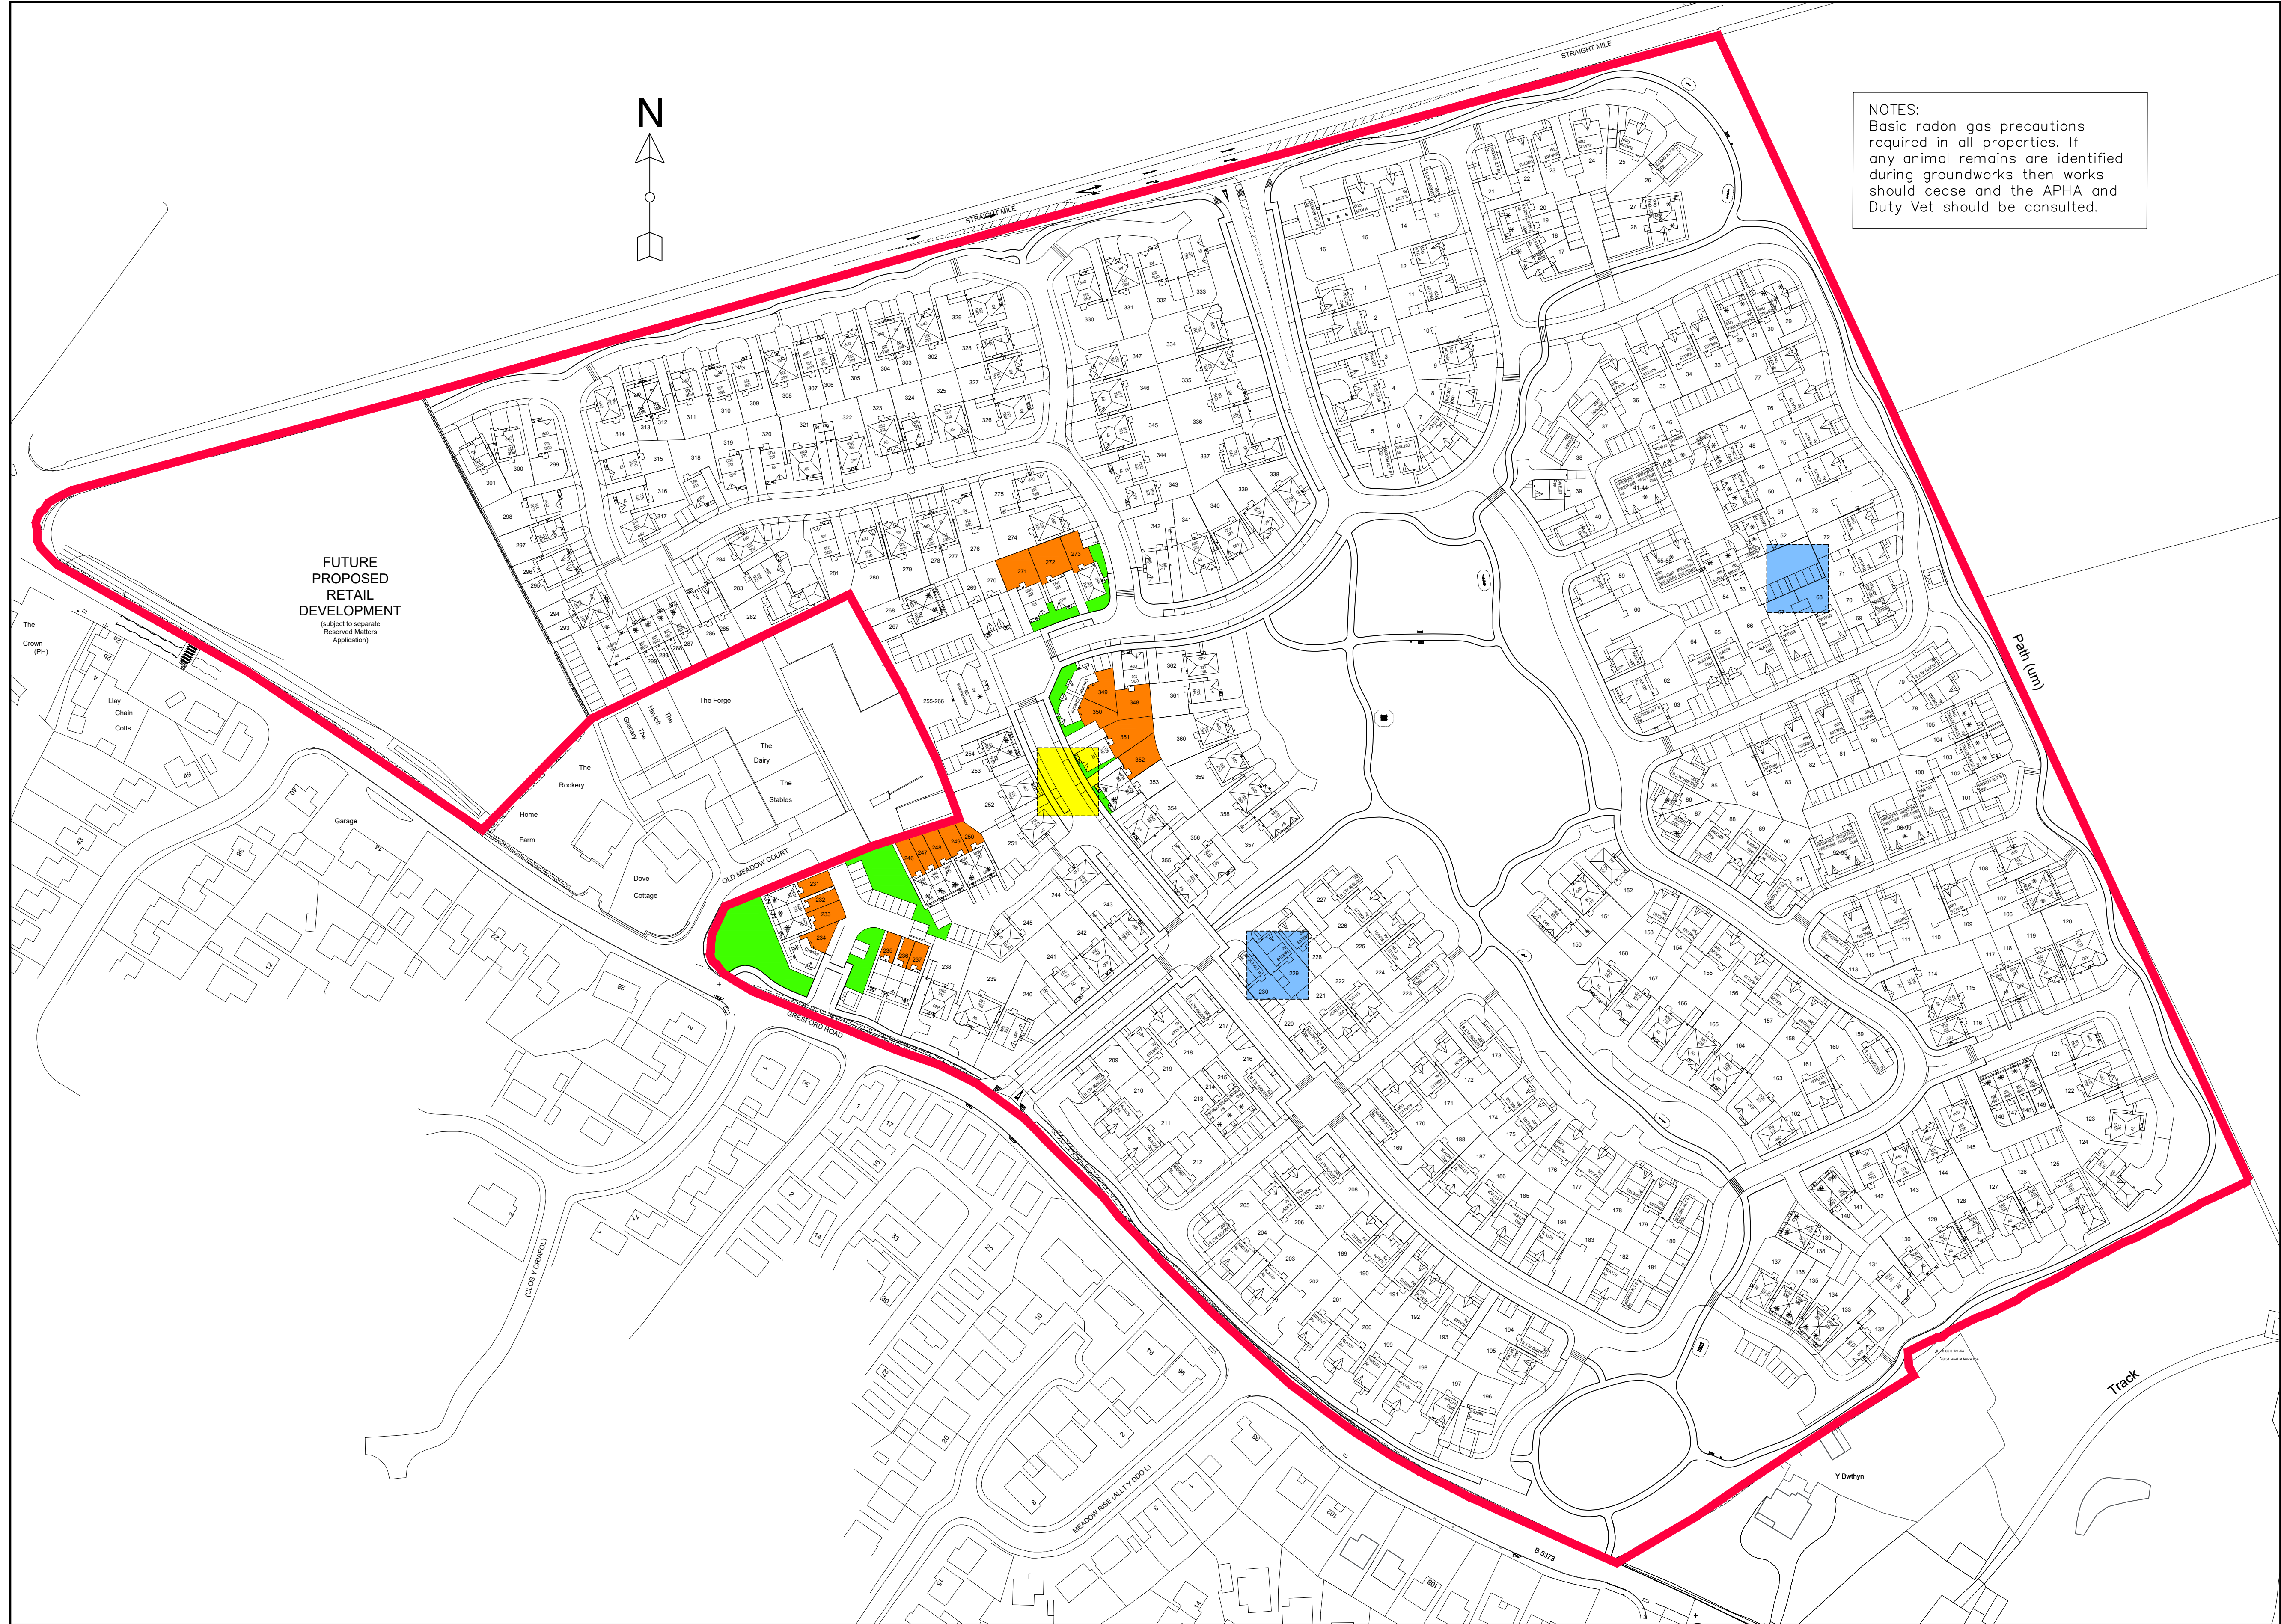
| DRAWING No | | 17040/25 |

NOTES:  
Basic radon gas precautions  
required in all properties. If  
any animal remains are identified  
during groundworks then works  
should cease and the APHA and  
Duty Vet should be consulted.

- KEY
- Approximate site boundary
  - Front garden landscaped areas where ground levels should be reduced or raised to accommodate 450mm of clean inert capping. Capping should consist of at least 150mm of topsoil.
  - Rear garden areas where ground levels should be raised or reduced to allow for at least 600mm of clean inert capping. Capping should consist of at least 150mm of topsoil.
  - Approximate location where animal remains have been identified and will require appropriate disposal in accordance with APHA and Duty Vet guidance.
  - Approximate areas where landowner has indicated where animal remains maybe present but not identified during the site investigation.

| Drawing title<br>Remediation Plan | | |

- 4.2 The previous ground investigations have identified marginal exceedances of arsenic and lead within localised made ground deposits within the site. Following the request of Wrexham Council where made ground deposits are present within garden areas the made ground should be reduced to completely remove or expose underlying natural strata or reduce to accommodate at least 600mm of clean inert material in all private rear garden areas. Within the landscaped and front garden areas, levels should be reduced or raised to accommodate 450mm of clean inert material. All capping layers should consist of at least 150mm of topsoil material which can be sourced from the site.

- *Previous ground investigation has identified the presence of animal remains and these are identified on the appended remediation plan. Other areas of potential burial sites were indicated by the landowner but no animal remains have been identified. The ground workers should maintain a watching brief throughout the ground works across the site to identify any potential animal remains during excavation works. If animal remains are identified then excavation works should cease and they should be backfilled immediately and contact should be made with the APHA and the duty vet to arrange appropriate disposal.*

- 4.5 *Details of the remediation measures are shown upon appended drawing number 17040/25 for reference.*
- 5.0 VERIFICATION**
- 5.1 *The engineer will liaise with the appointed ground works contractor and inspect the site during the works and upon completion.*
