## **BAT GROUND LEVEL TREE ASSESSMENT**

### **Plot 3A**

Wrexham Industrial Estate  
Wrexham  
Wrexham County Borough  
L22 3XS

| UES reference: | UES03448/06 |

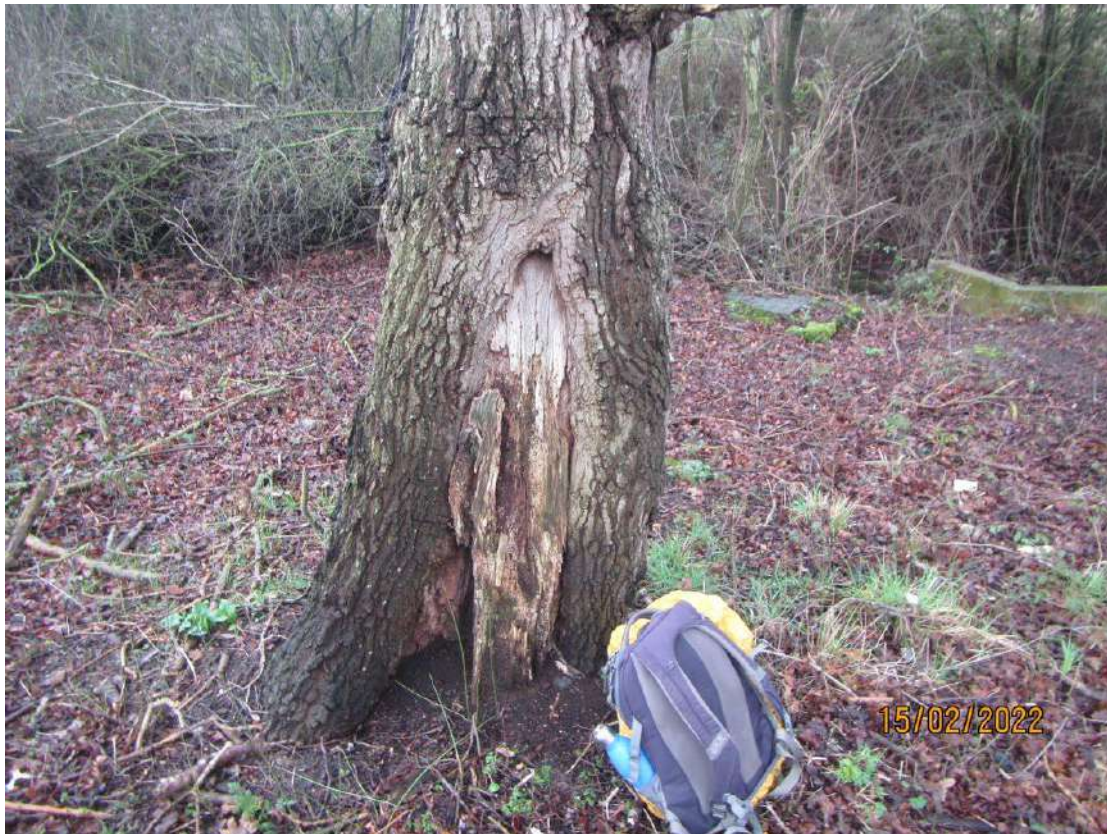
Photograph 3 – T3 showing basal stem cavity.

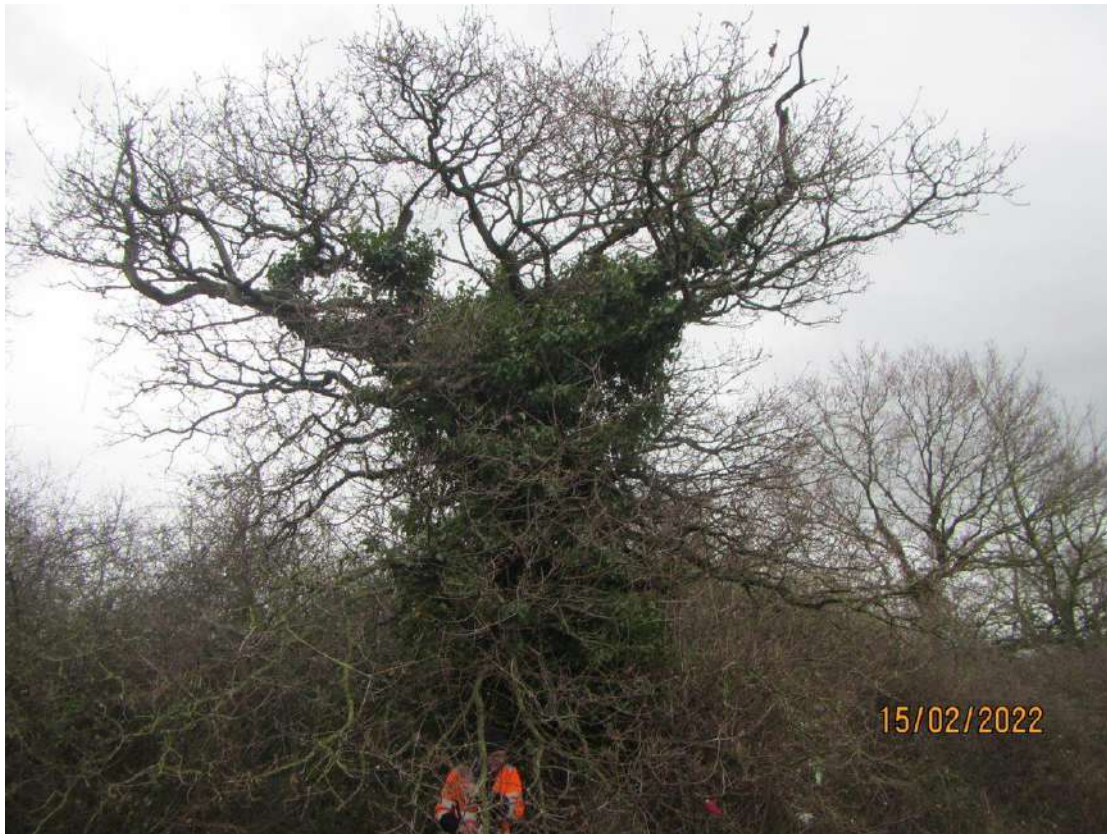
Photograph 5 – T4 showing ivy cover.

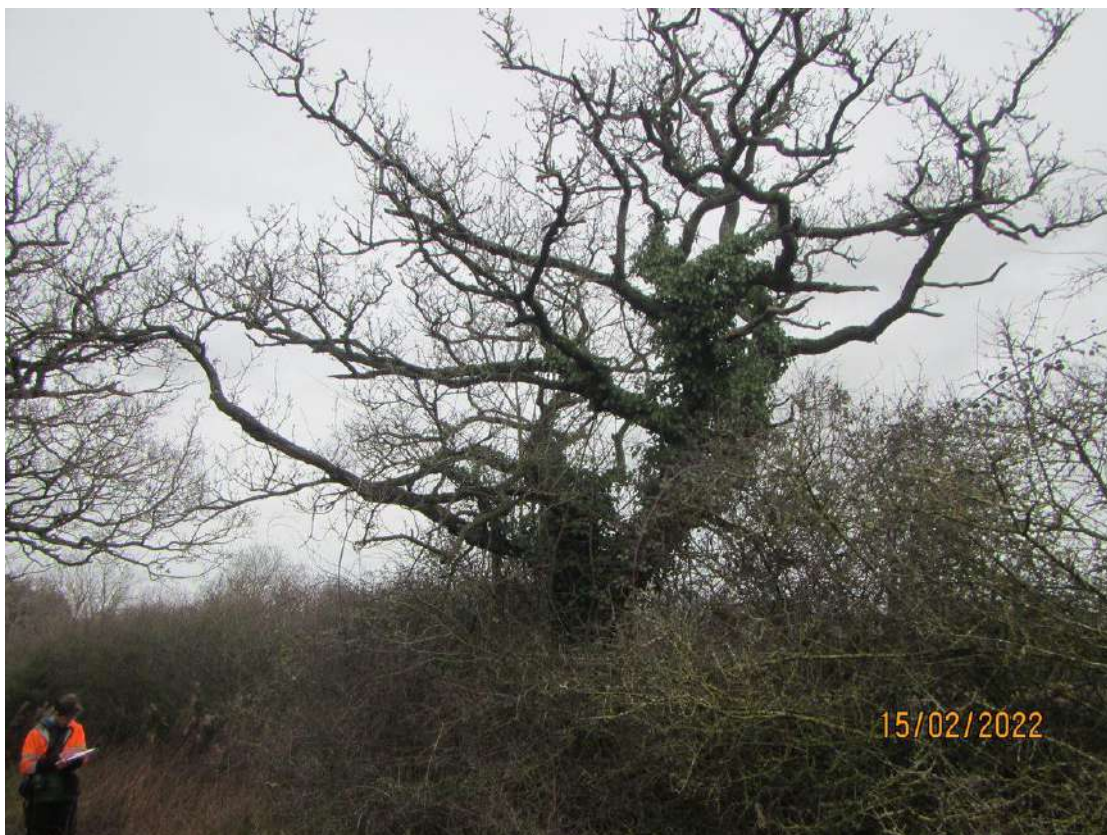
Photograph 13 – The crown of T9.

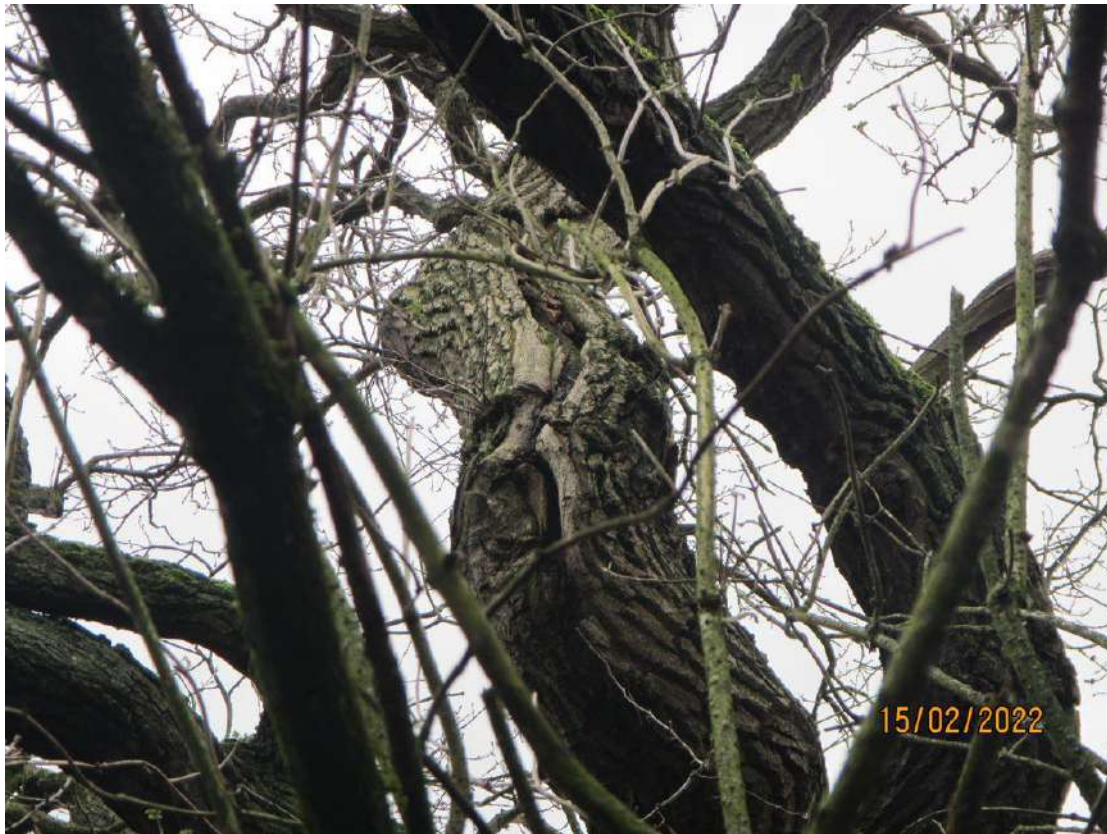
Photograph 19 – T11 showing vertical callus-roll.

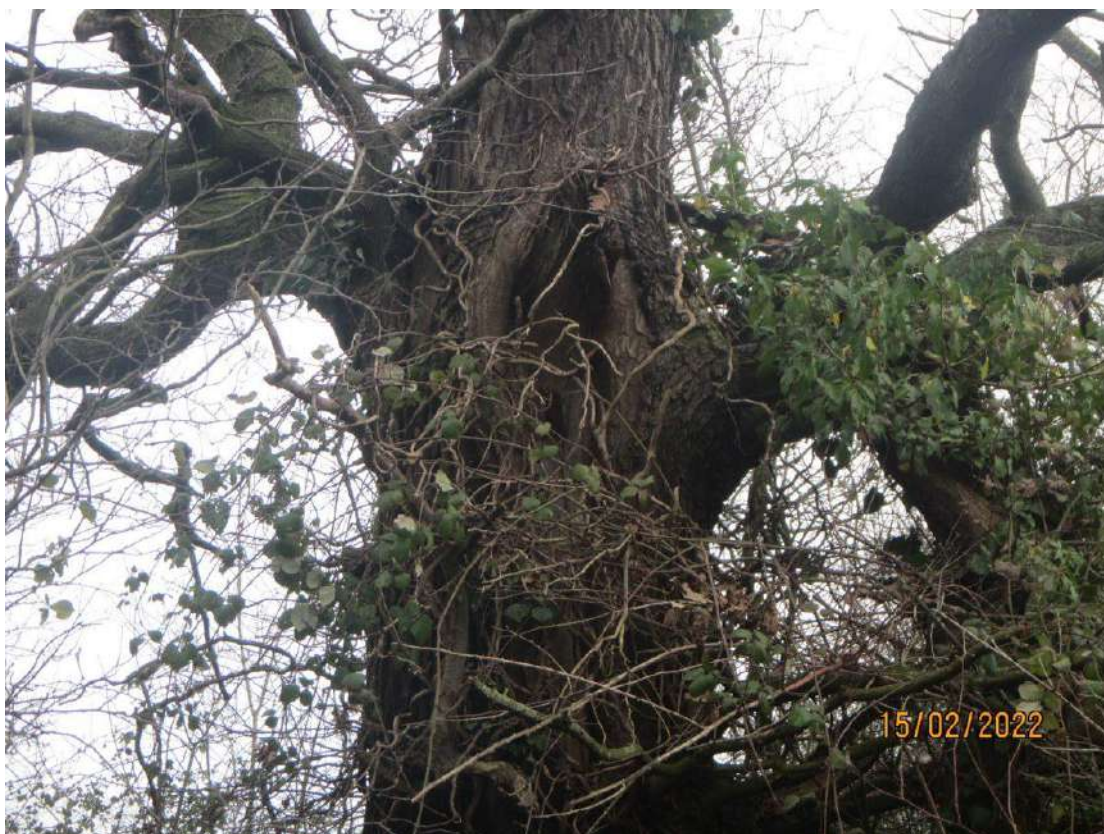
Photograph 24 – T14 showing stem cavity.

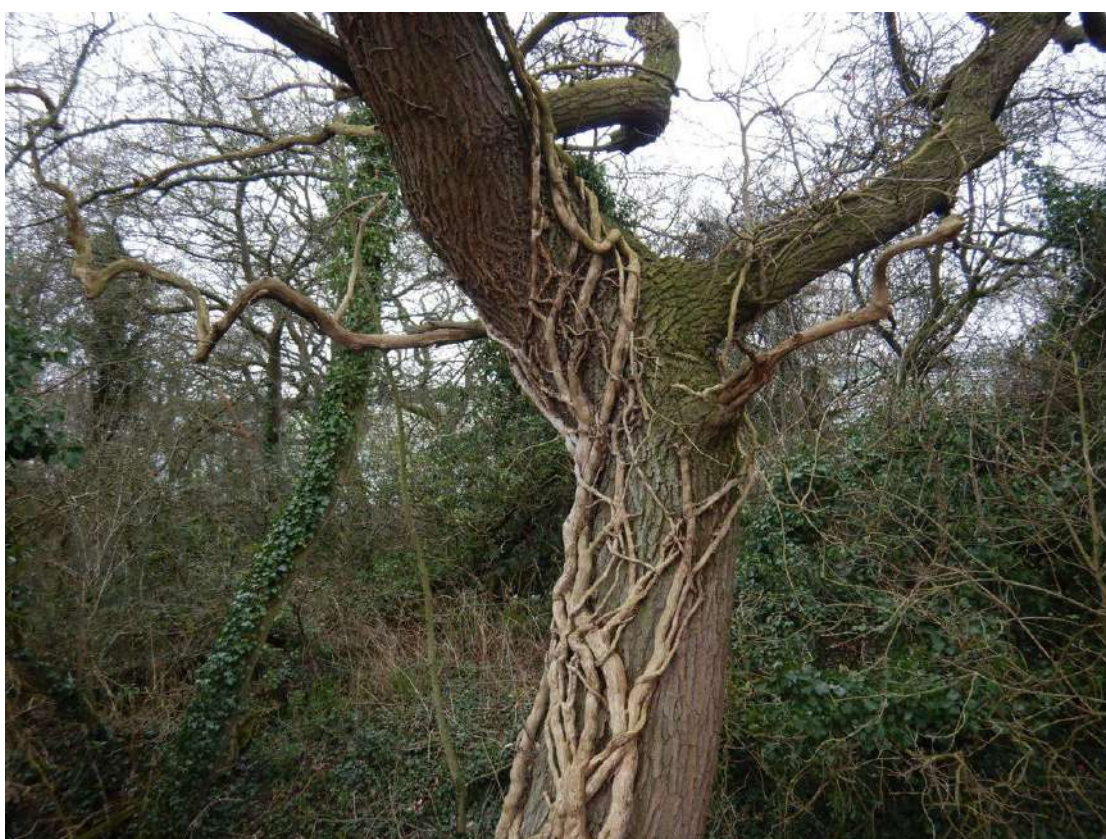
Photograph 40 – T25 showing ivy cover.

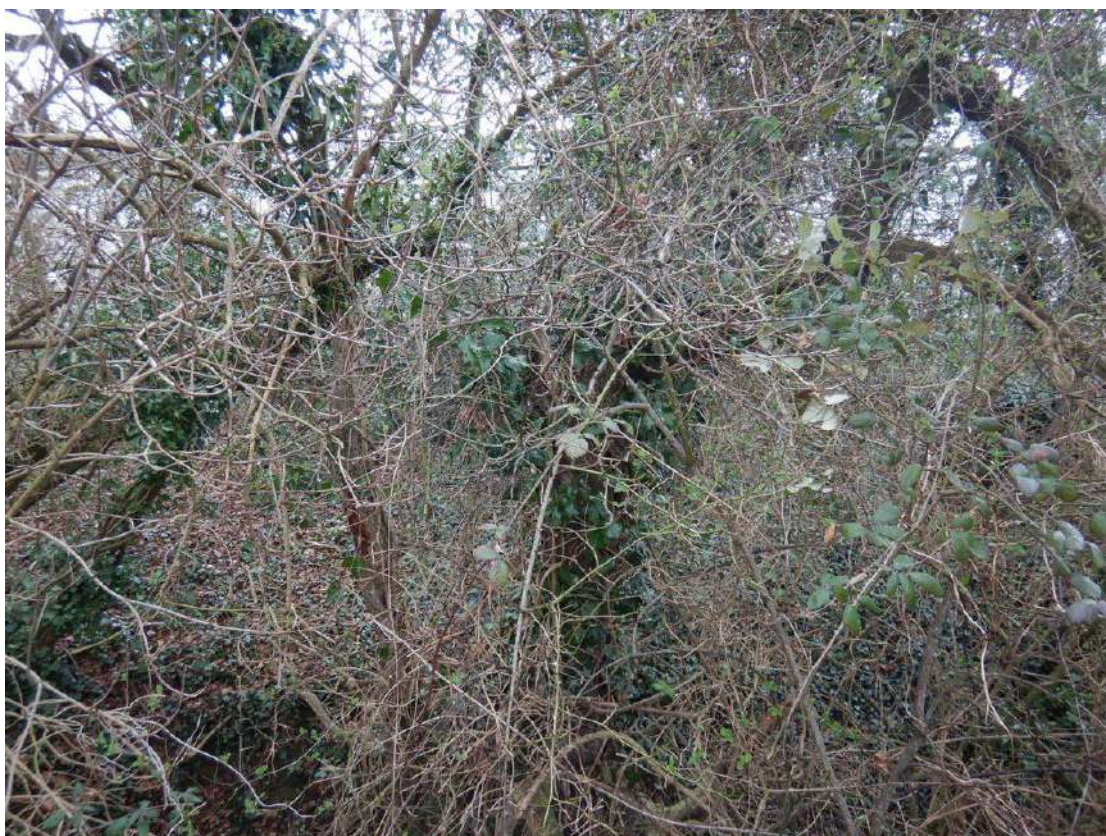
Photograph 49 – T29 showing clutter by surrounding scrub.

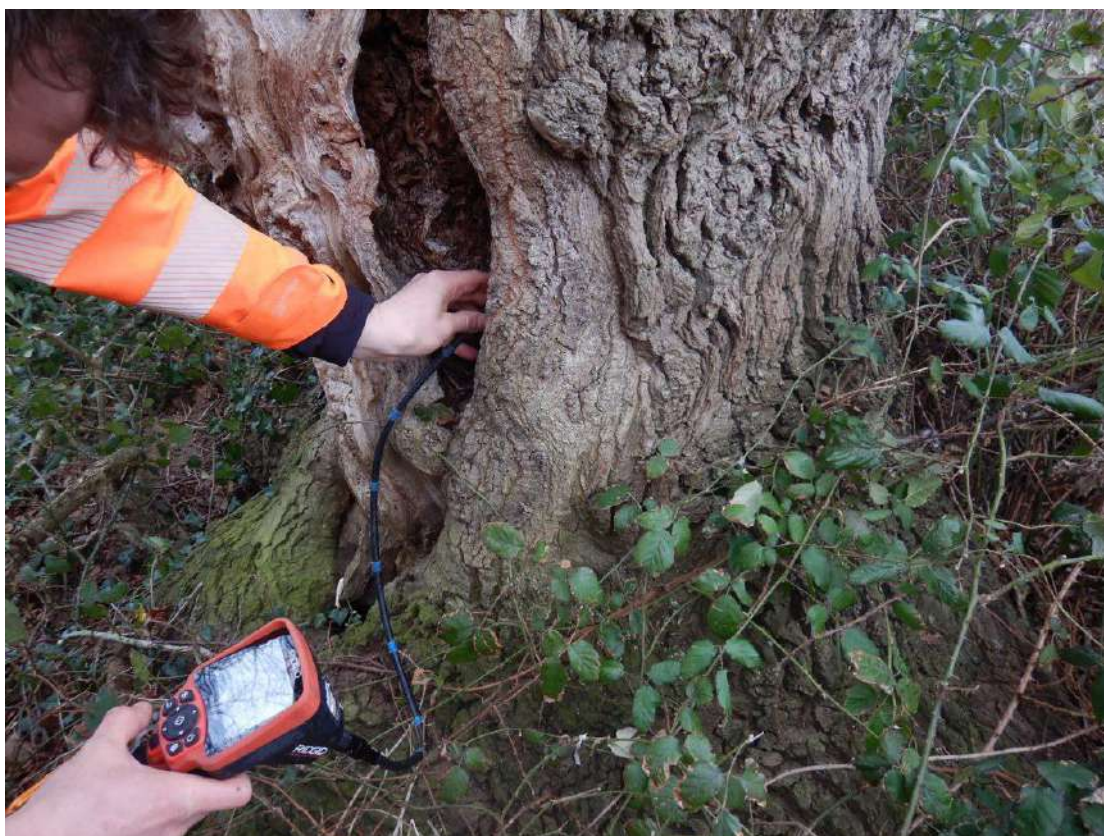
Photograph 53 – T31 showing basal stem cavity.

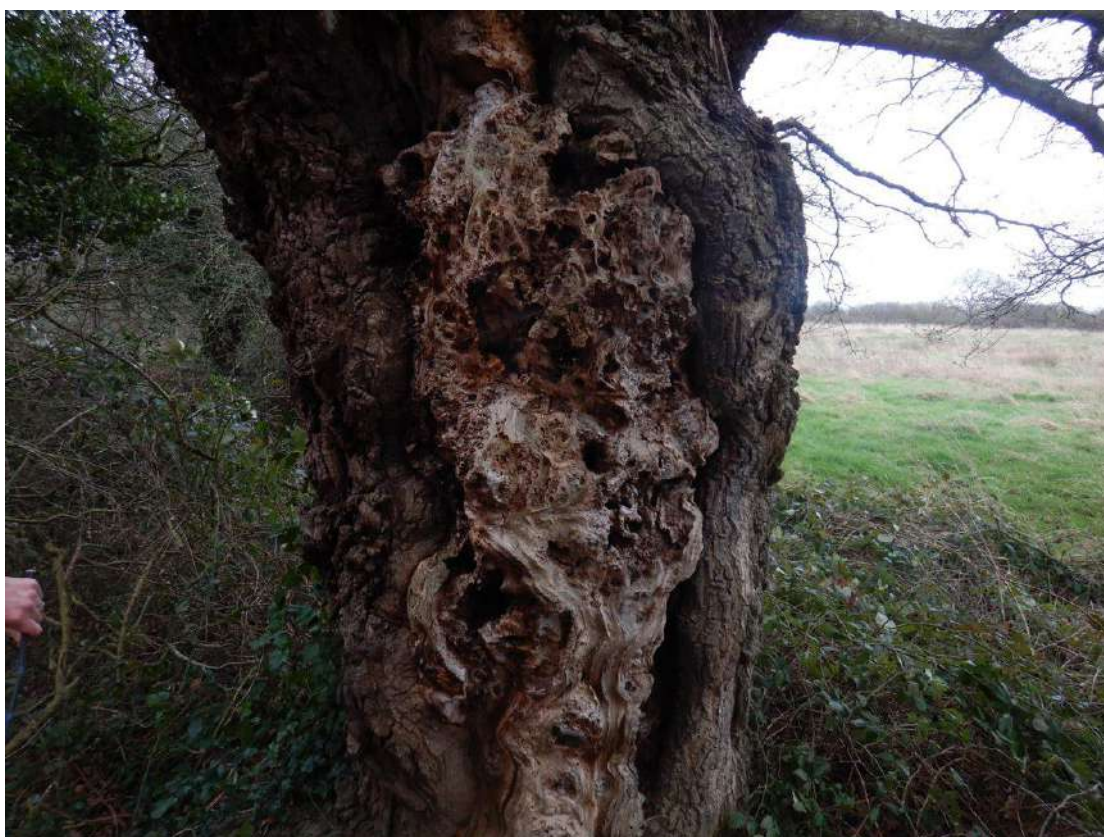
Photograph 54 – T31 showing multiple stem cavities in exposed heartwood.

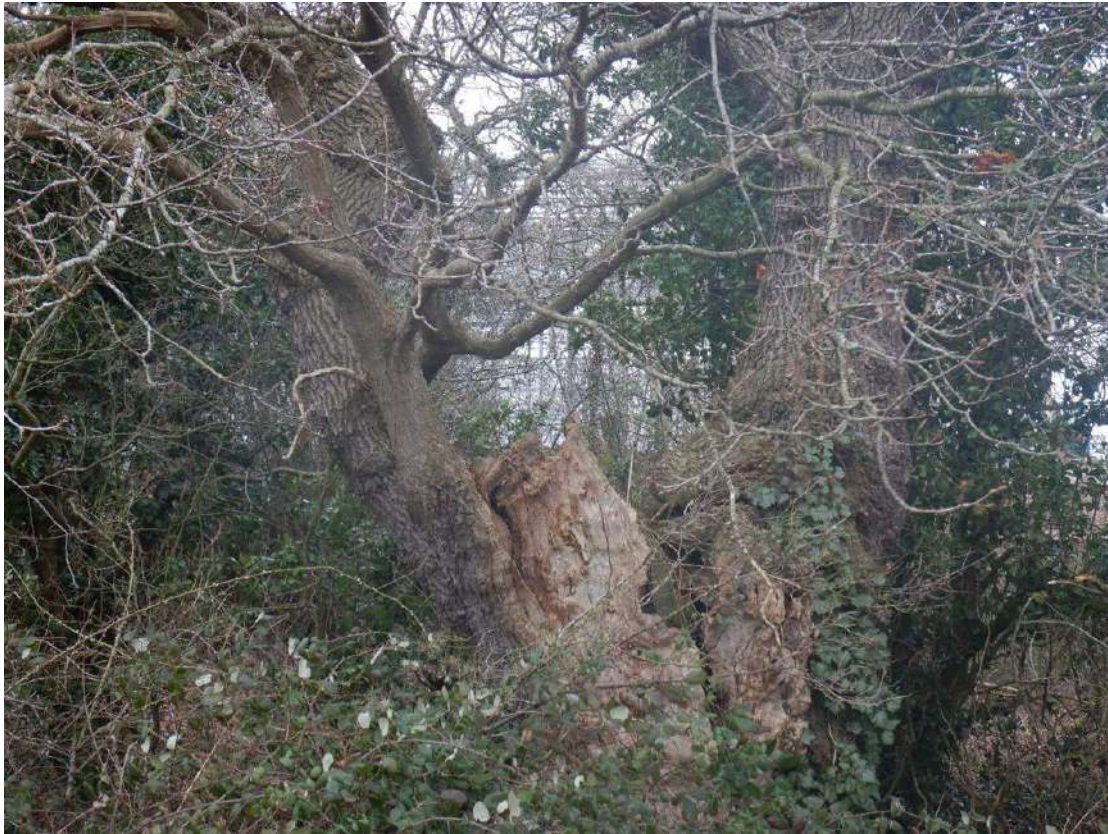
Photograph 55 – T32 showing trunk v-split.

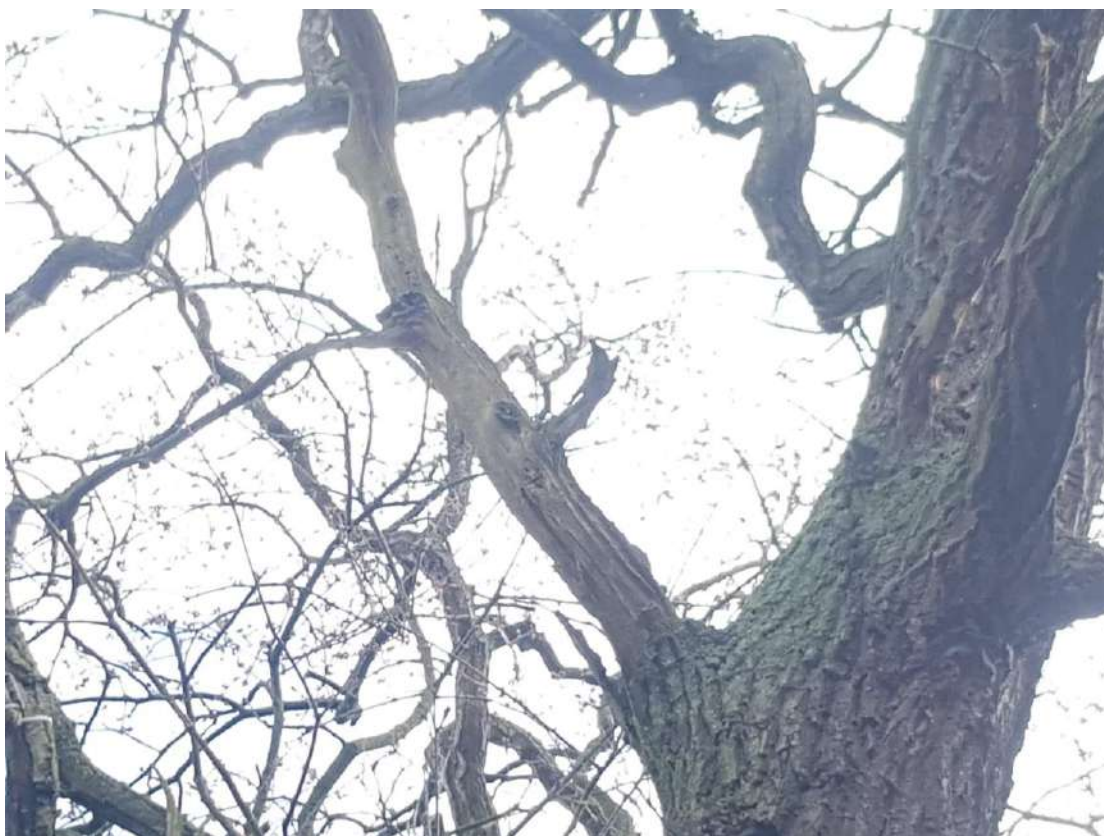
Photograph 61 – T34 showing deadwood on northern aspect.

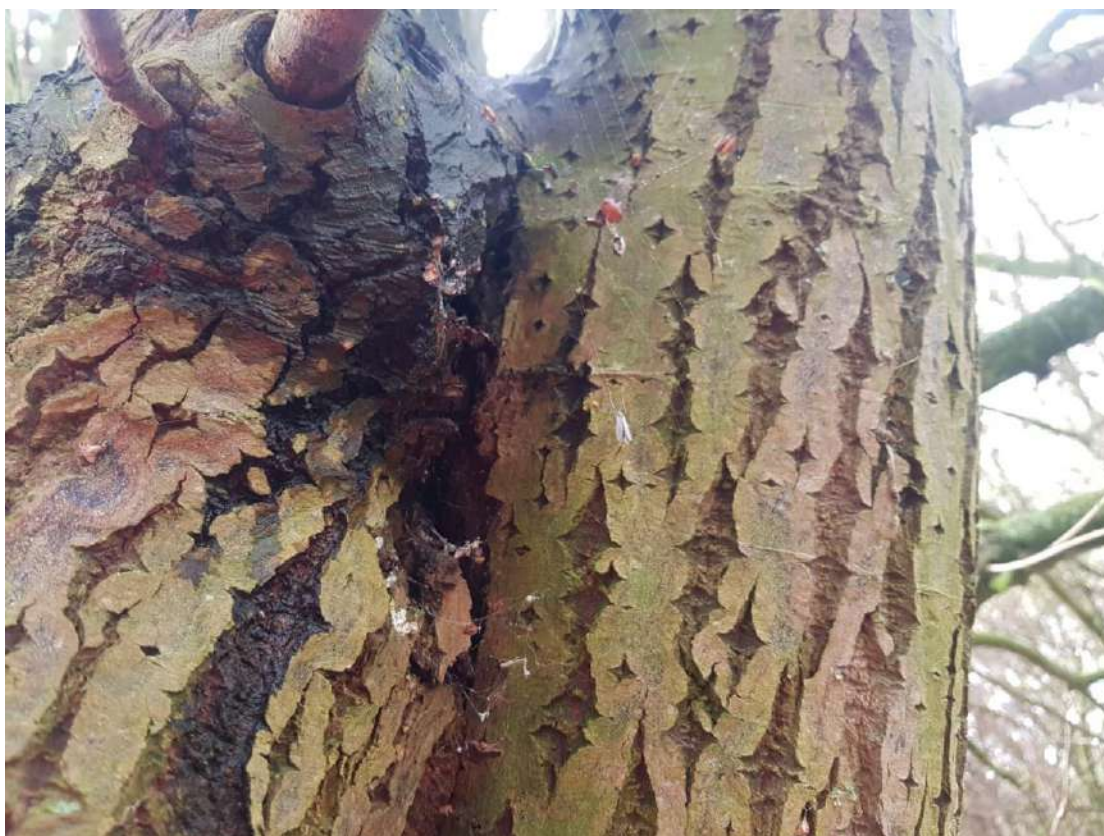
Photograph 71 – T36 showing stem cavity.

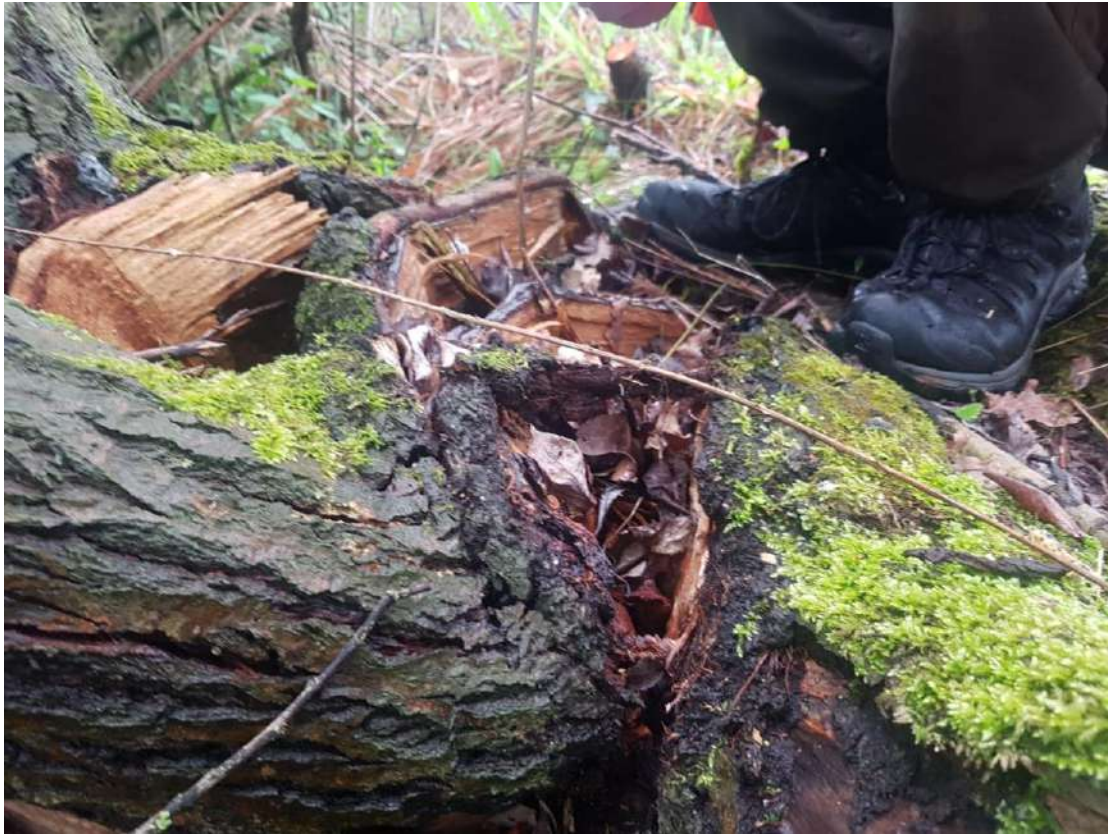
Photograph 77 – T39 showing basal stem cavity.

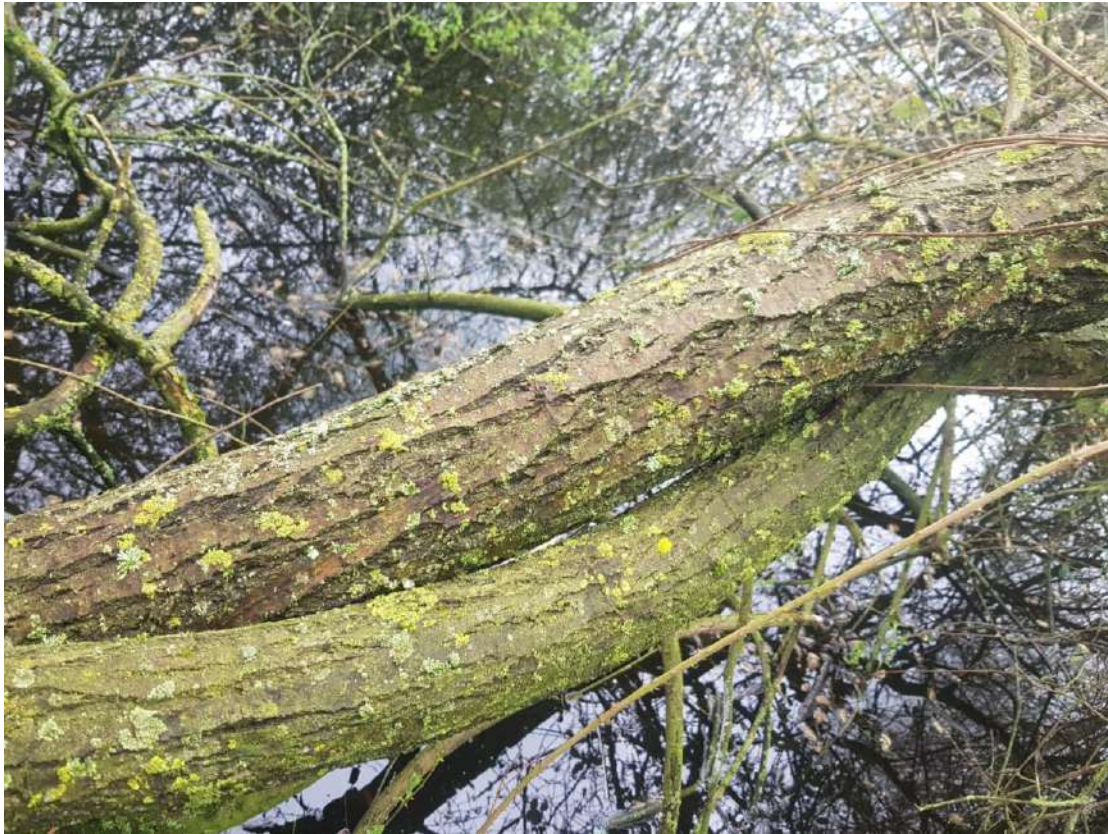
Photograph 79 – T39 showing weld.
