Our Ref: 01016/Rep 01  
Date: 10<sup>th</sup> July 2015

## **STRUCTURAL INSPECTION AND LETTER REPORT – GAMFORD FARM, ROSSETT**

We thank you for instructing Woodbank Consulting Engineers Ltd (Woodbank) to carry out a visual survey of the barns and main property at Gamford Farm, Rossett, which are to form part of a planning application.

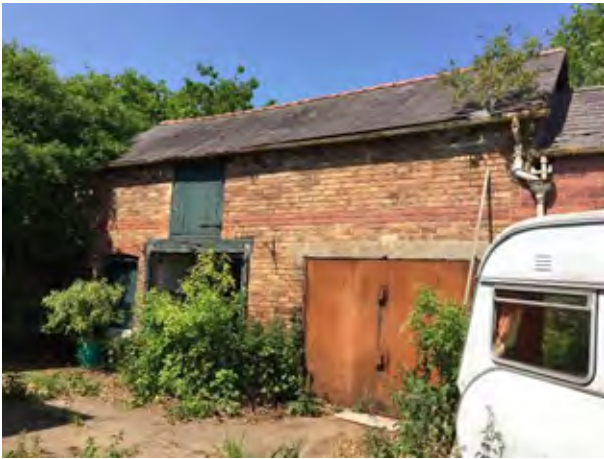
Front elevation, right hand side.

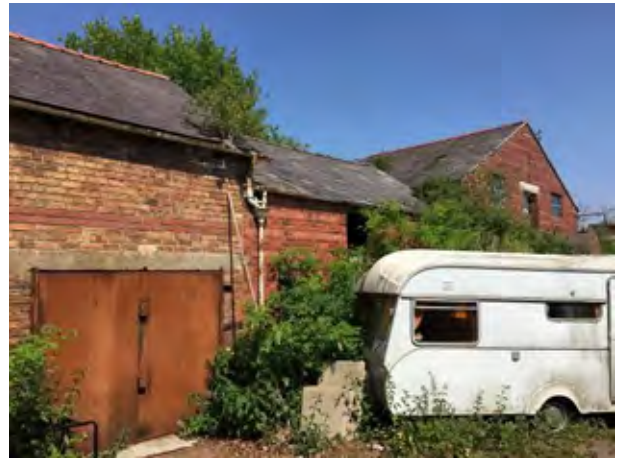
Front elevation, left hand side.

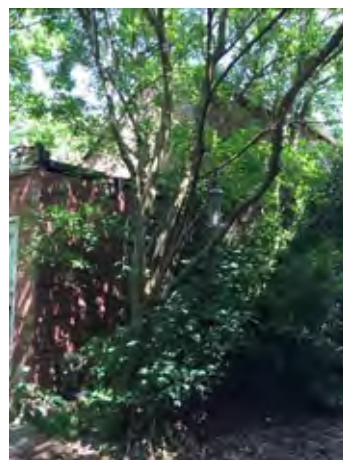
Vegetation in front of elevation.

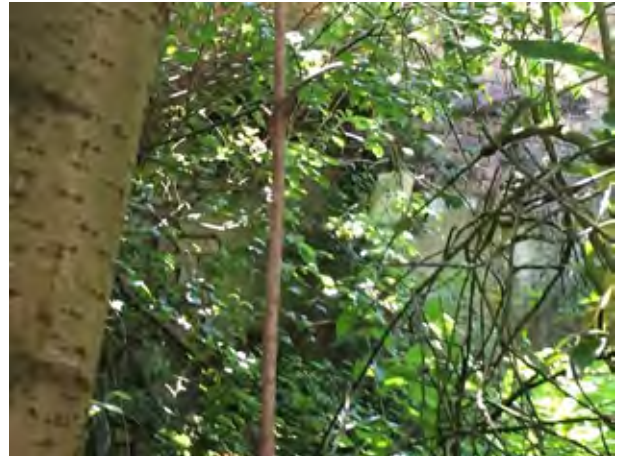
Vegetation in front of elevation.

Many trees had grown close up to the elevation and these should be cleared. Vegetation was also noted growing through the elevation in places. This should be removed and localised brickwork repairs carried out.

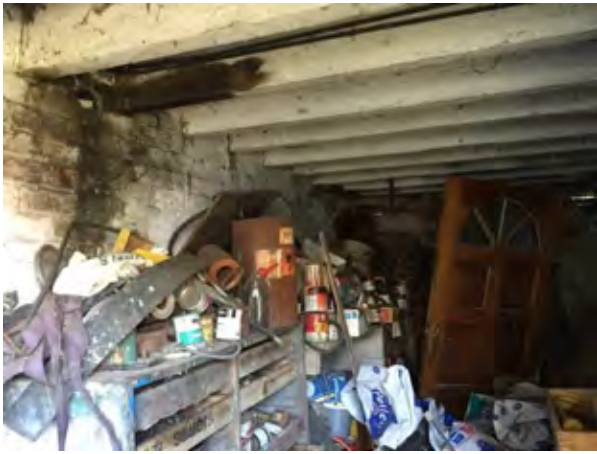
Room 1.

Room 1 was filled with stored materials which covered the majority of the walls and floor, therefore a detailed inspection was not possible. No significant structural defects were noted where visible. It is anticipated that the walls are 215 mm solid brick walls.

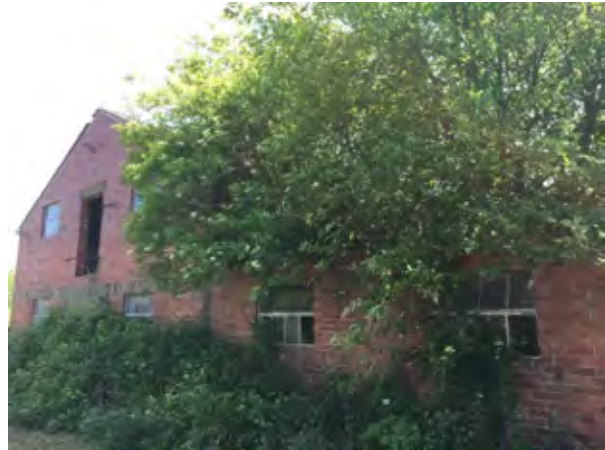
Left hand side elevation hidden by single storey building and vegetation.

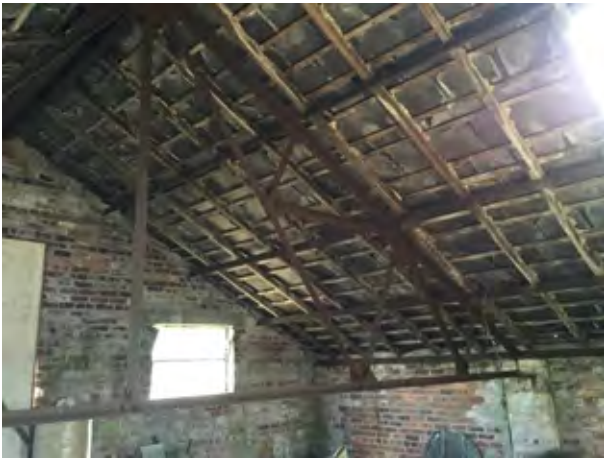
First floor level.

The timber floor was considered to be suitably level. Some of the timber rafters and battens would benefit from replacement.

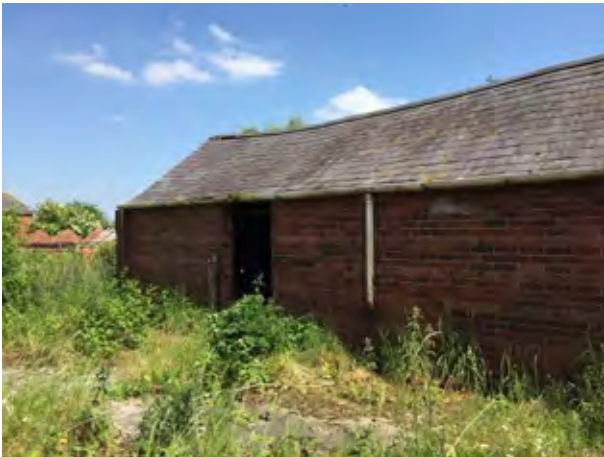
Left hand side of front elevation.

Horizontal and some stepped cracking was noted in a number of places across the elevation. This had generally occurred where steelwork was embedded within the brickwork. It is anticipated that the steelwork has corroded and delaminated, opening up the bed joints. A similar crack had occurred where there was a pipe penetration through the elevation.

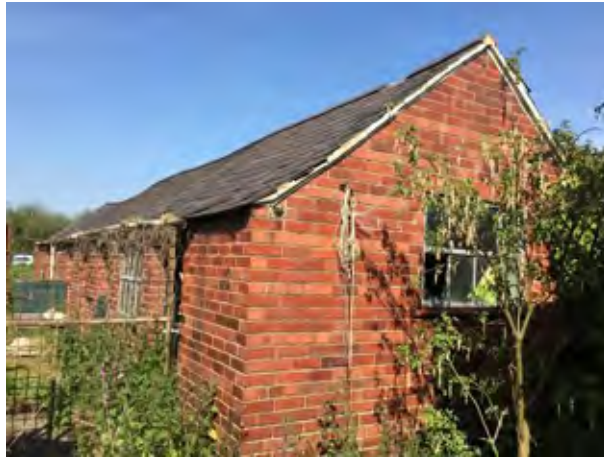
Right hand side elevation.

The majority of the elevation was hidden by vegetation and therefore are unable to comment on all areas of the elevation.

Mortar has weathered and dislodges from the verges and should be repointed.

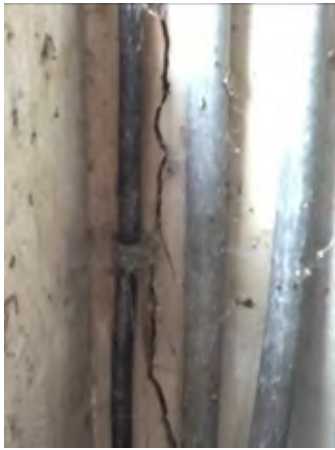
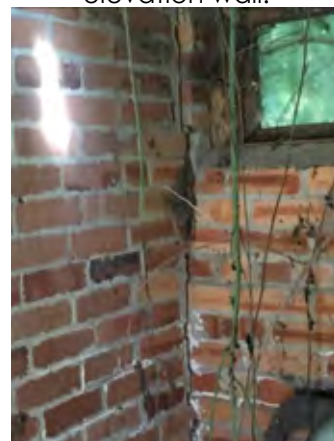
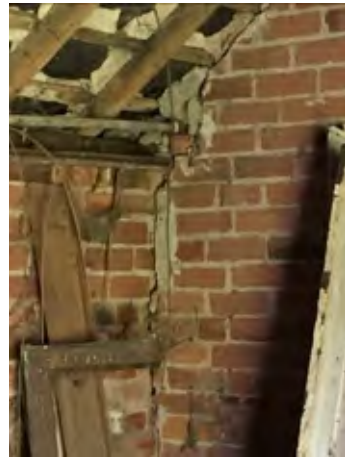
Vertical cracking of approximately 2 mm width was noted at the junction of the cross wall between Rooms 1 and 2 and the rear wall. It is likely that the rear wall has moved outwards slightly as the roof has spread.

The gap between the cross wall between Rooms 2 and 3 and the rear wall was wider, approximately 7 mm. A similar gap was noted between the same cross wall and the front elevation wall, although the width was approximately 5 mm wide. It was noted that the rafter ends were rotting.

The gap between the cross wall between Rooms 2 and 3 was slightly larger on this face of the wall, it ranged from 7 mm to 10 mm. A further 10 mm wide gap was noted between the cross wall between Rooms 3 and 4 and the front wall.

As in the previous rooms there is a lack of restraint between the cross walls and the front and rear walls and gaps of up to 10 mm were noted.

Crack formed between cross wall and front elevation wall.

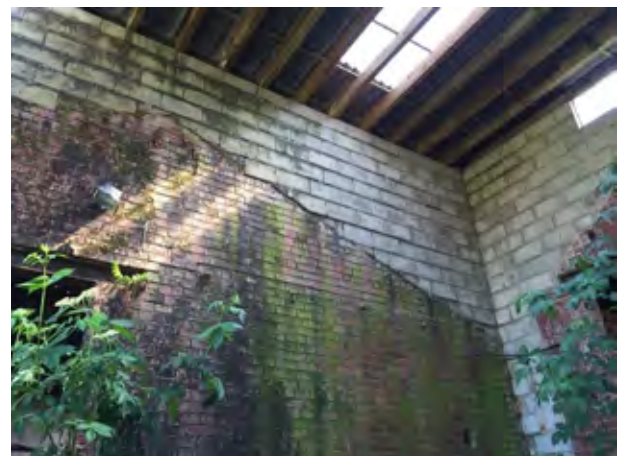
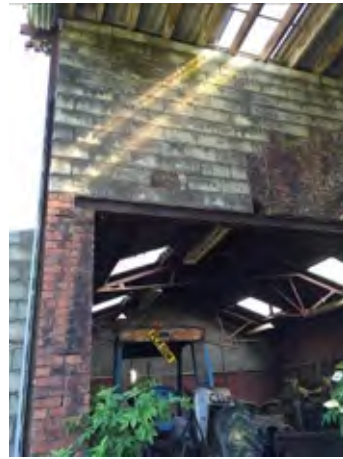
The steel beams provided to form the opening between the barn and the adjacent taller barn has corroded causing the masonry adjacent to the steelwork to crack. We recommend that the steelwork is cleaned and provided with a suitable corrosion protection product is applicable, or the steelwork should be replaced. The cracked masonry should be repointed.

Large opening from through the right hand side gable wall. Blockwork constructed over original gable profile to increase height of adjacent barn.

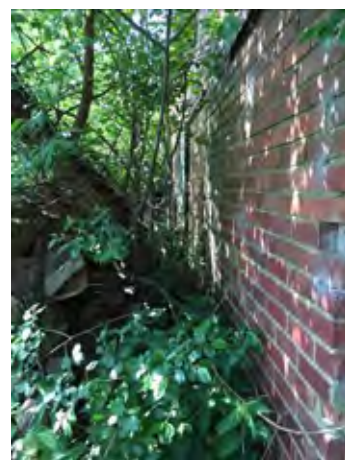
Trees and vegetation close to rear elevation.

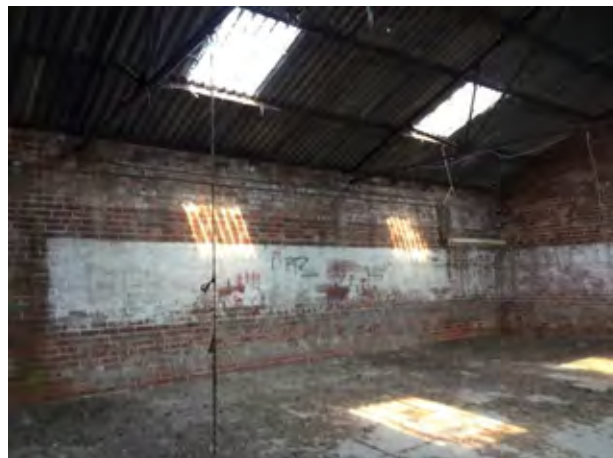
Within Room 1 the front wall appeared to have moved outwards slightly, it was noted that the bottom chord of the truss had been removed and therefore the restraint afforded had been compromised. Additional restraint or a repair will be required to the truss to prevent further movement of the front wall.

Internal face of front elevation wall.

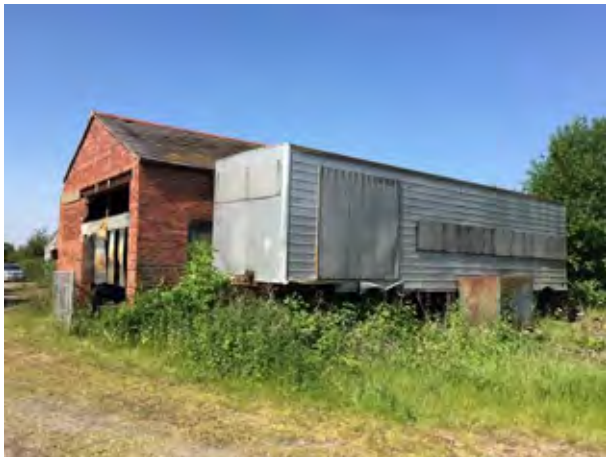
The majority of the two storey part of the elevation was hidden by a large trailer. Where visible it was noted that the windows were boarded over and the gutters were missing. A slight bow in the wall was evident, however, this was considered to be within acceptable limits.

Left hand side of rear elevation hidden by large trailer.

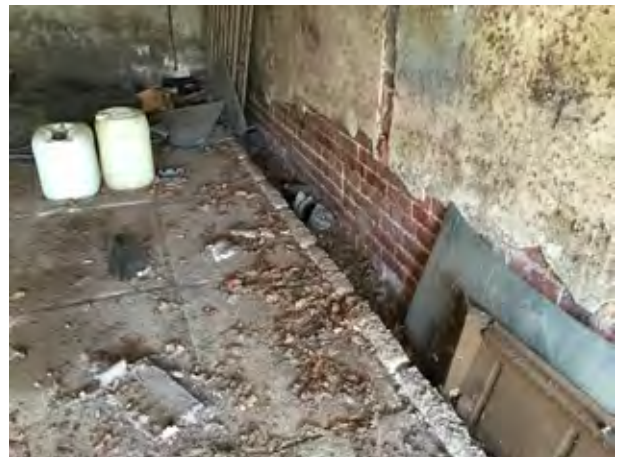
Trough in floor.

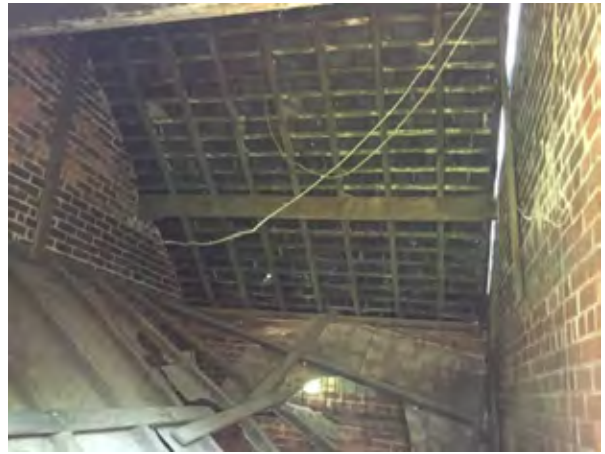
Ceilings collapsing.

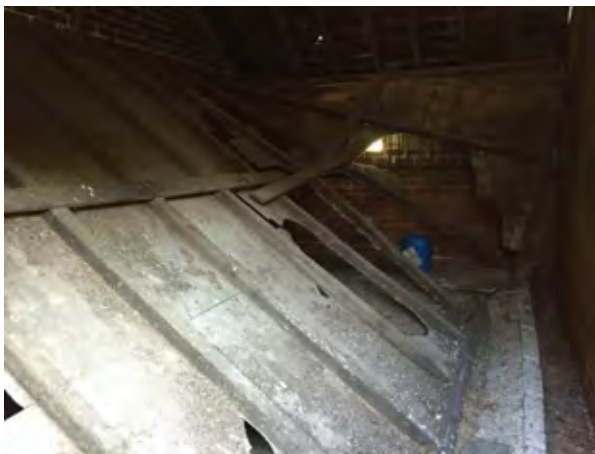
Collapsed ceilings.

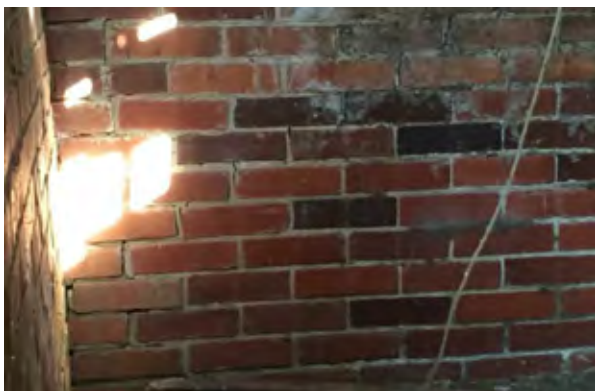
Cracking to cross wall.

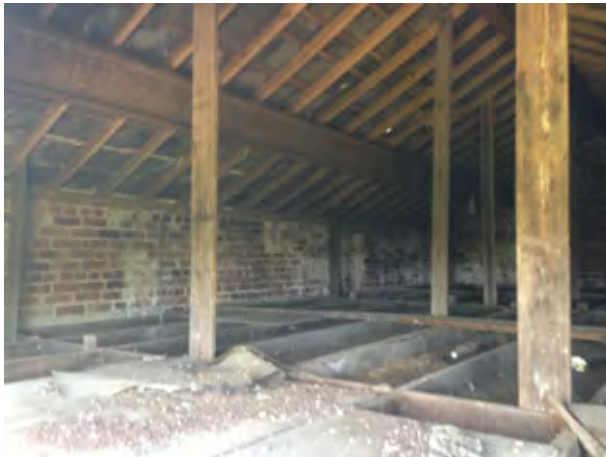
First floor.

The floor / ceiling between the upper and lower level of the two storey part of the structure has been hung from the roof structure. A steel ridge beam and steel purlins have been provided to strengthen the roof and should prevent further splaying of the roof structure.

We would recommend that the first floor is supported independently of the roof structure.

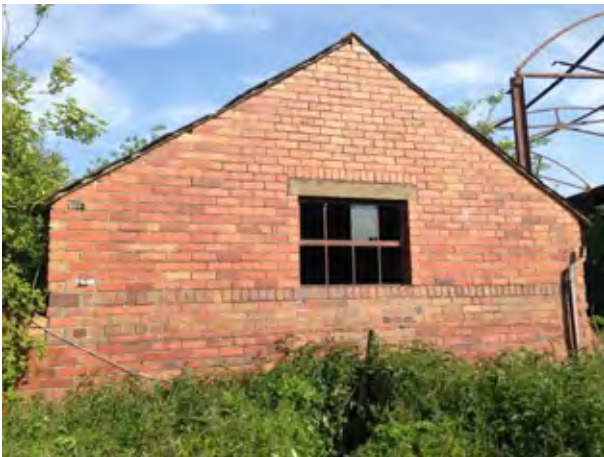
Right hand side elevation.

The wall plates are visible on the gable elevation. These appear to have weathered.

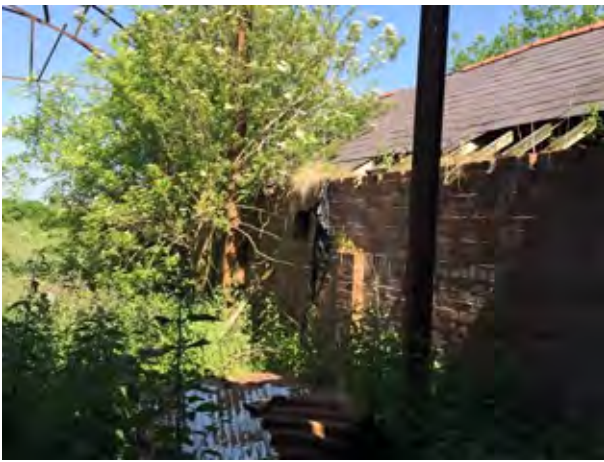
Rear elevation

Some of the clay ridge tiles were missing and no rain water goods were visible.

A large part of the roof over room 1 had rafters and slates missing. Vegetation was growing through the roof.

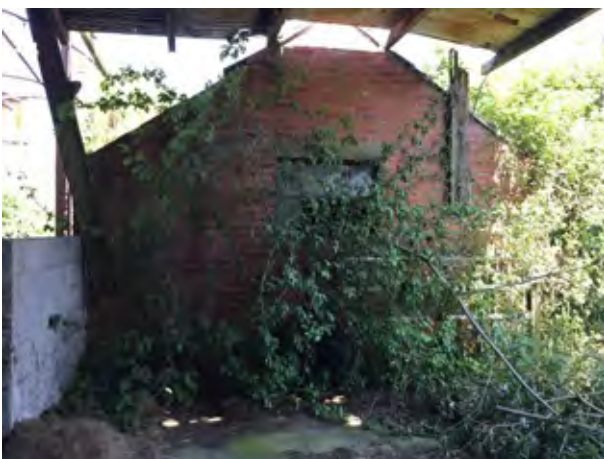
Left hand side elevation.

Water staining was noted on the face of the elevation suggesting that the drainage from the upper roof is inadequate. We assume that the upper roof will be removed within any further refurbishment schemes.

Some holes through the elevation had been provided for services; these should be infilled.

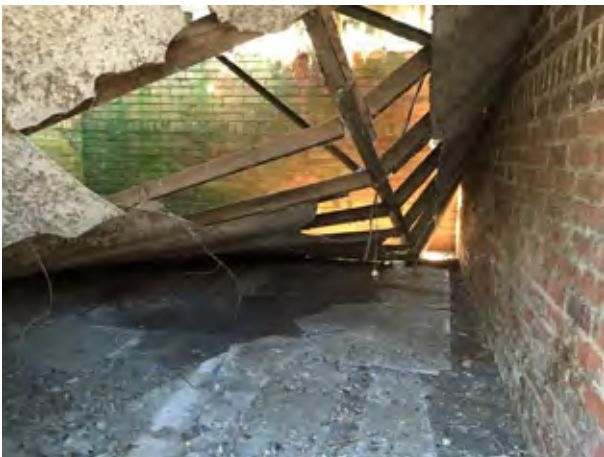
The ceiling to room 3 was intact, but could collapse at any time, as it is likely to have been constructed at the same time as the collapsed and collapsing ceilings in the other rooms. Daylight was visible at high level indicating that there must be at least one hole through the roof. There was no ceiling to room 4 and it was noted that the right hand side elevation wall had been constructed so it was angled; i.e. not at 90 degrees to the front and rear walls.

Ceilings collapsing.

We would recommend that the barn is re-roofed, replacing timbers as required and providing a ridge beam. This will prevent further spreading of the roof timbers and will repair holes etc.

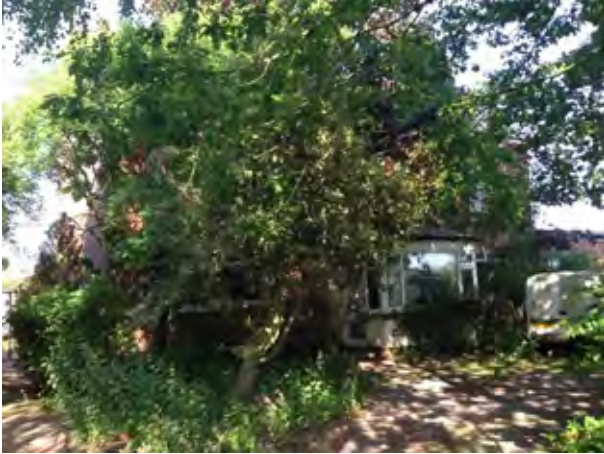
Front elevation hidden by vegetation.

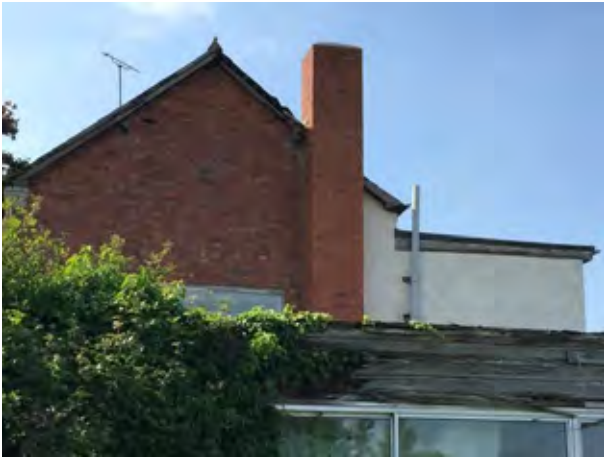
Right hand side elevation generally.

The right hand side of the side elevation has a steel beam over the large opening. The timber fascia over has rotten and dislodged. Vegetation is growing across the elevation from both sides. This should be cleared and repairs undertaken as required to the affected timbers.

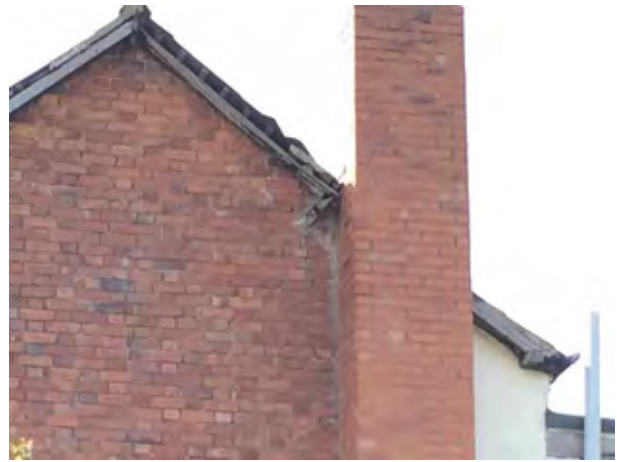
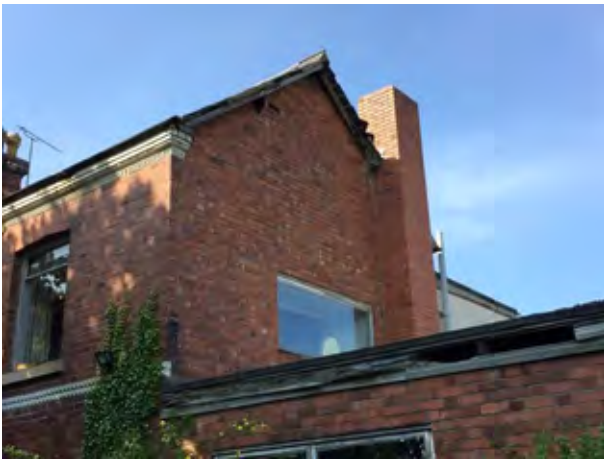
Right hand side elevation of original dwelling.

A large window opening was noted at first floor level within the original gable elevation. It was not possible to assess whether a lintel had been used. We recommend that this should be investigated further.

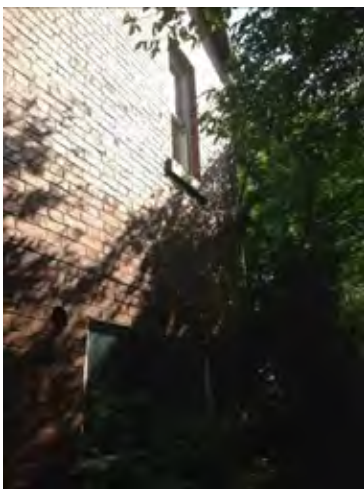
Left hand side elevation generally.

The main side wall had a vertical crack over the window and the render had cracked adjacent to the lintel. A brick arch lintel had been provided and it would appear that this has slipped slightly. A repair should be provided to minimise future movement of the elevation.
