## Photographic Schedule of Condition

Goulbourne  
Borras Park Road  
Wrexham  
Clywd, LL12 7TF

Star Pubs & Bars

Tel: 01604 664366  
Fax: 01604 664367  
Date: 4 May 2016  
Ref: 0101487-BC-0000

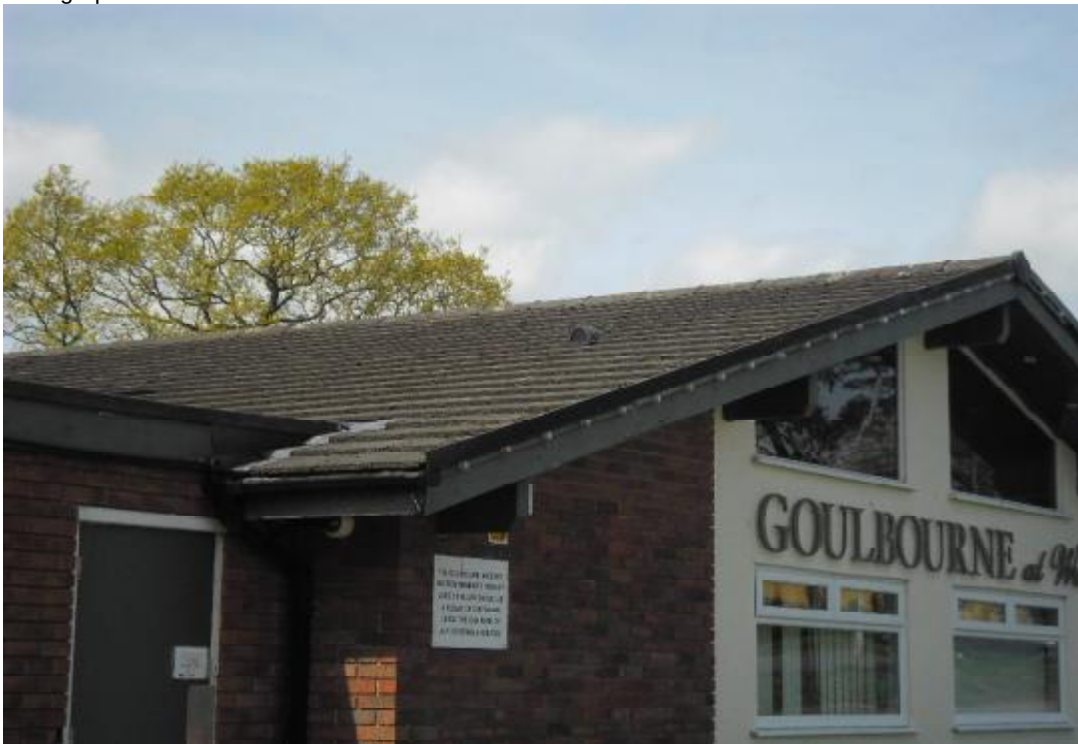
Photograph 6: View of roof to left-hand side elevation.

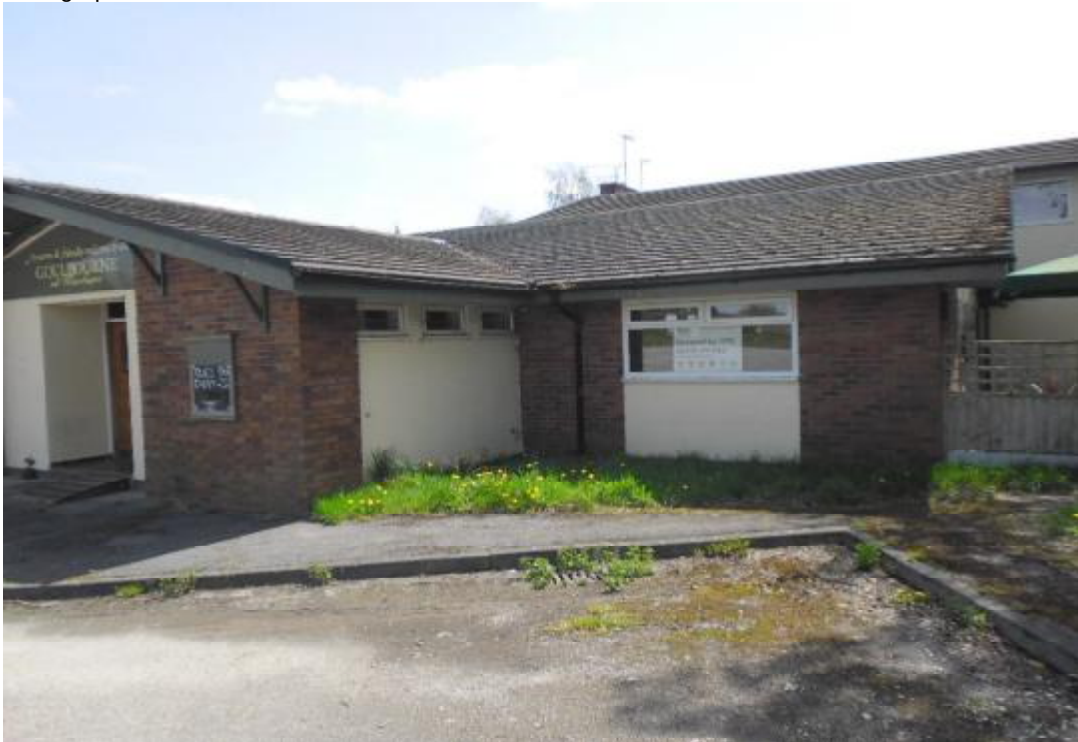
Photograph 10: Right-hand view of front elevation.

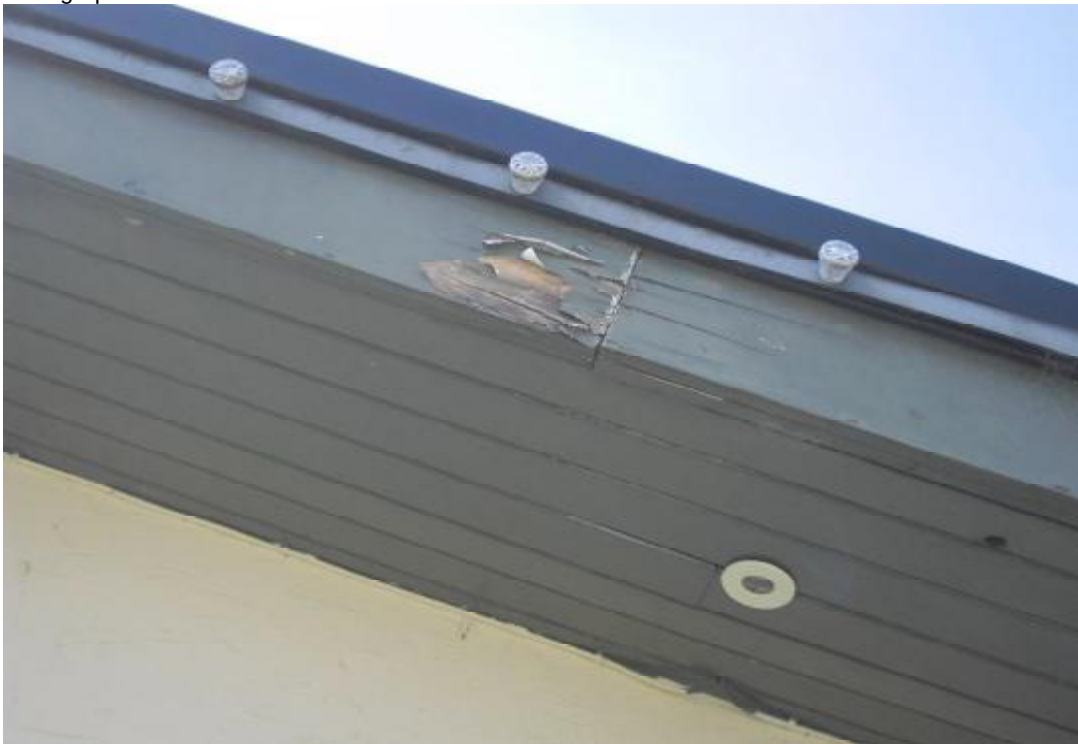
Photograph 16: Poor decorations to fascias and soffits.

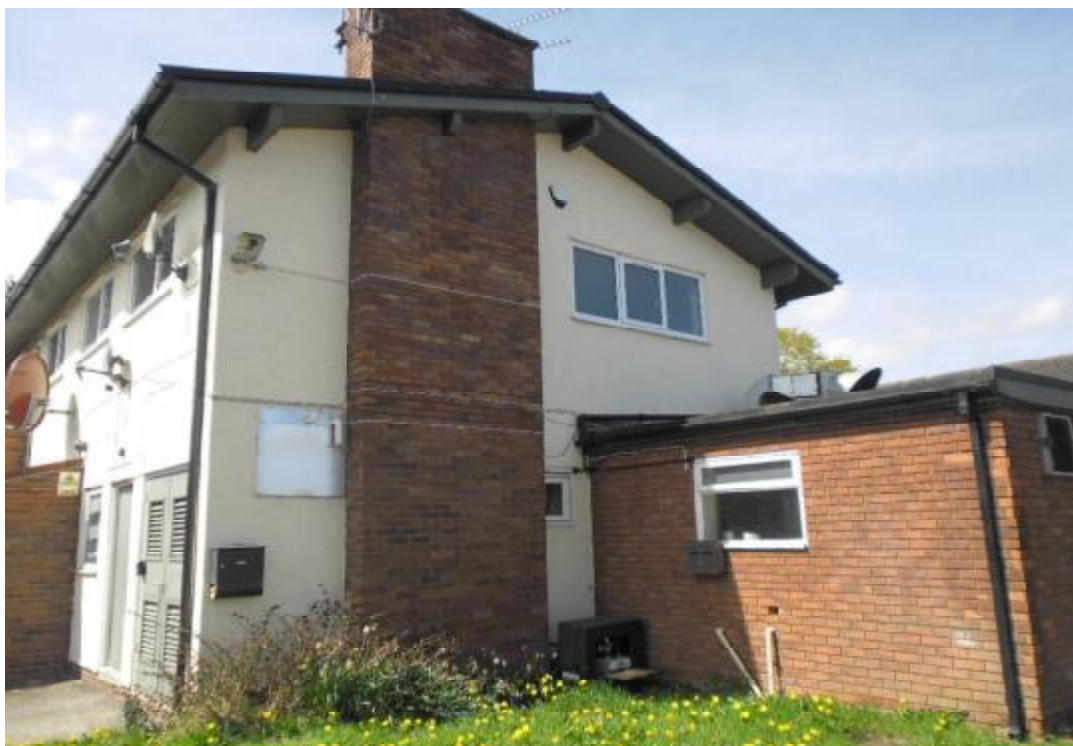
Photograph 21: Right-hand view of rear elevation.

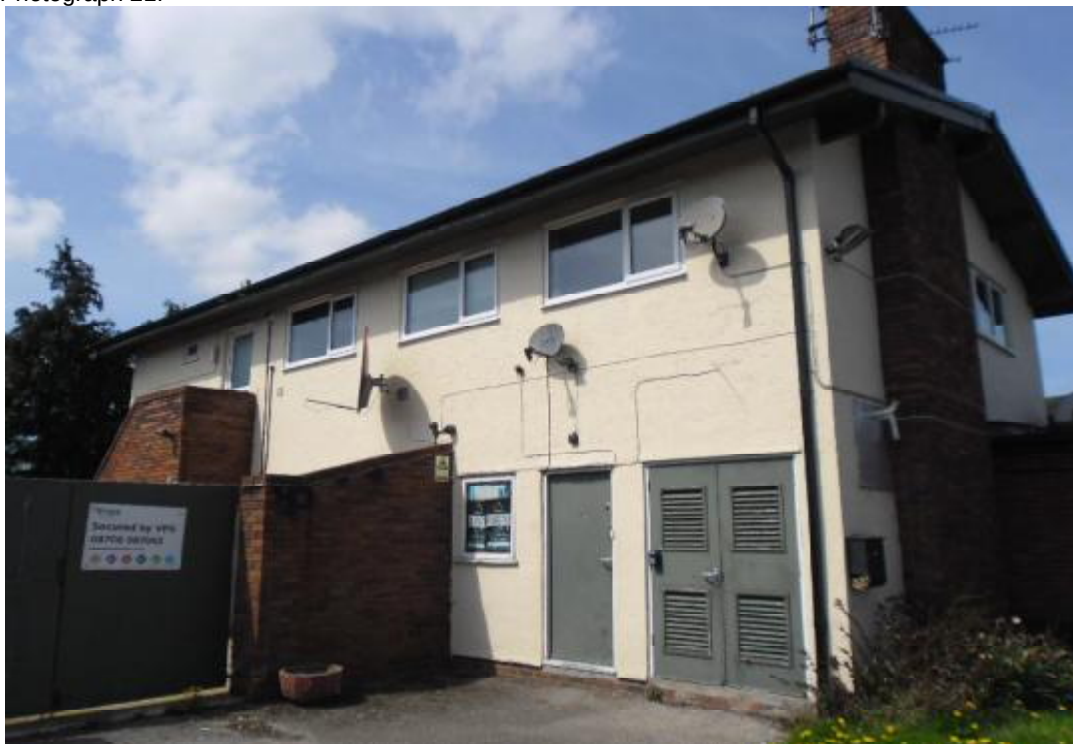
Photograph 22: View of rear elevation.

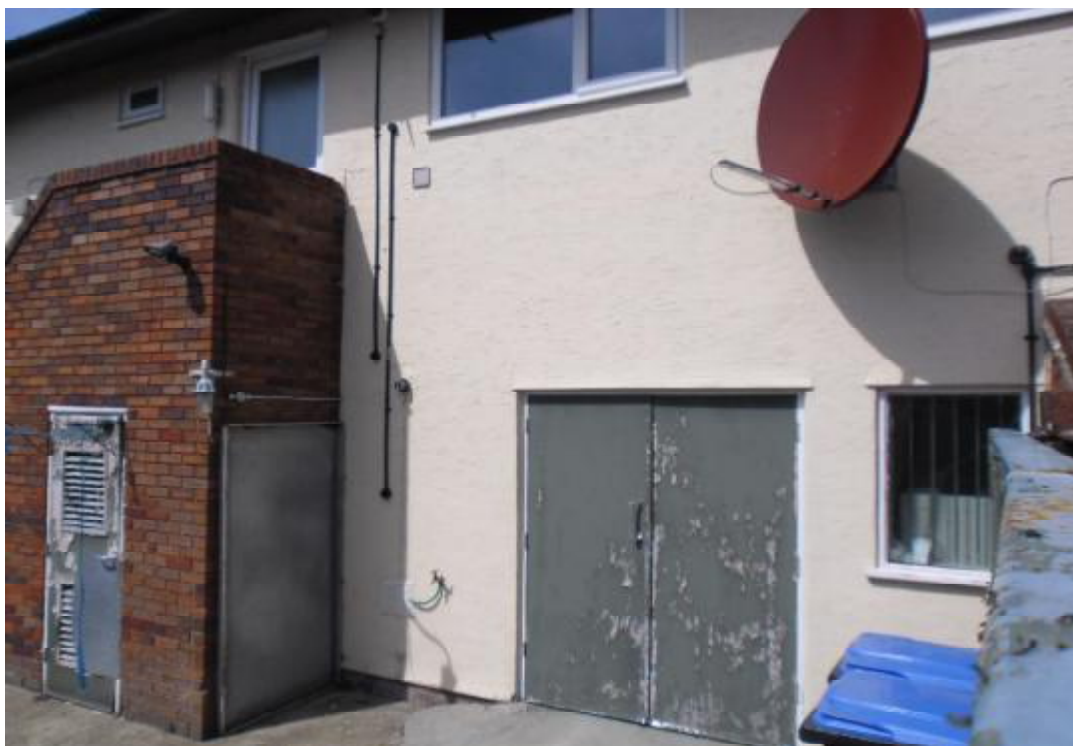
Photograph 23: View of rear elevation. Decorations to access door flaking.

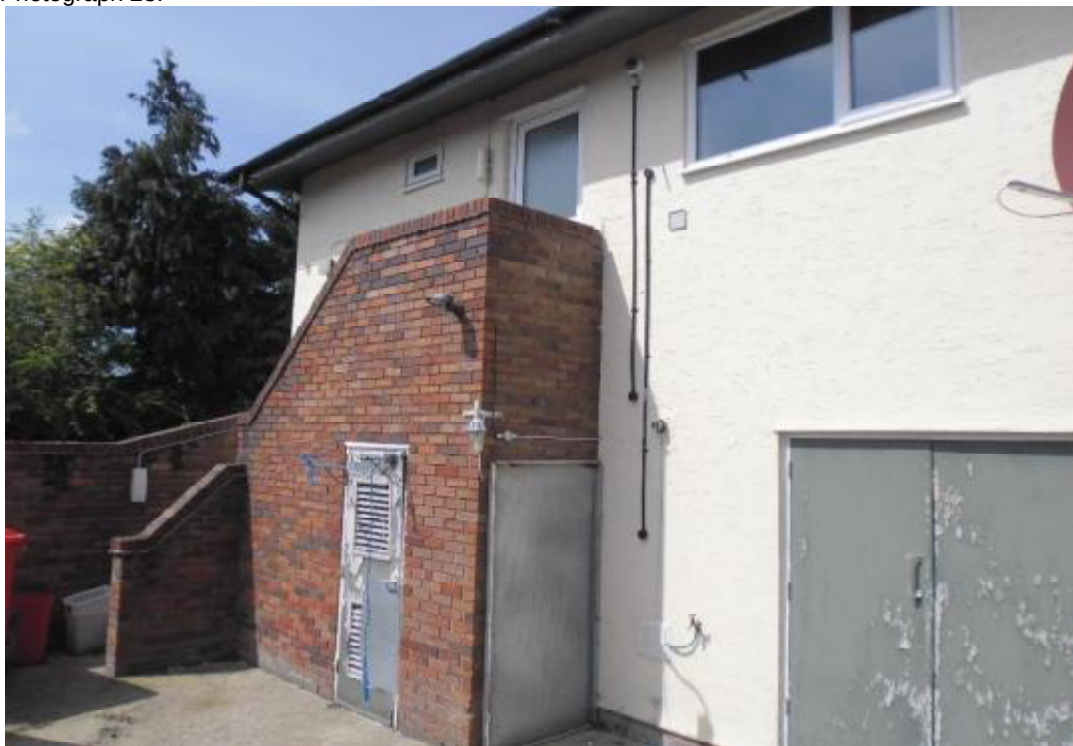
Photograph 24: View of rear elevation.

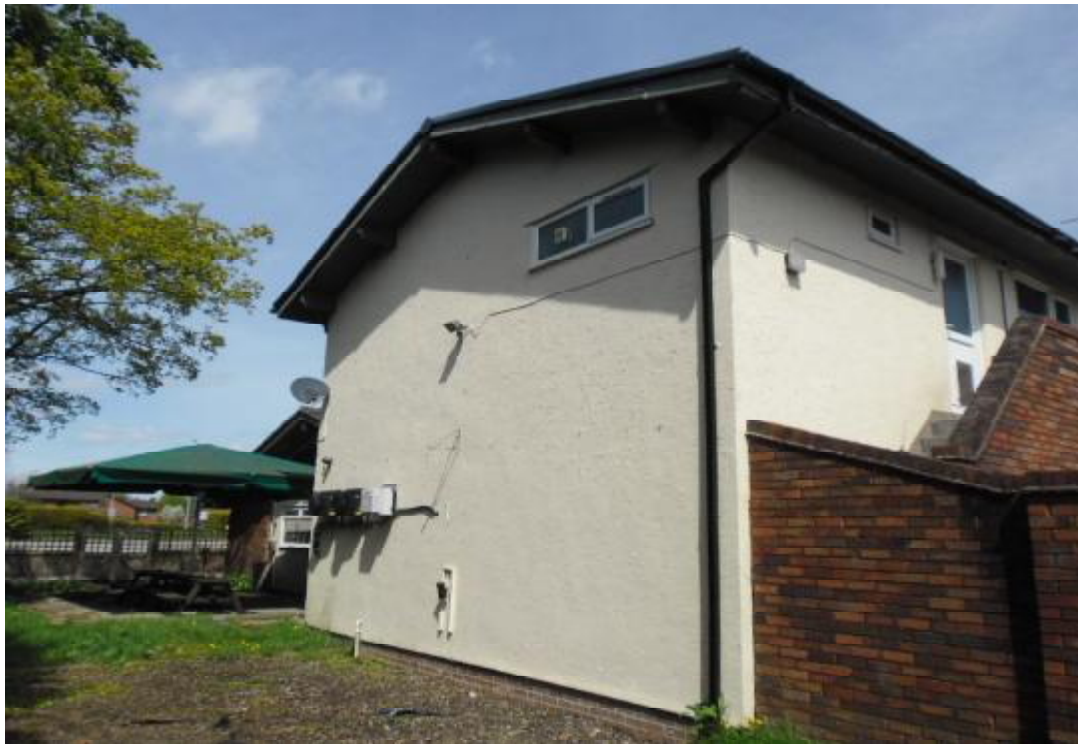
Photograph 27: General view of right-hand elevation.

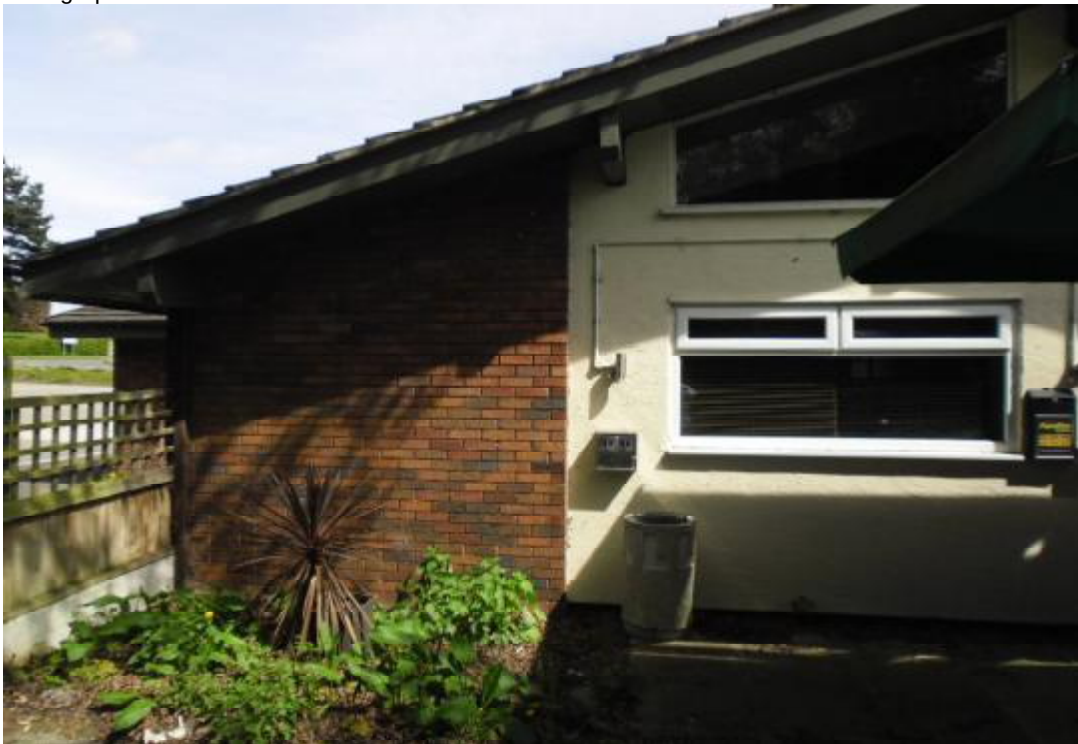
Photograph 30: Left-hand view of right-hand elevation.

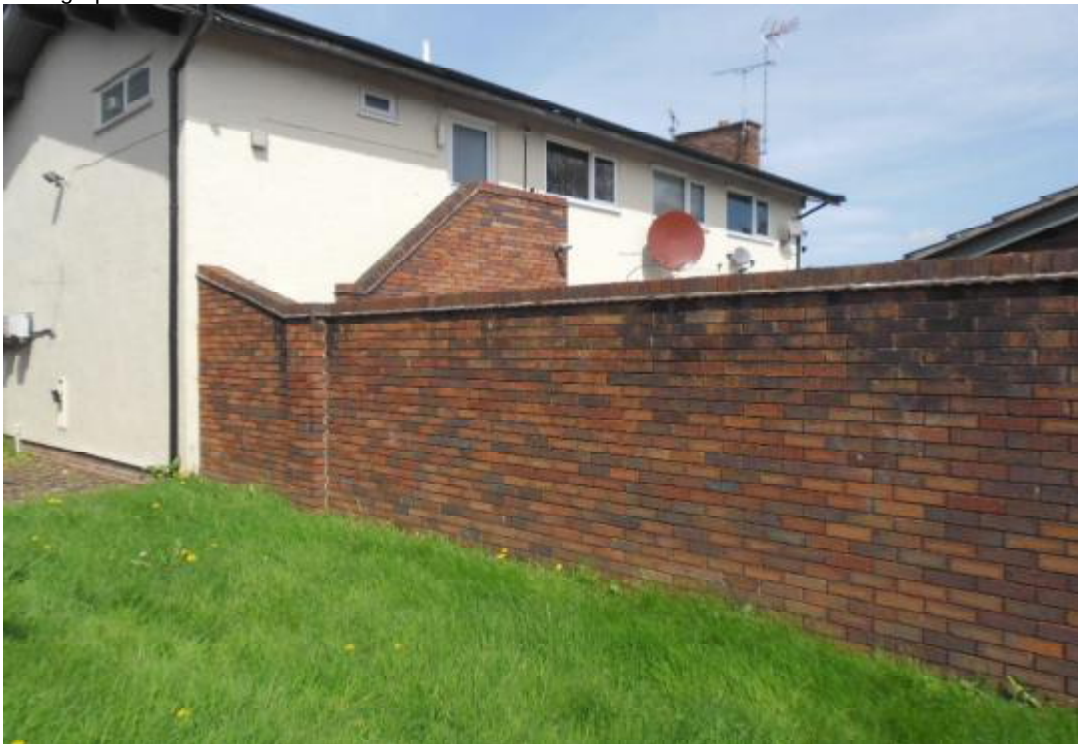
Photograph 38: General view of boundary wall forming rear yard.

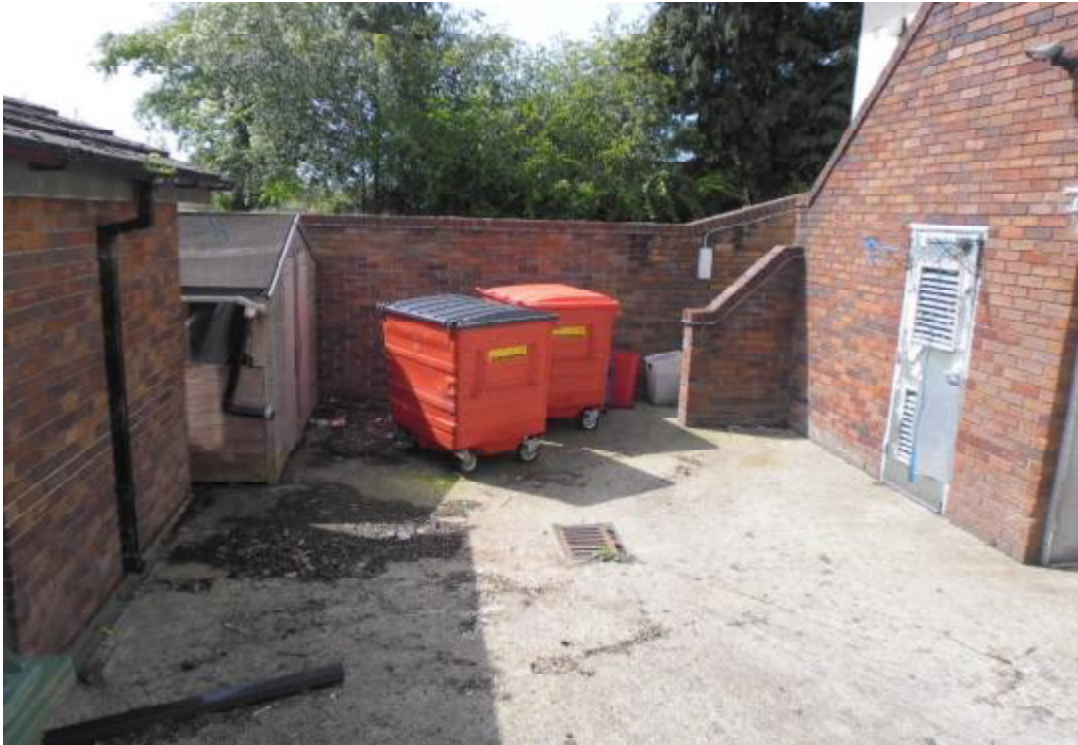
Photograph 39: Internal view of rear yard.

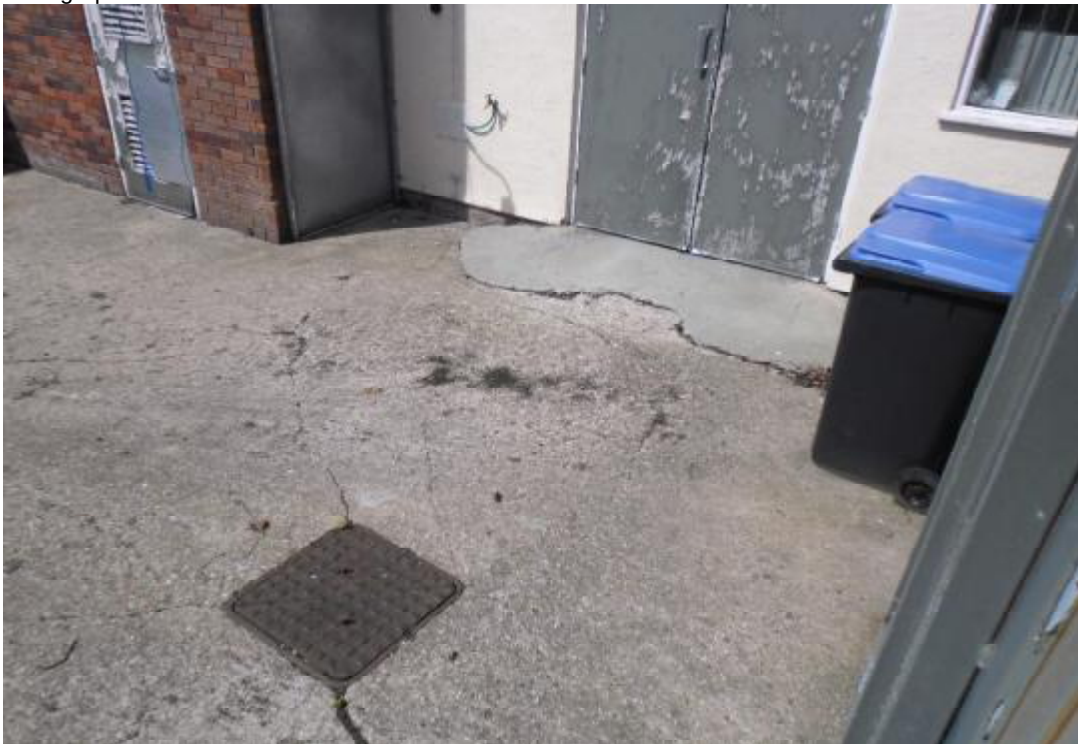
Photograph 40: View of yard hardstandings.

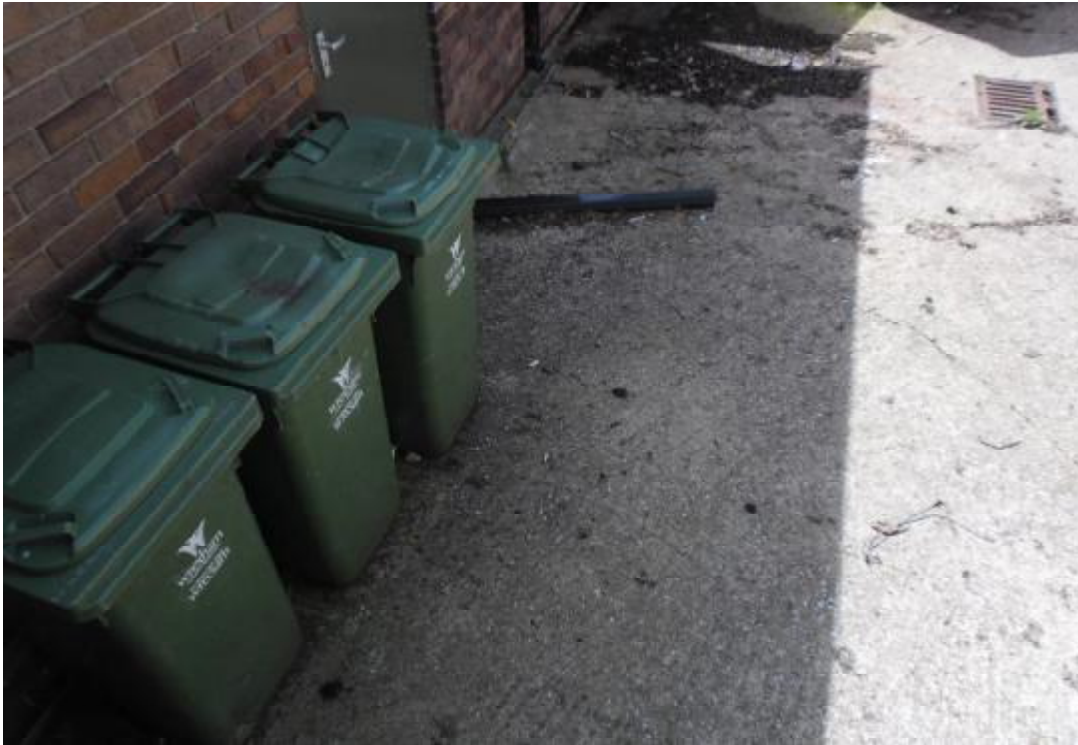
Photograph 41: View of hardstandings adjacent garage.

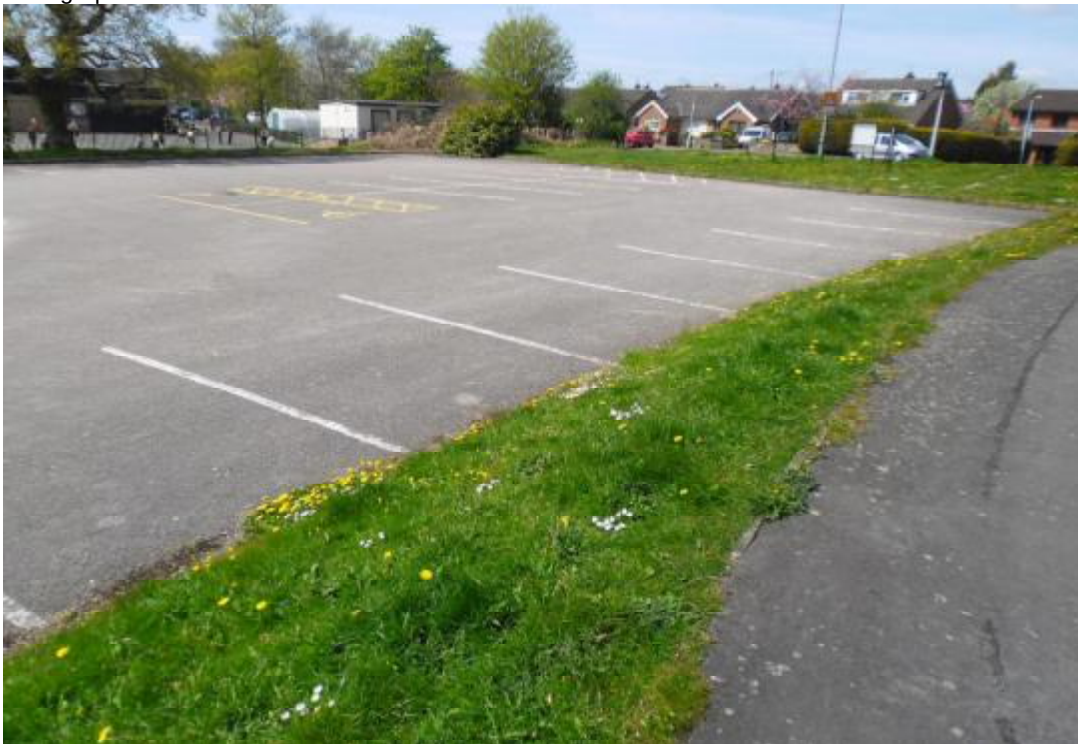
Photograph 42: General view of car park.

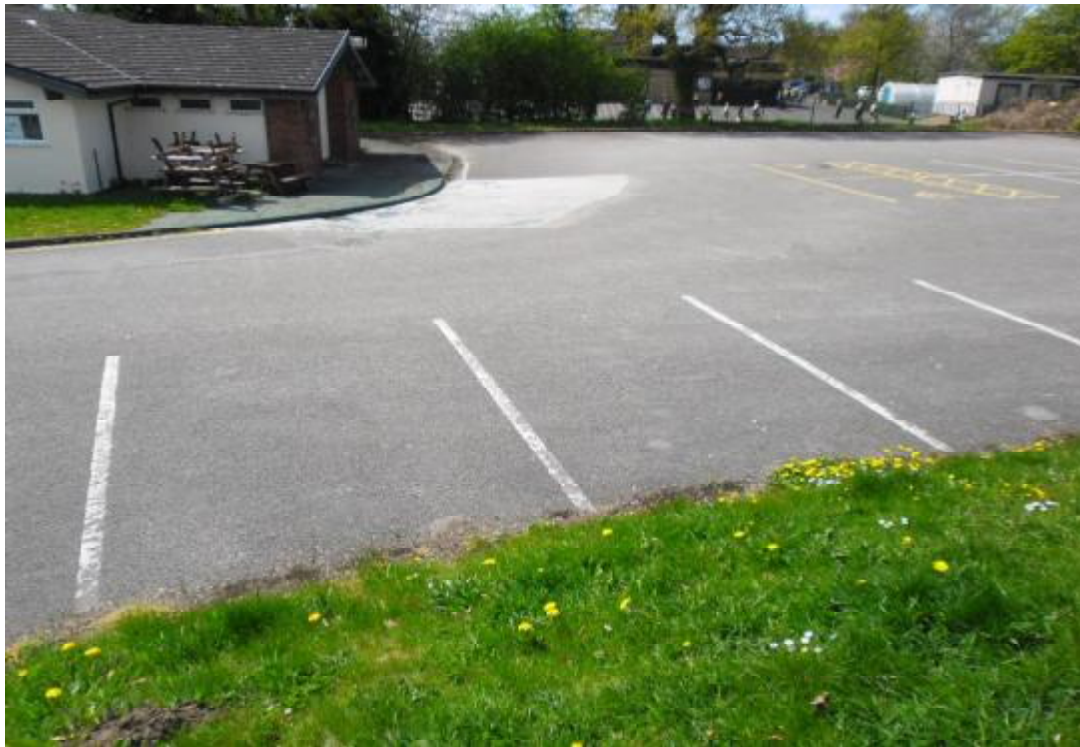
Photograph 43: General view of car park.

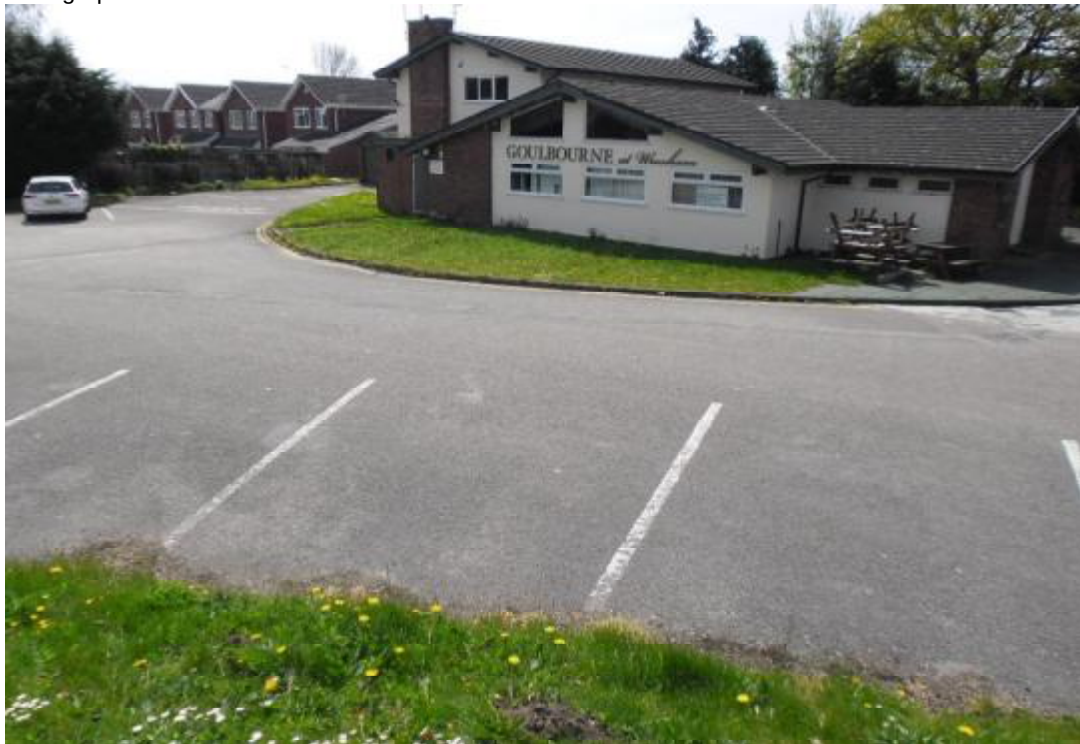
Photograph 44: General view of car park.

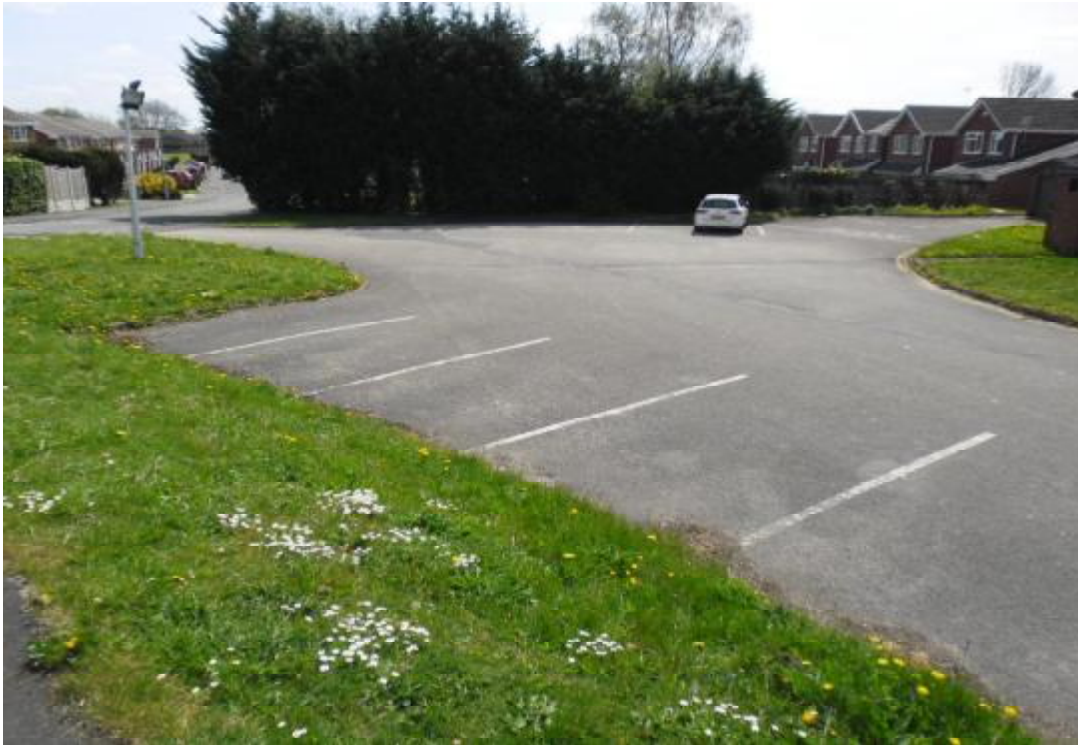
Photograph 45: General view of car park.

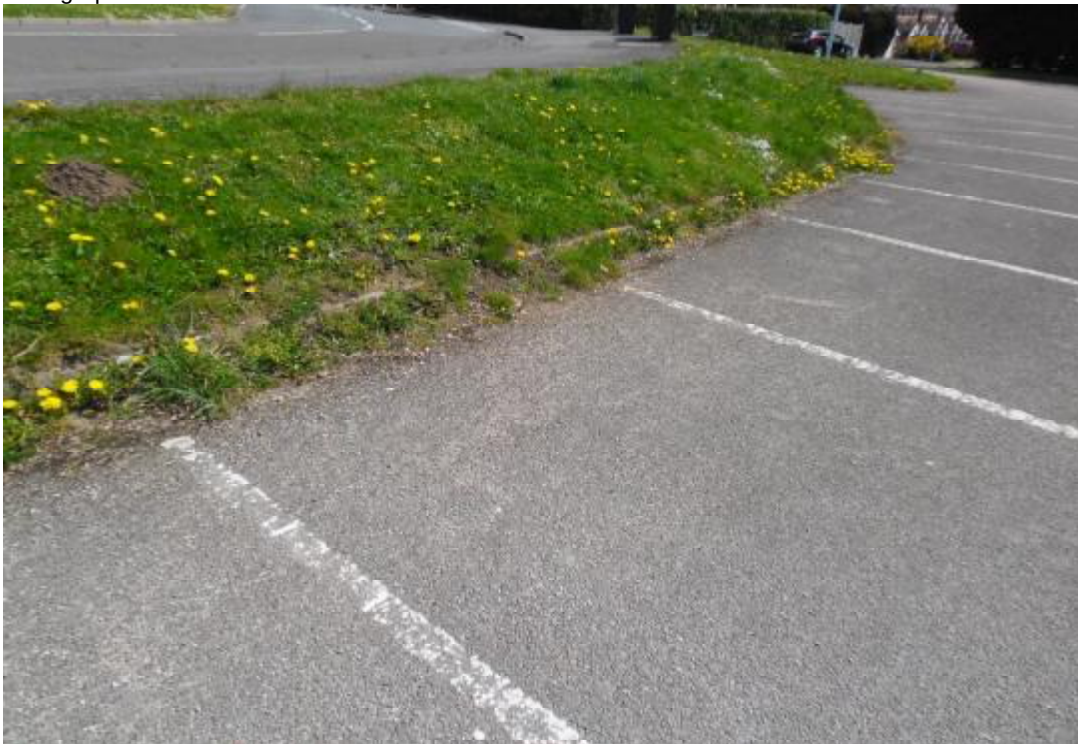
Photograph 46: View of vegetation growth within car parking area adjacent to kerb stones.

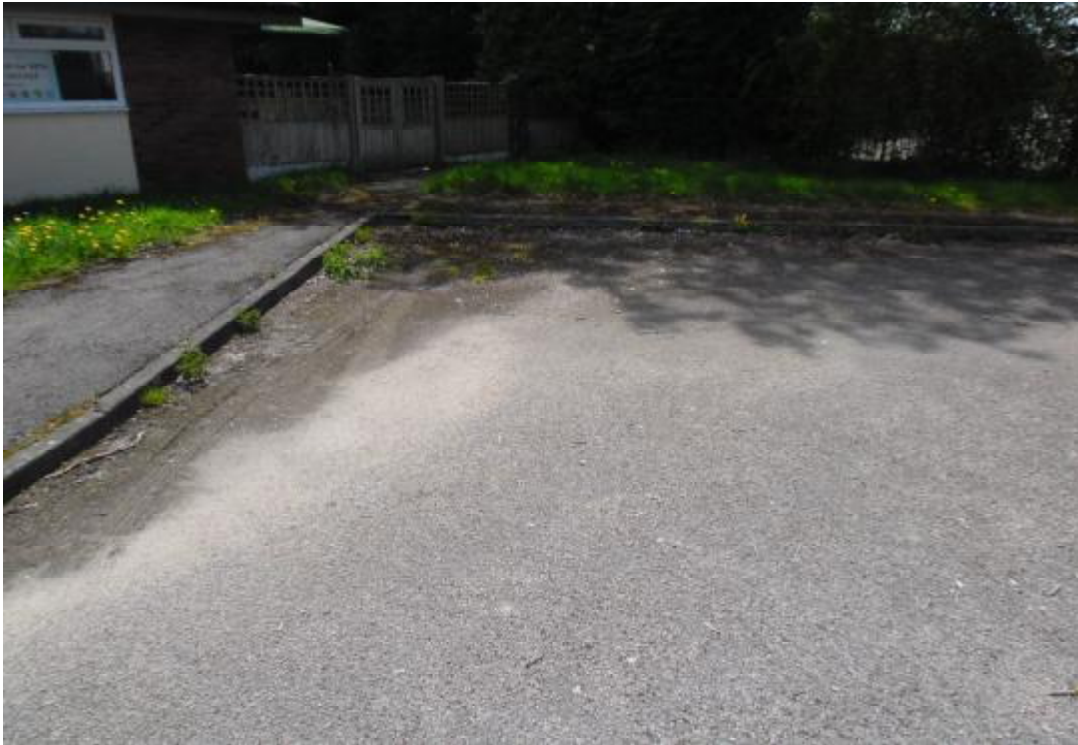
Photograph 47: General view of debris and mud within car parking area.

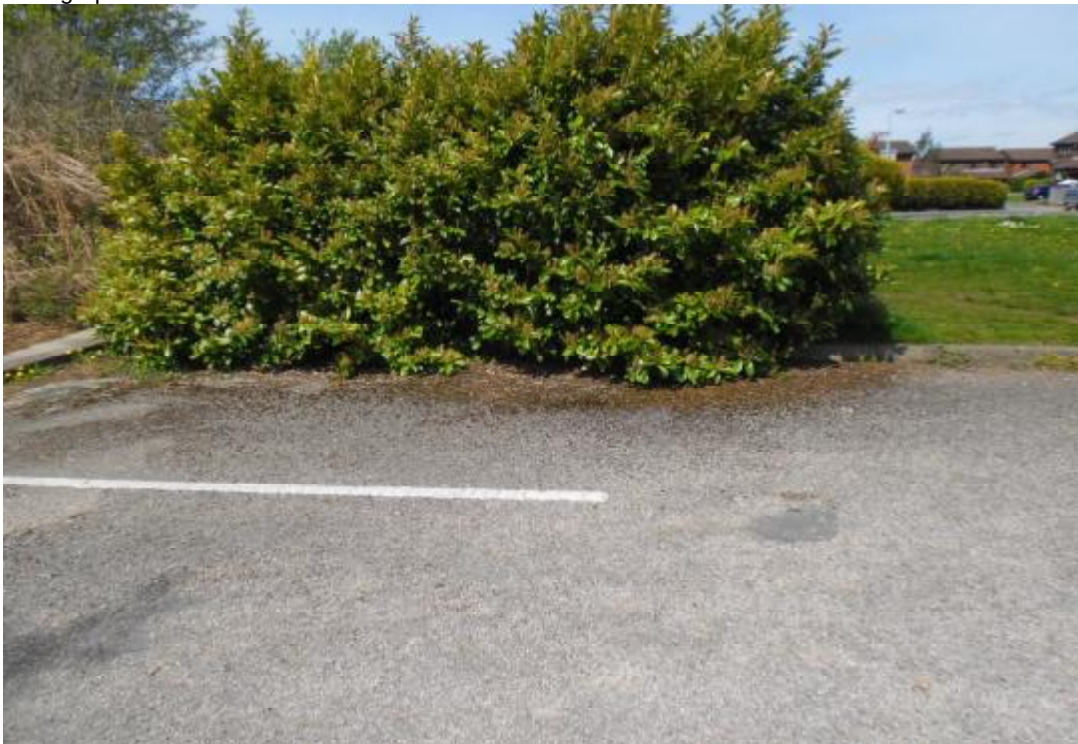
Photograph 48: View of vegetation growth over spilling into car park.

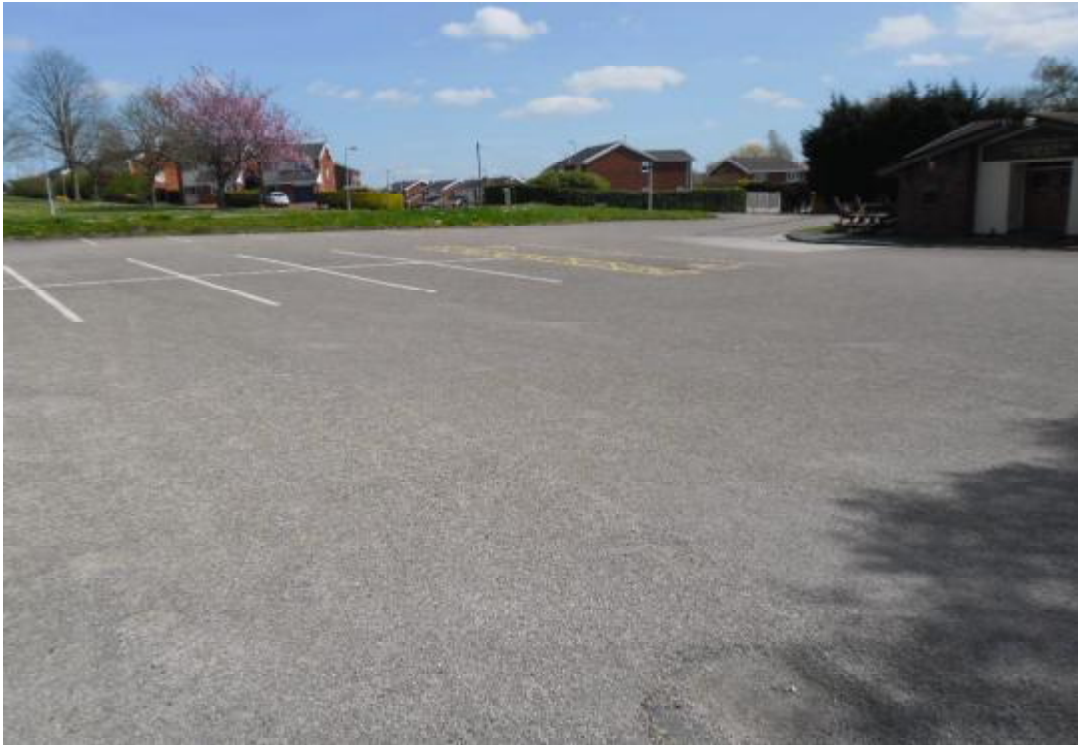
Photograph 49: General view of car park.

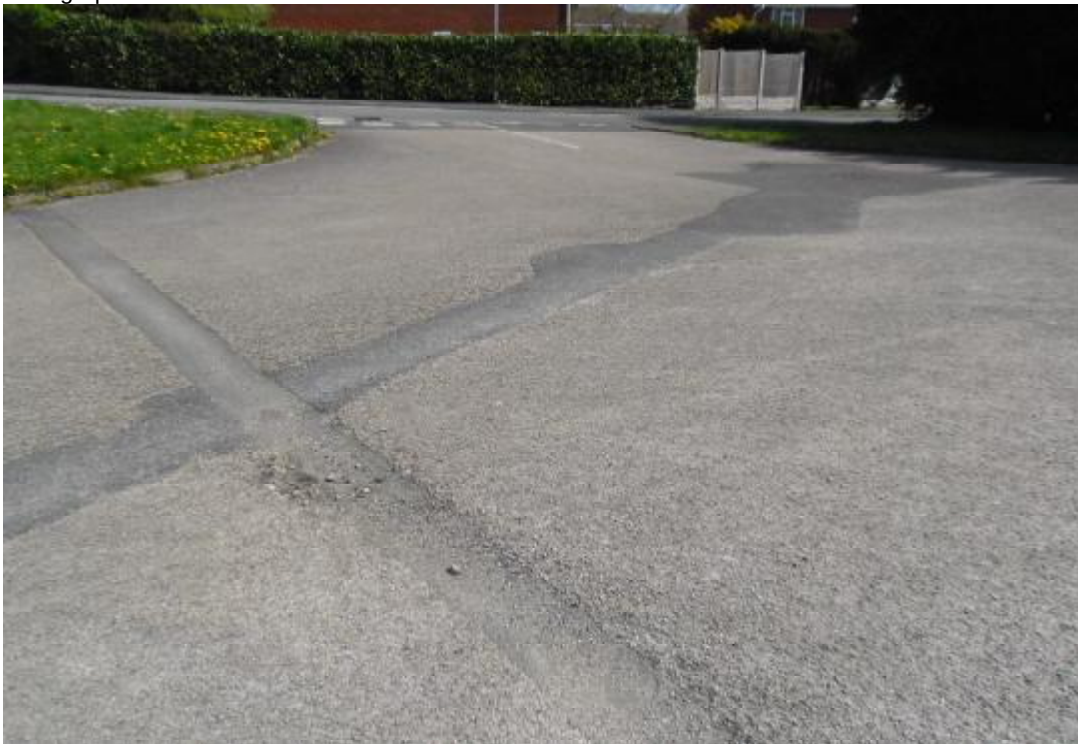
Photograph 50: General view of car park and access road into car park area.

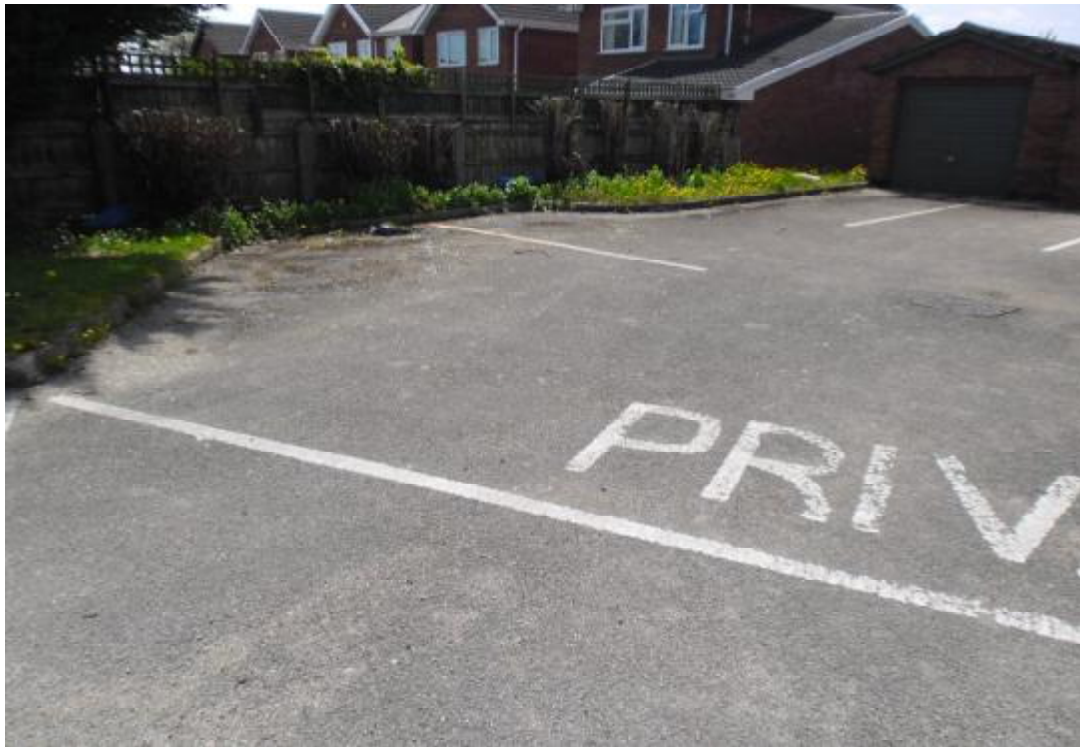
Photograph 51: View of car park to the rear.

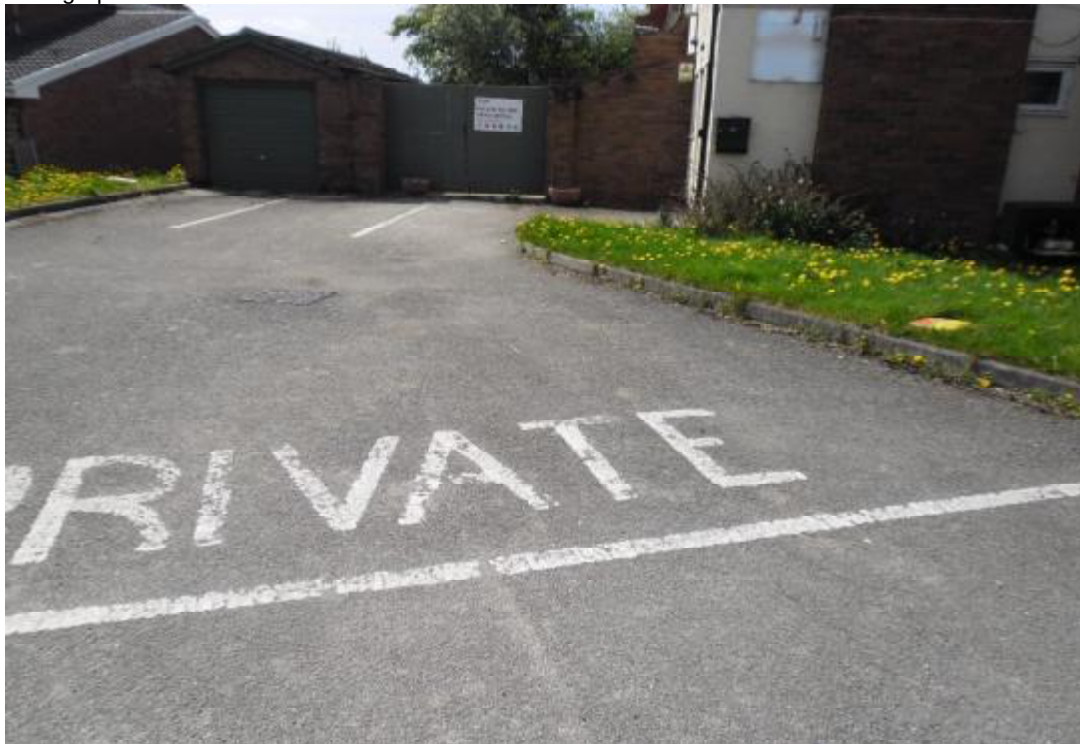
Photograph 52: View of car park to the rear of the building.

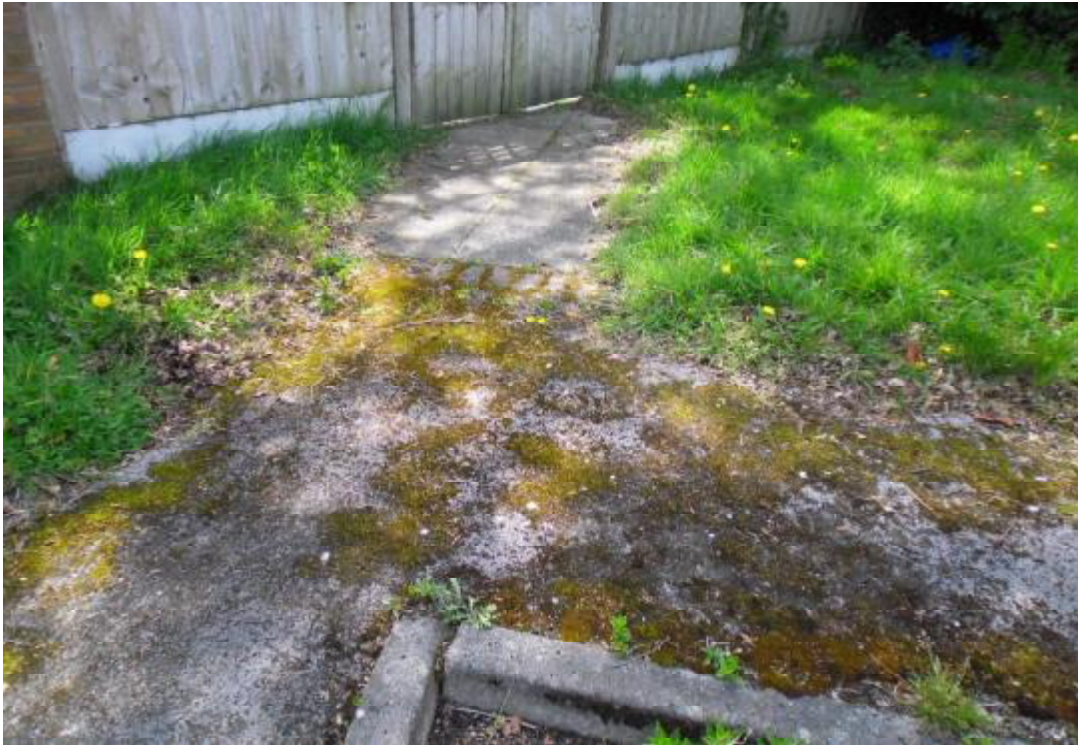
Photograph 53: General view of hardstandings to the front elevation and car parking area.

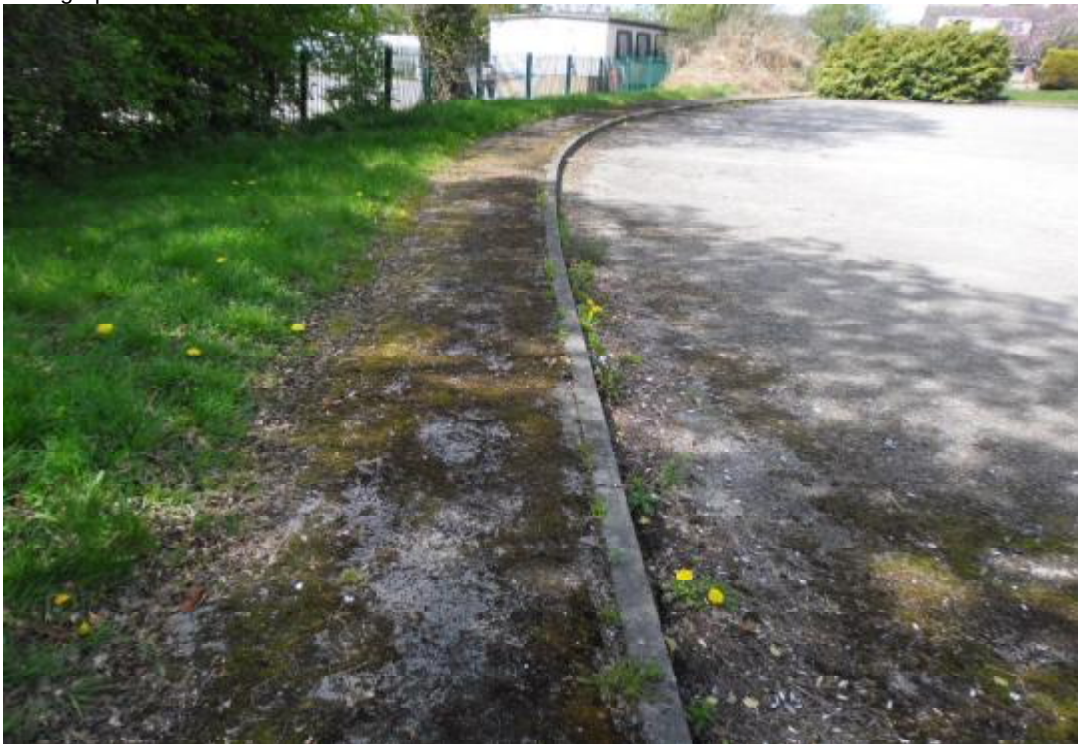
Photograph 54: View of hardstandings adjacent front car park.

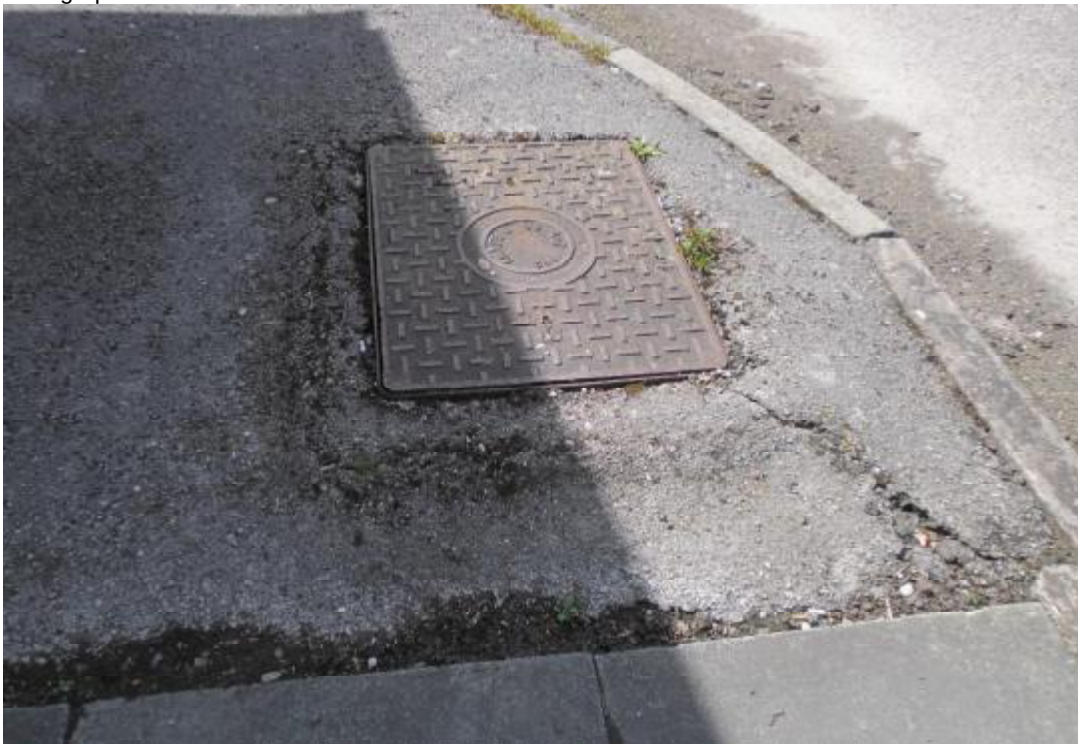
Photograph 56: View of manhole cover and undulated tarmacadam pavement area to the front elevation.

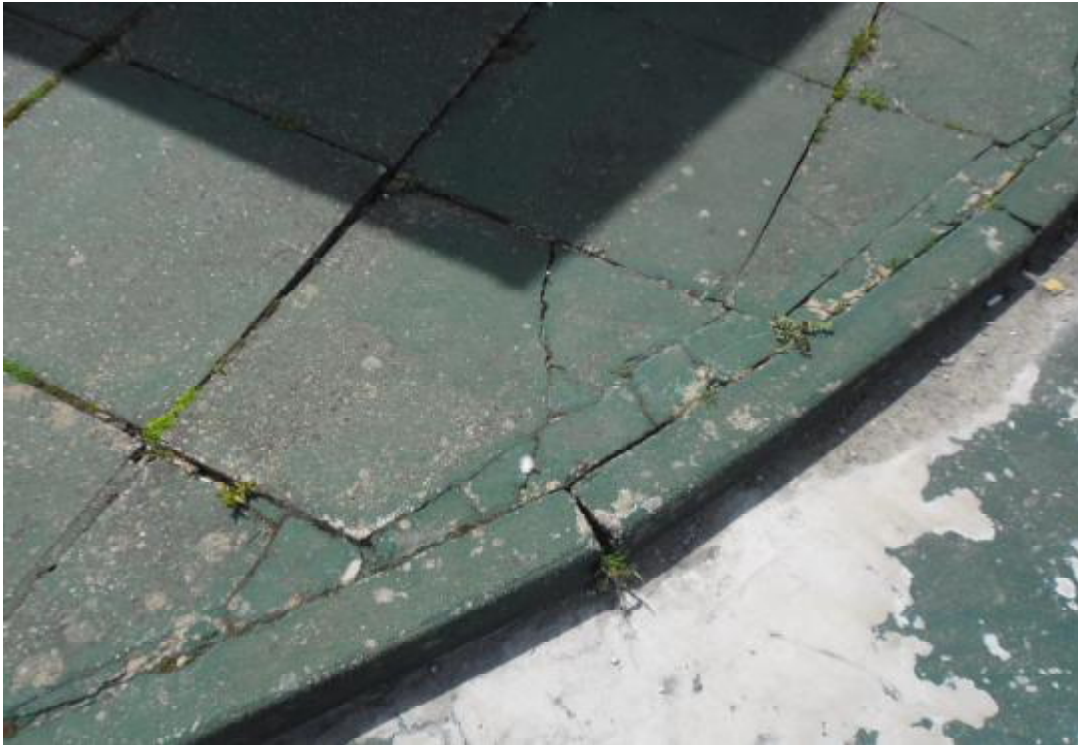
Photograph 57: View of cracked paving slabs to front elevation.
