## Photographic Schedule of Condition

Goulbourne  
Borras Park Road  
Wrexham  
Clywd, LL12 7TF

Star Pubs & Bars

Tel: 01604 664366  
Fax: 01604 664367  
Date: 4 May 2016  
Ref: 0101487-BC-0000

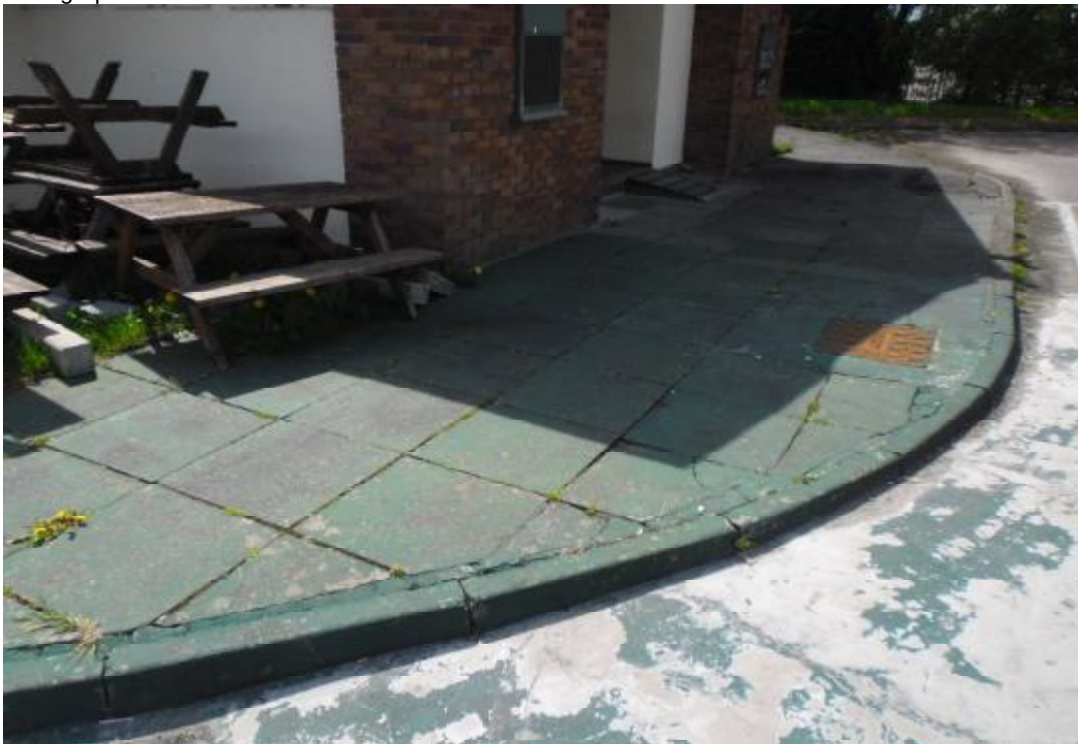
Photograph 58: General view of hardstandings to front elevation.

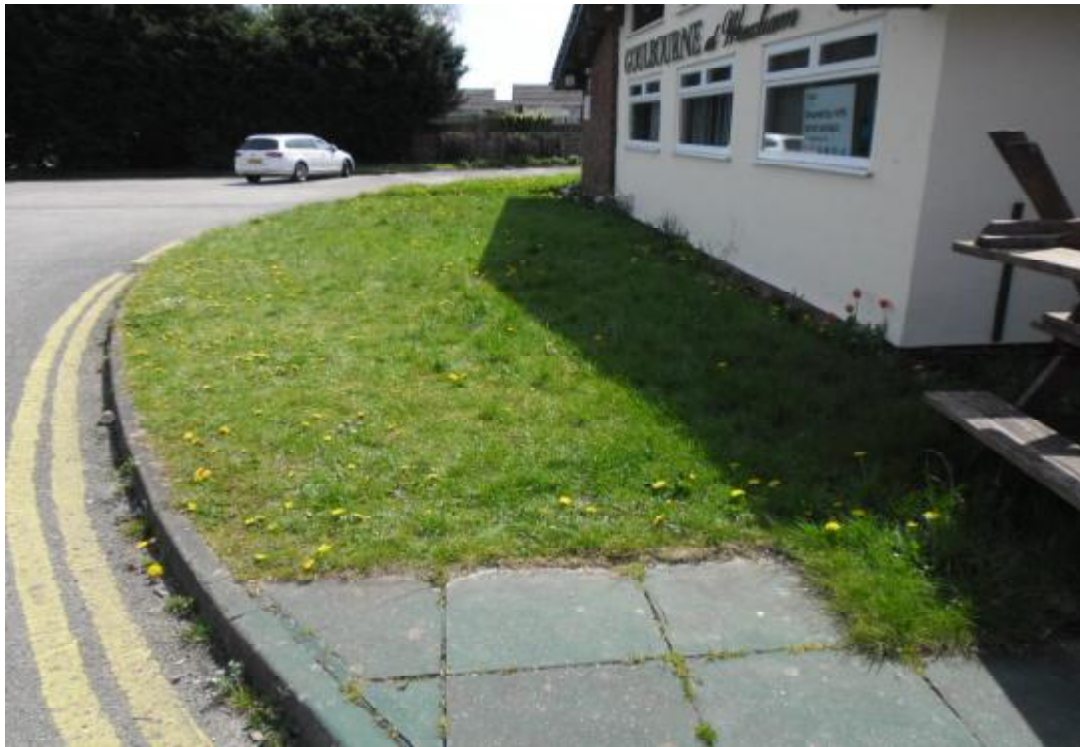
Photograph 59: View of lawn to the left-hand elevation.

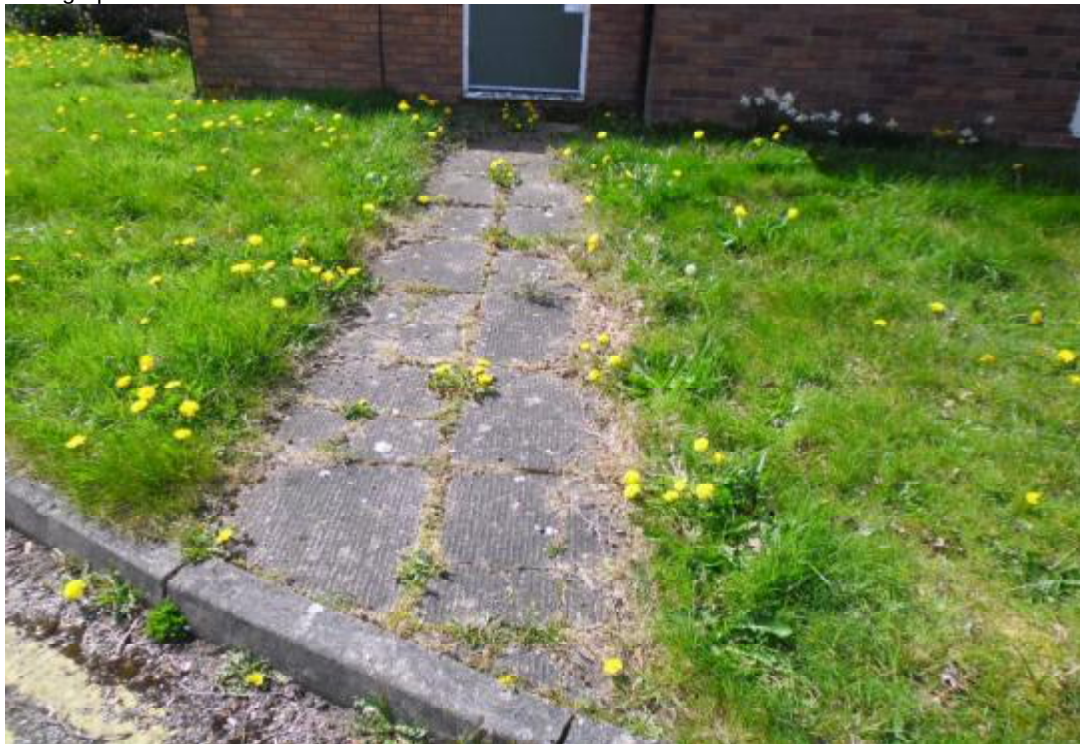
Photograph 60: View of pedestrian walkway to left-hand side elevation hardstandings.

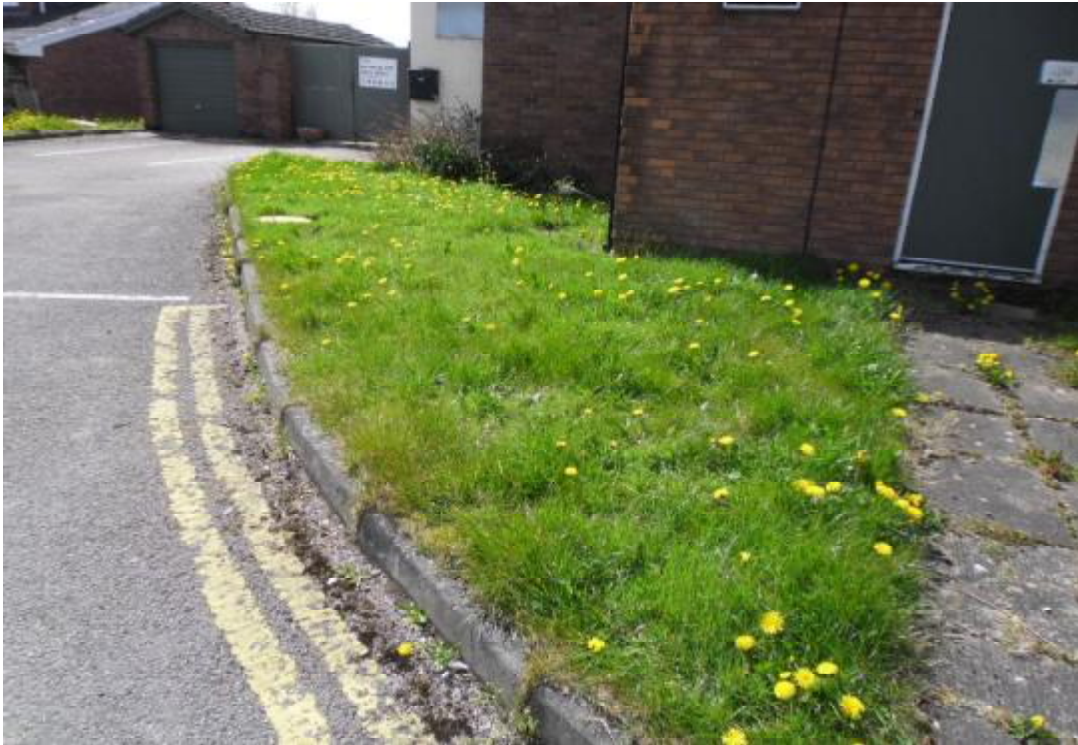
Photograph 61: View of lawn to left-hand elevation.

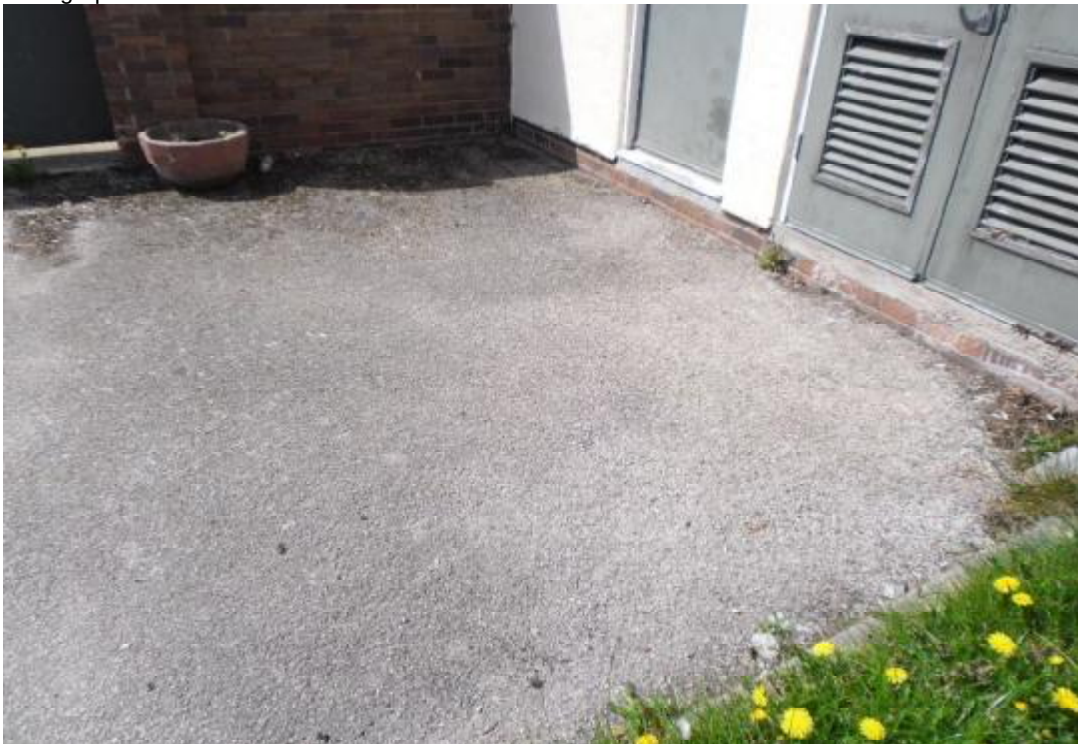
Photograph 62: View of hardstandings to rear elevation.

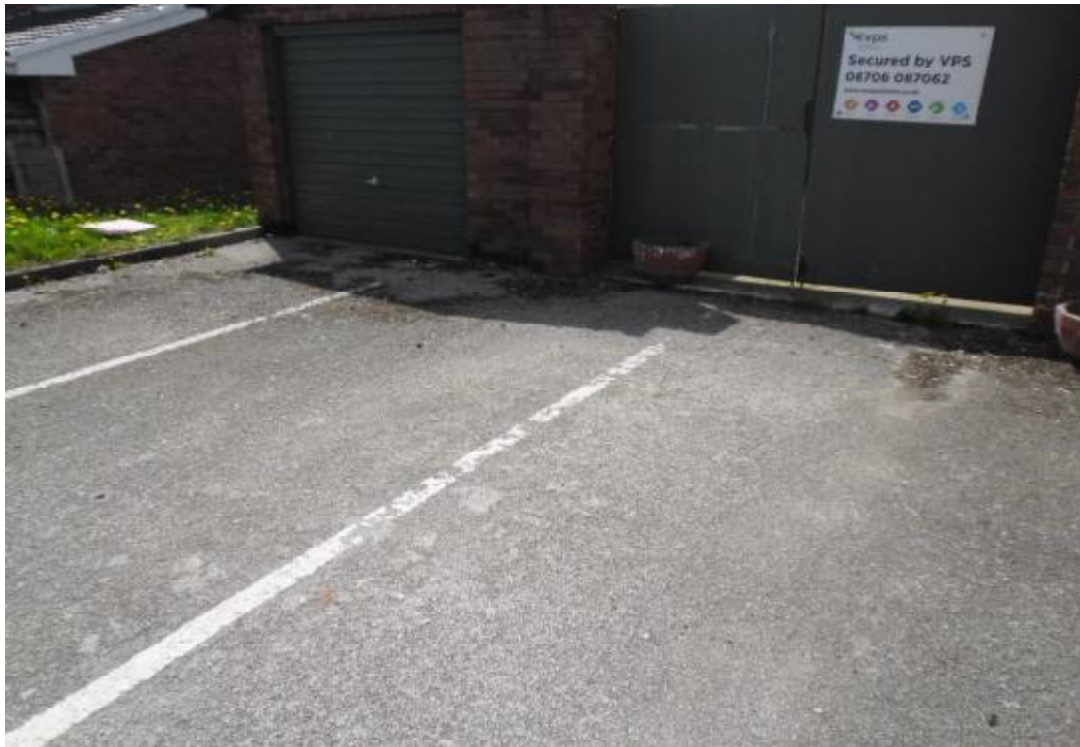
Photograph 63: View of hardstandings in front of garage.

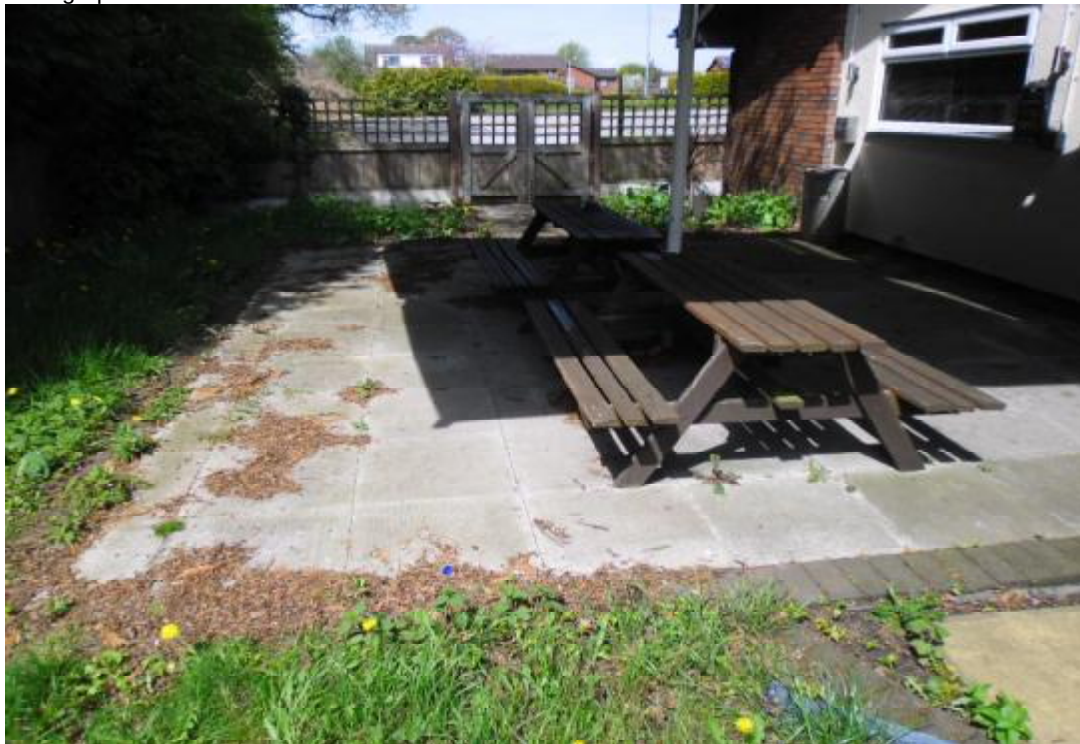
Photograph 64: View of hardstandings to the right-hand elevation.

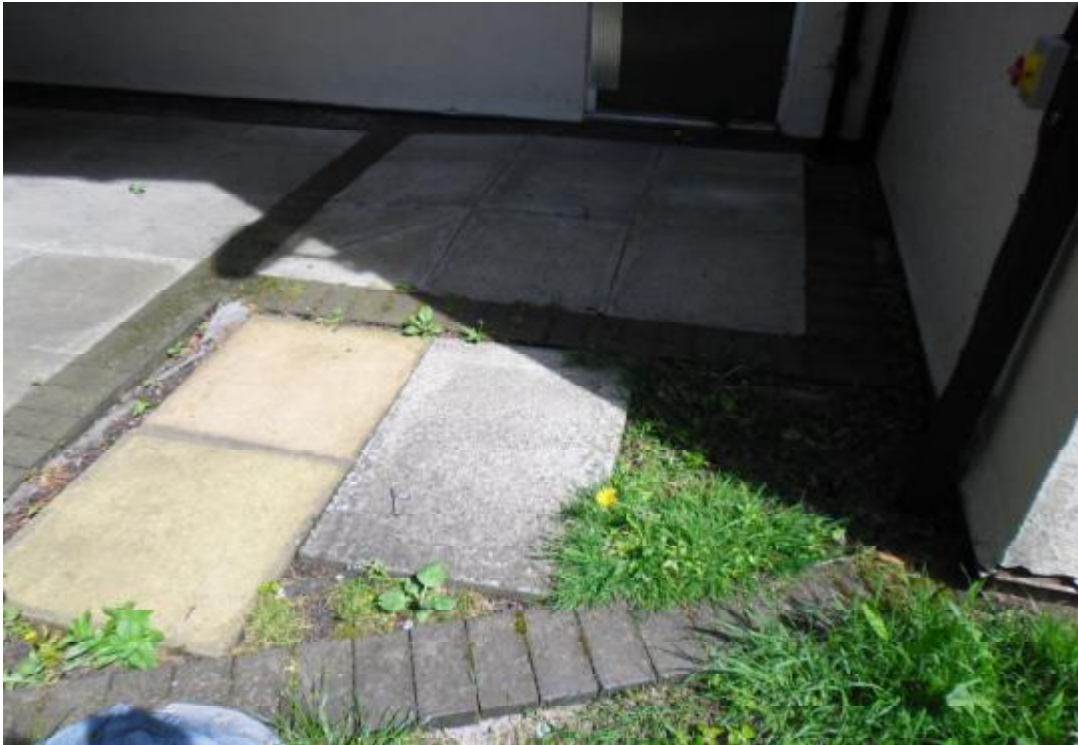
Photograph 65: View of hardstandings to right-hand elevation access door.

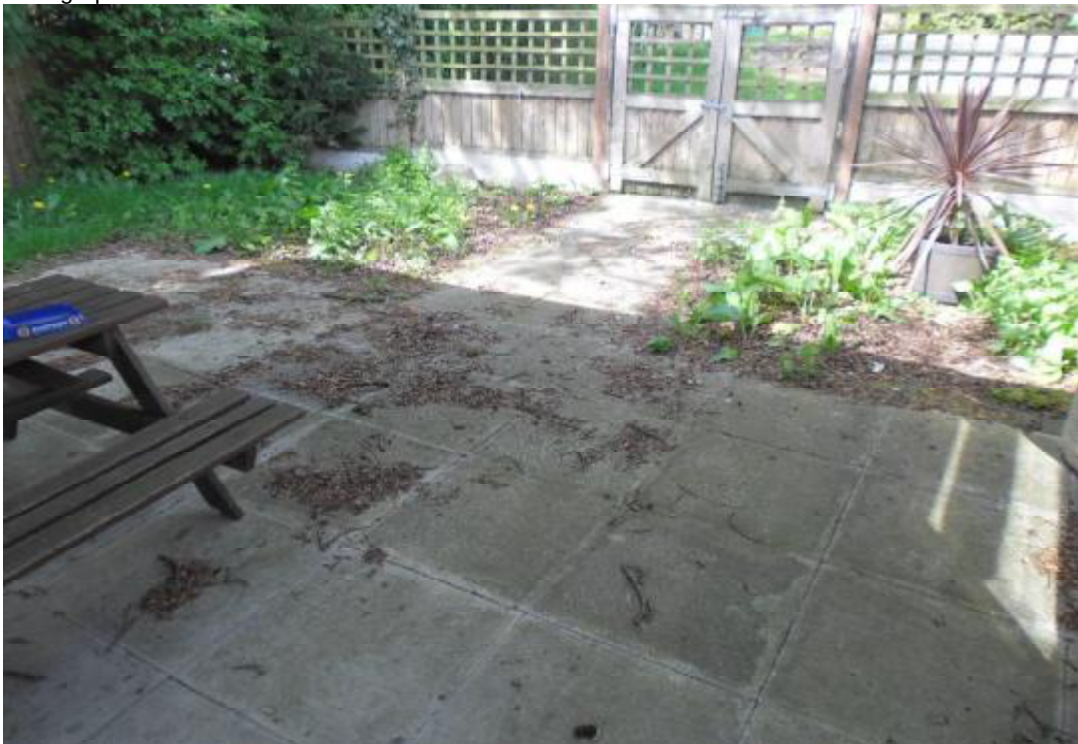
Photograph 66: View of hardstandings to right-hand elevation.

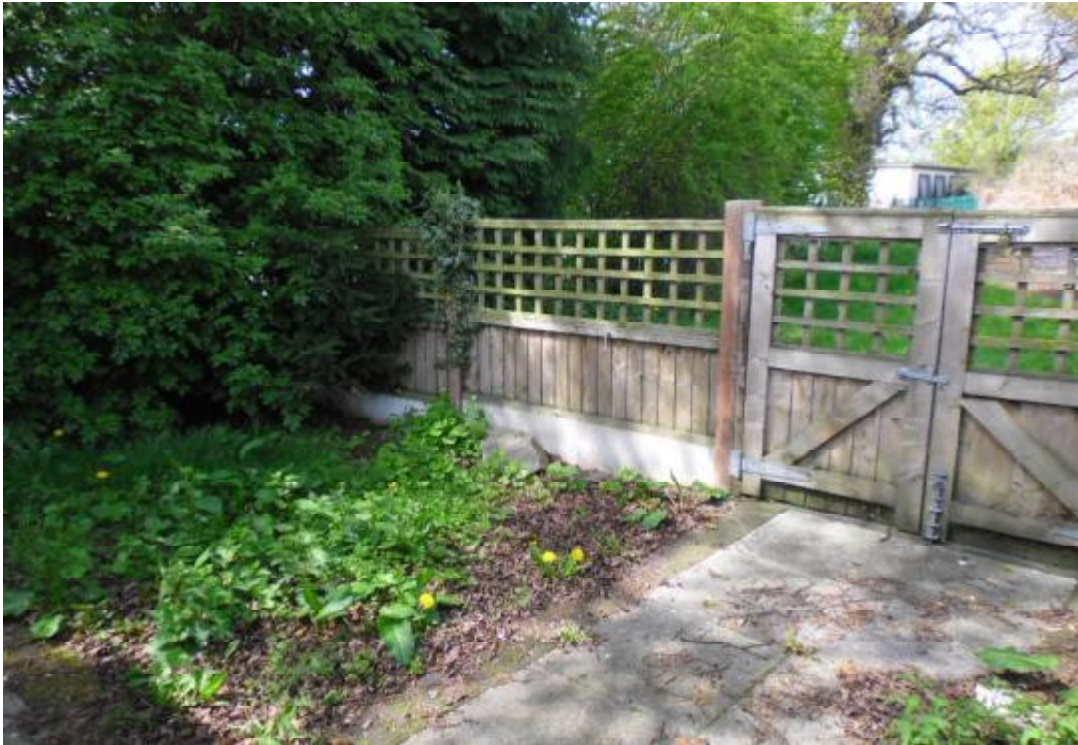
Photograph 67: View of timber fence enclosing right-hand side yard area.

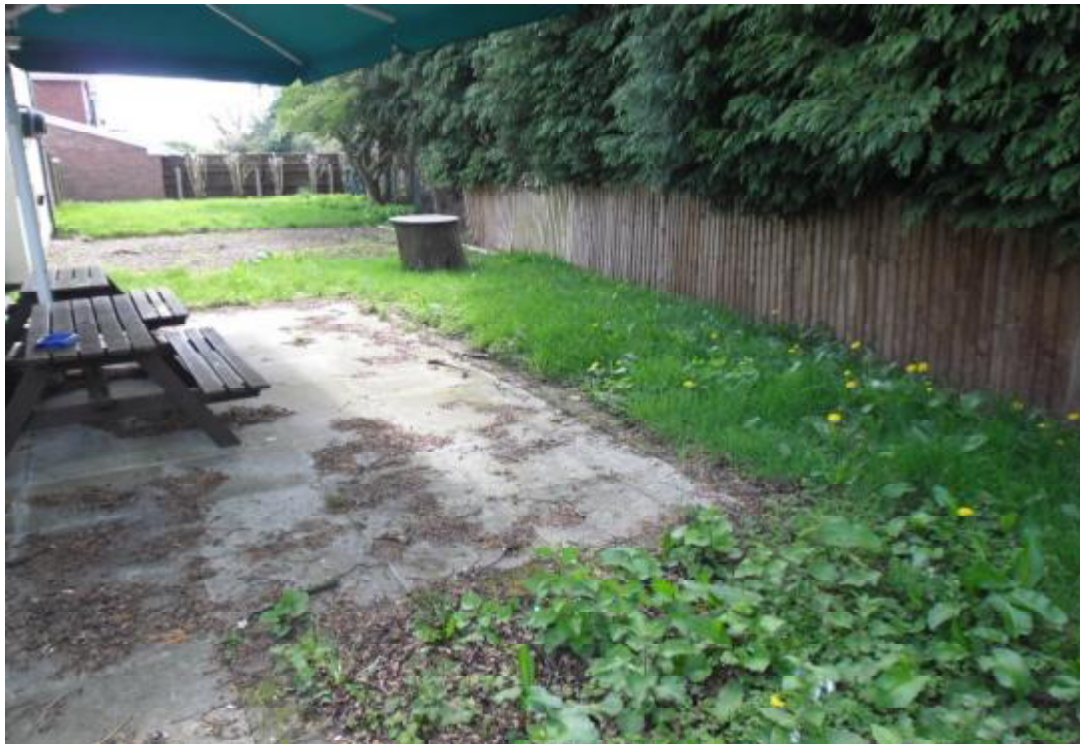
Photograph 68: View of timber fence.

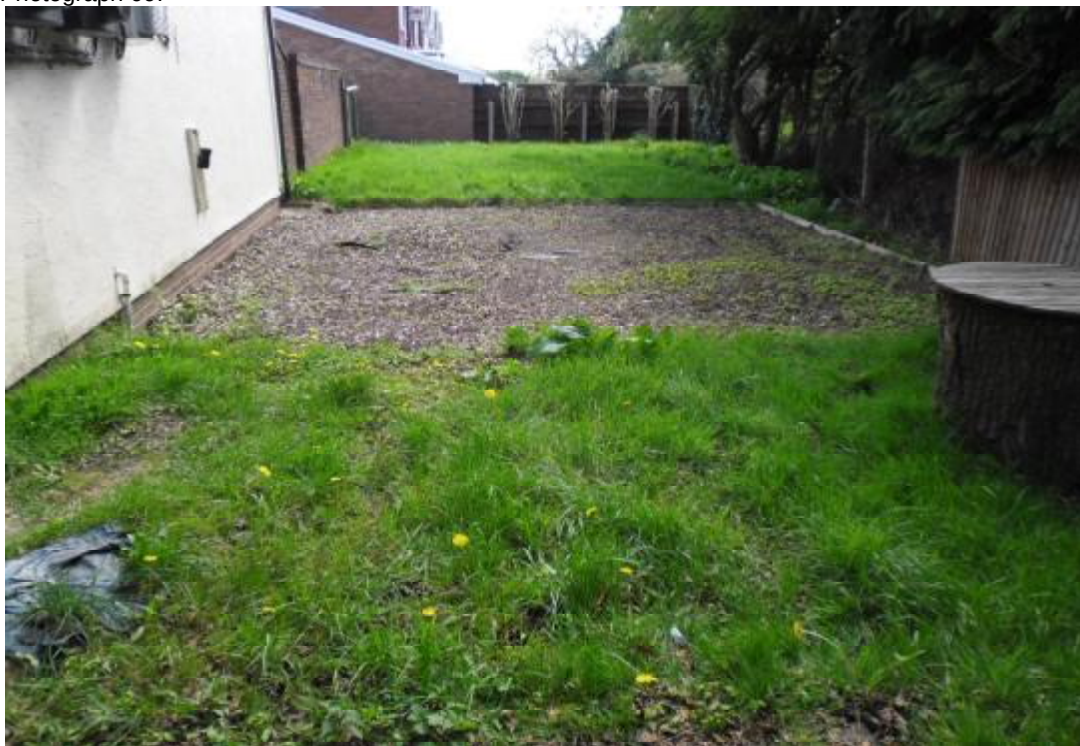
Photograph 69: View of right-hand side yard area and boundary fence.

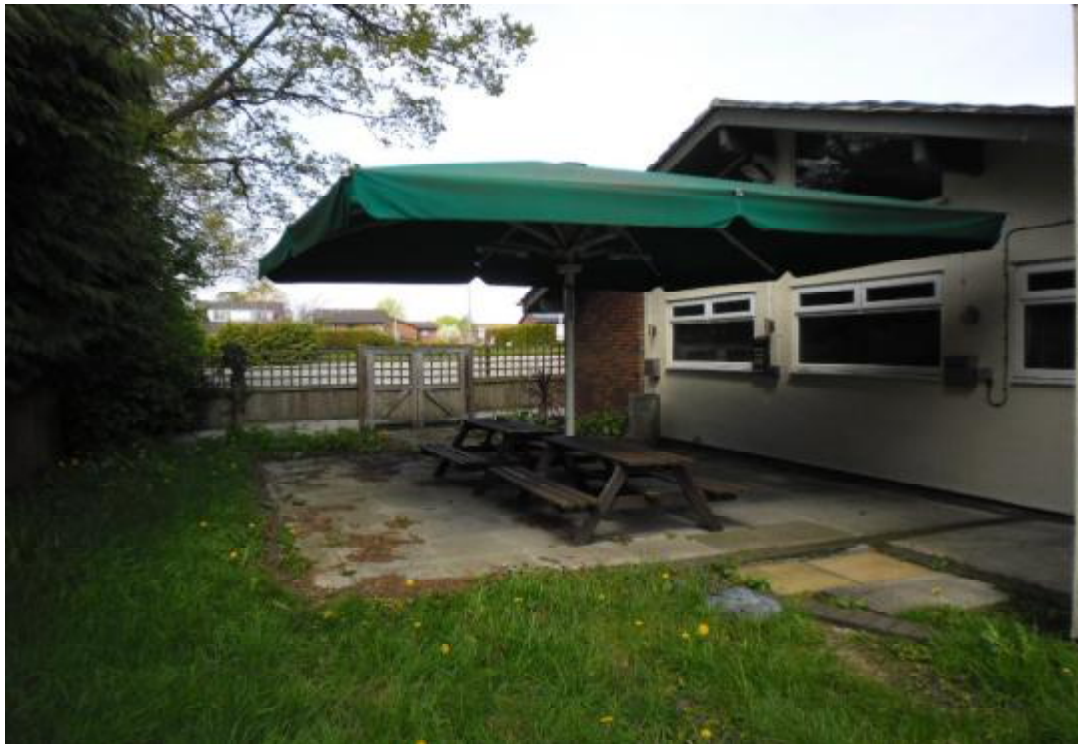
Photograph 70: View of right-hand side yard area.

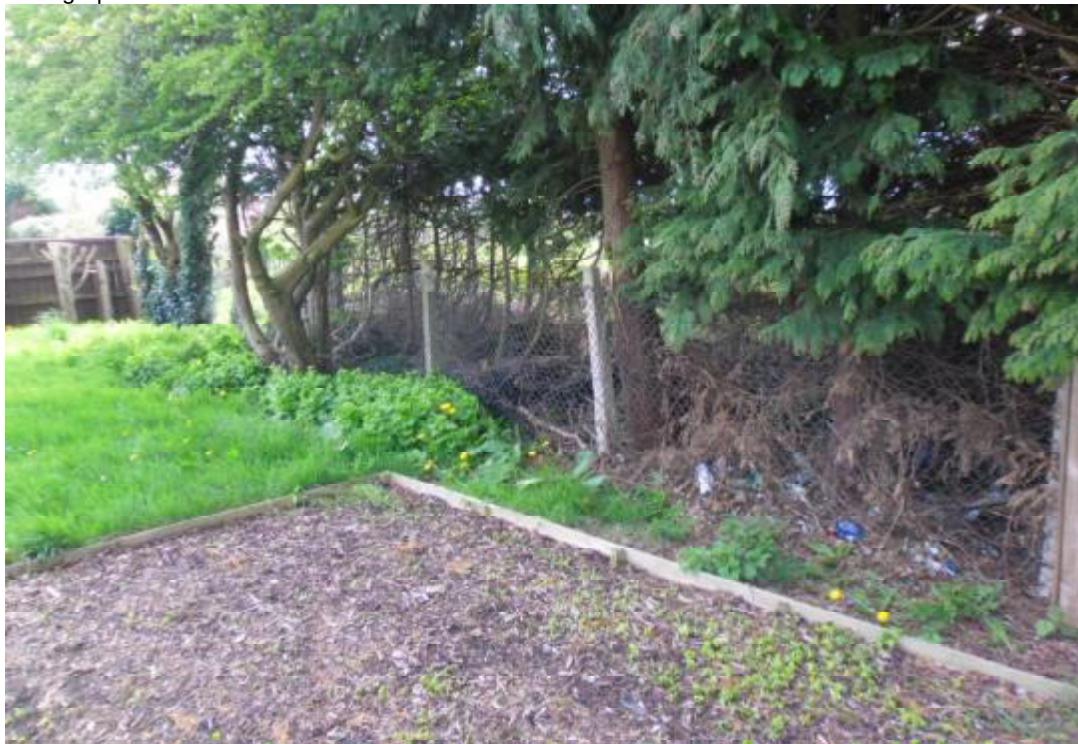
Photograph 71: Alternative view of right-hand side yard area.

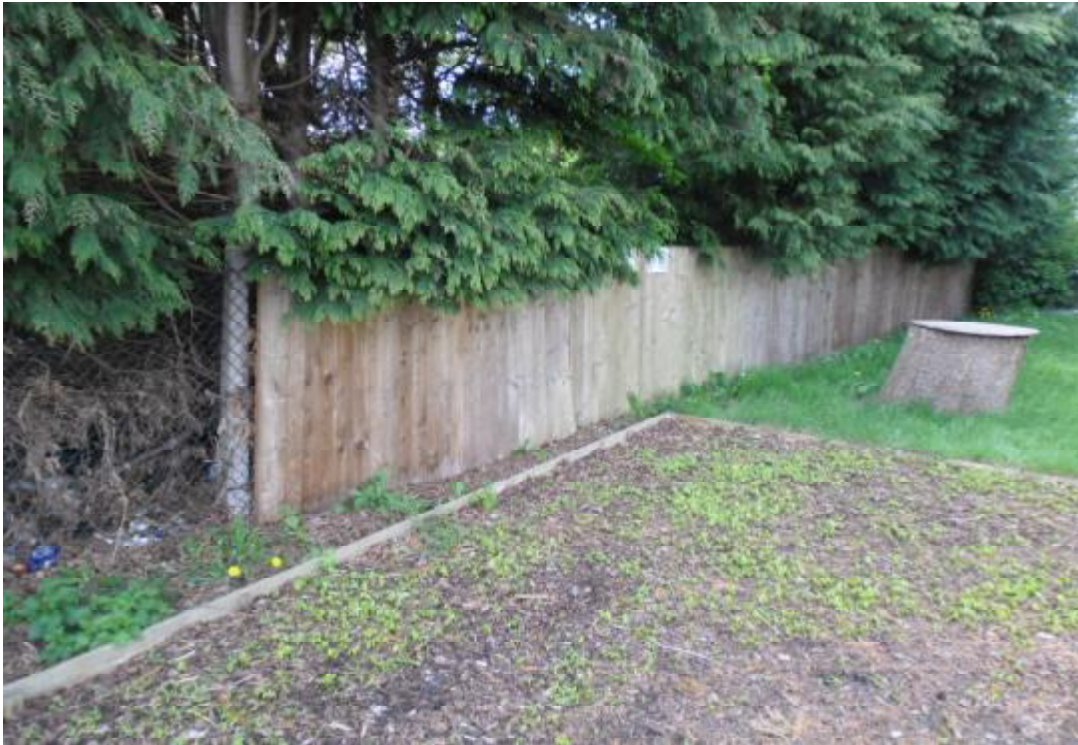
Photograph 72: View of right-hand side boundary fence.

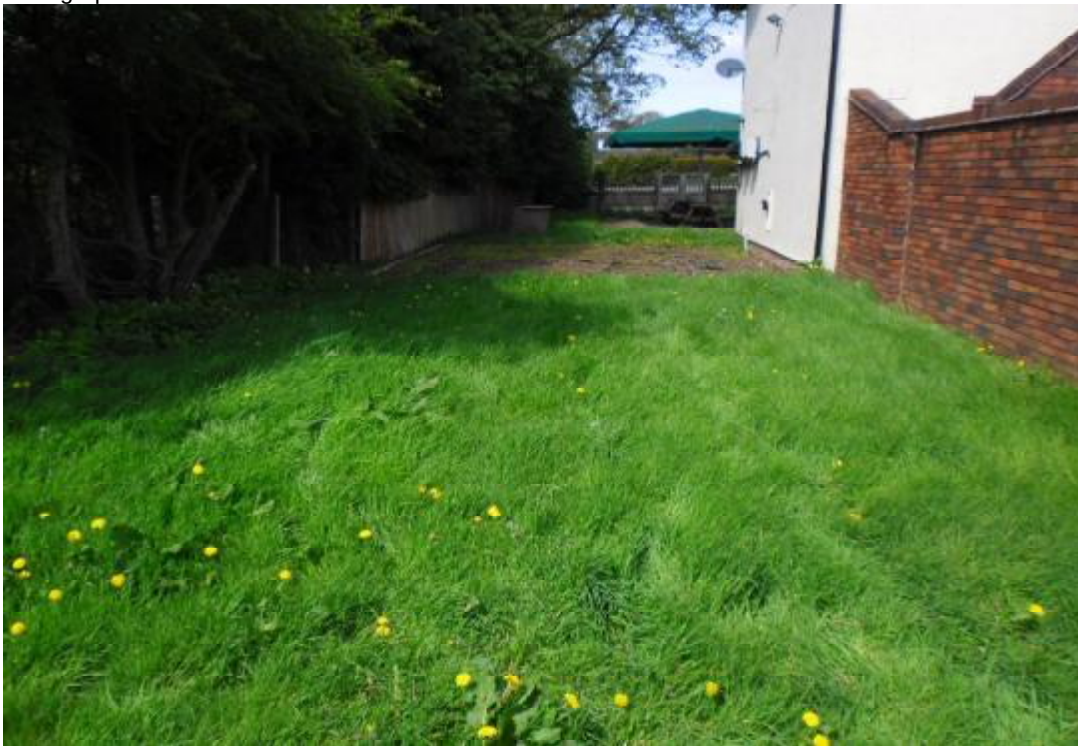
Photograph 73: View of boundary fence to right-hand side.

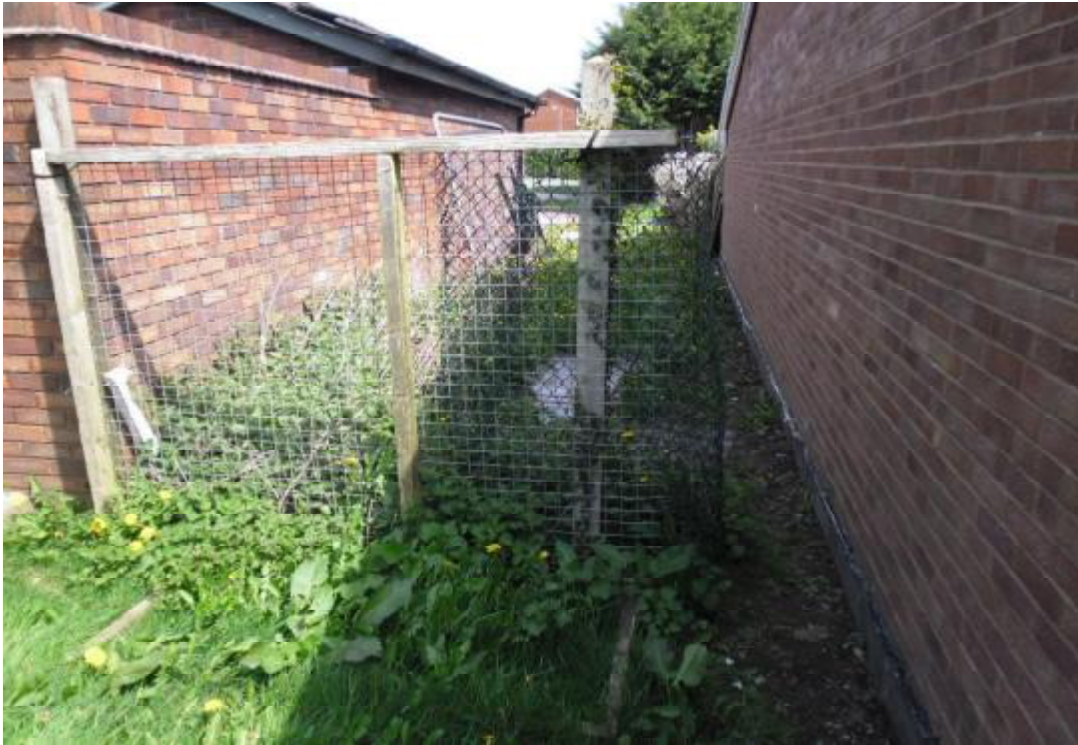
Photograph 74: View of right-hand side yard area.

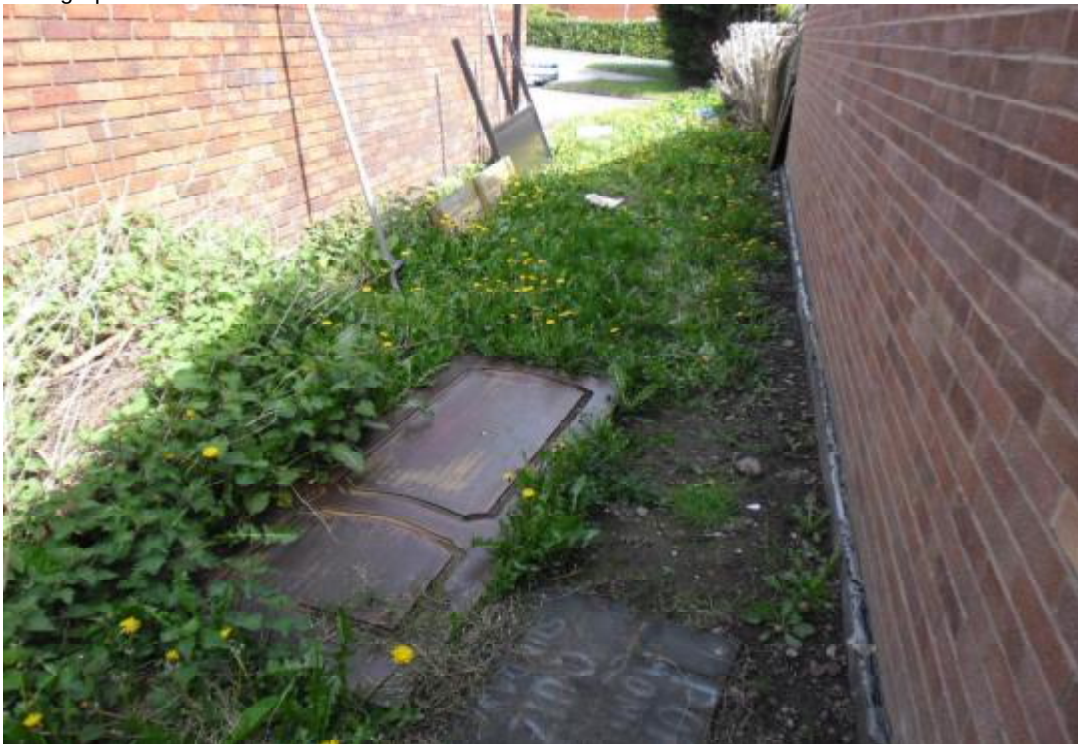
Photograph 75: View or rear yard area with timber and metal fence.

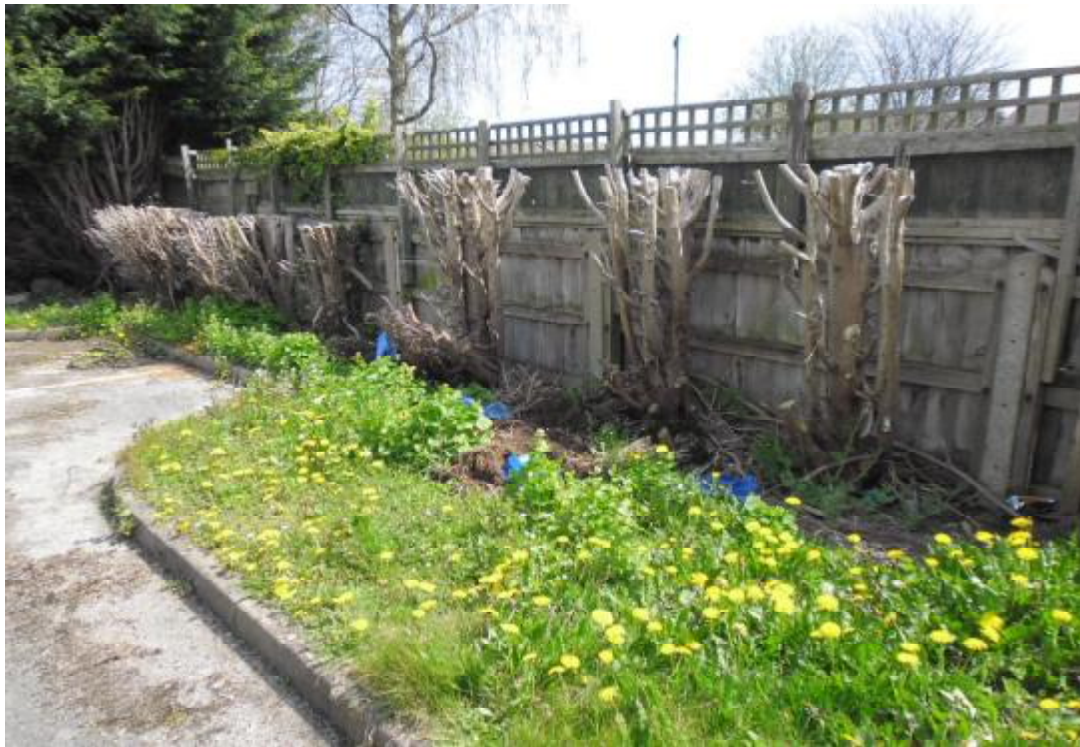
Photograph 76: View of rear yard.

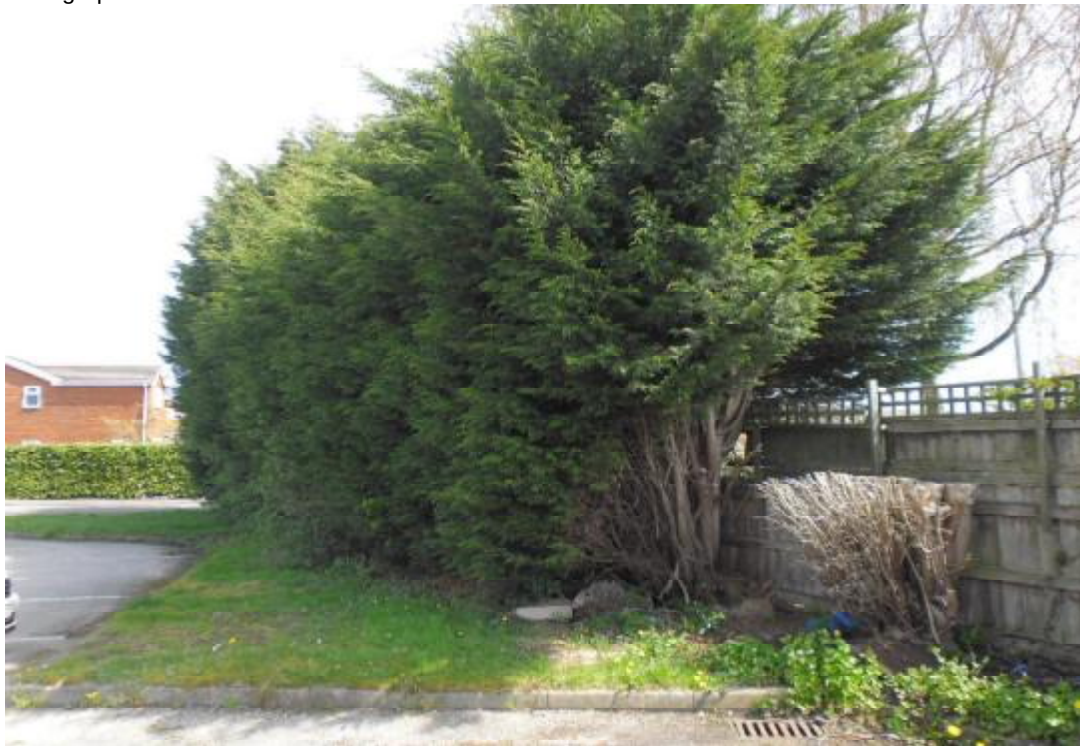
Photograph 77: View of rear boundary fence.

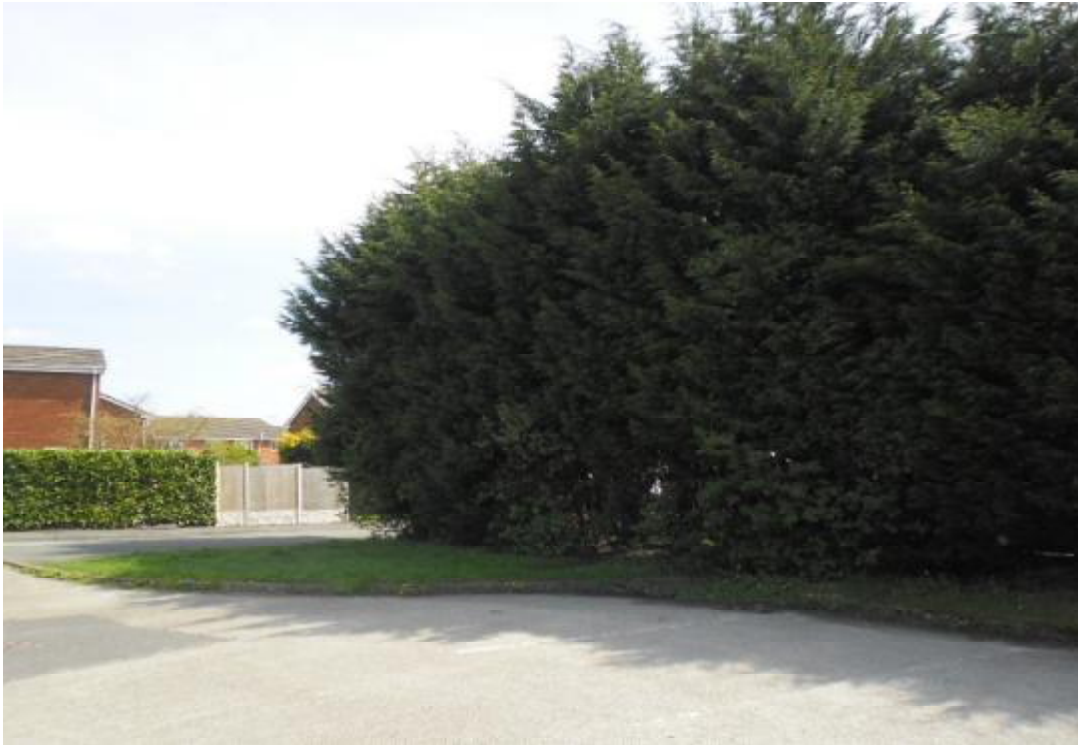
Photograph 78: View of rear boundary fence.

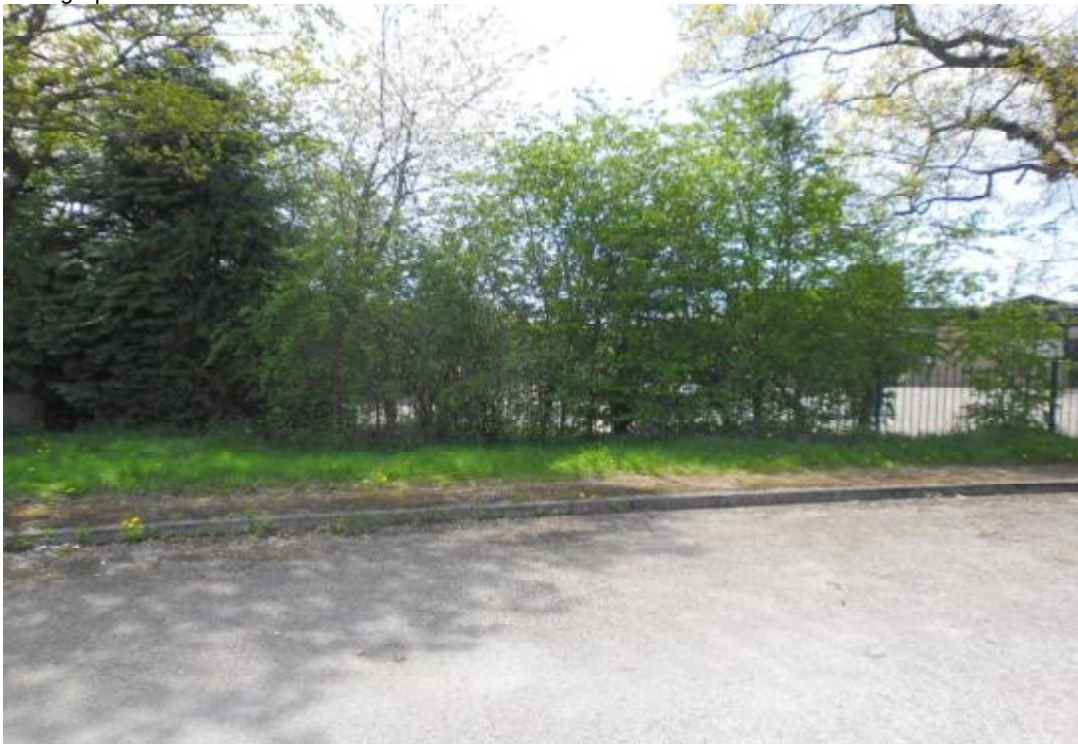
Photograph 79: View of rear boundary fence with vegetation growth in front of timber fence.

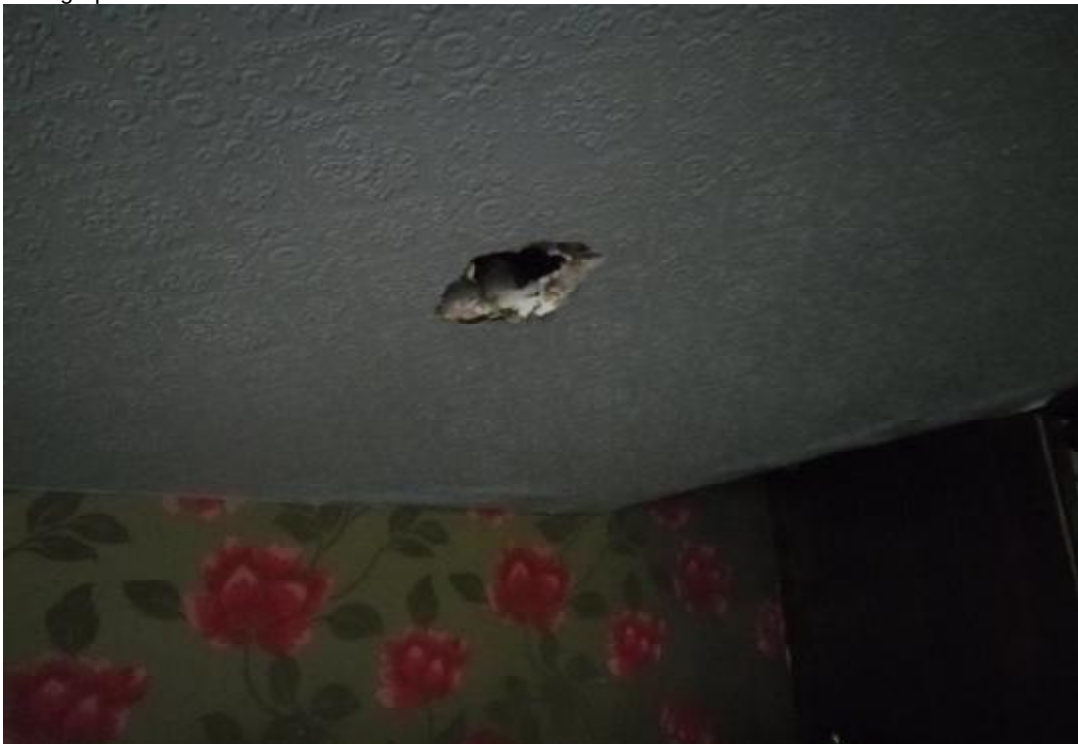
Photograph 95: Damage to ceiling within trading area and general view of seating.

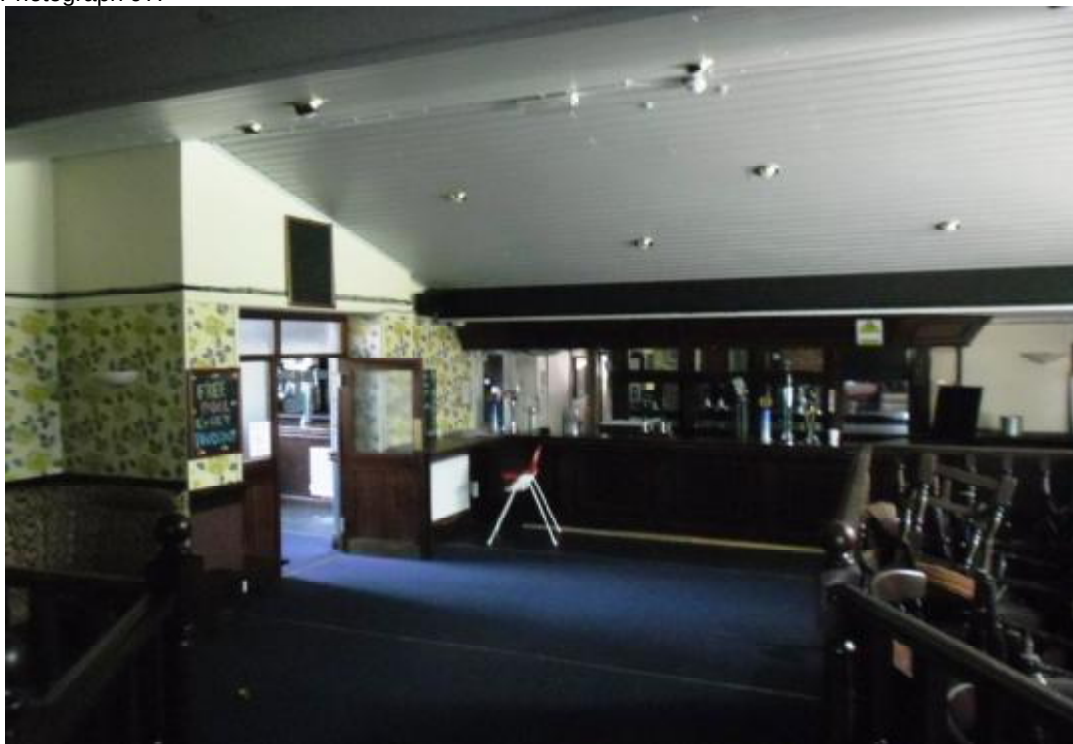
Photograph 97: General view of trading area.

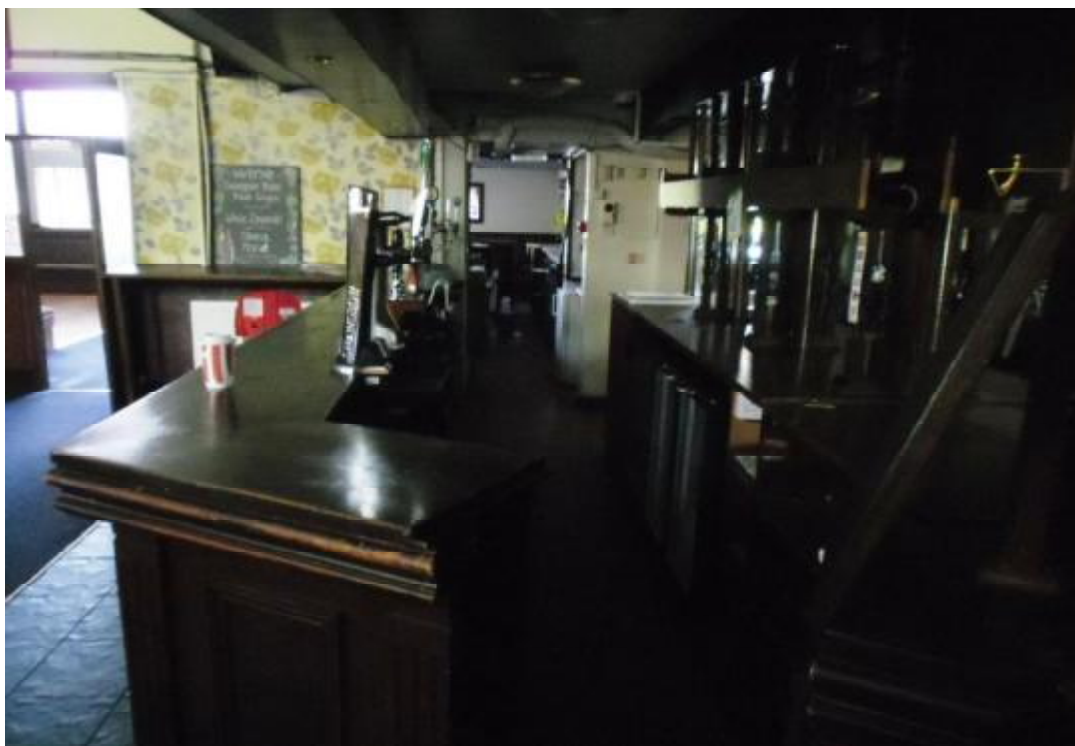
Photograph 100: General view of trading area.

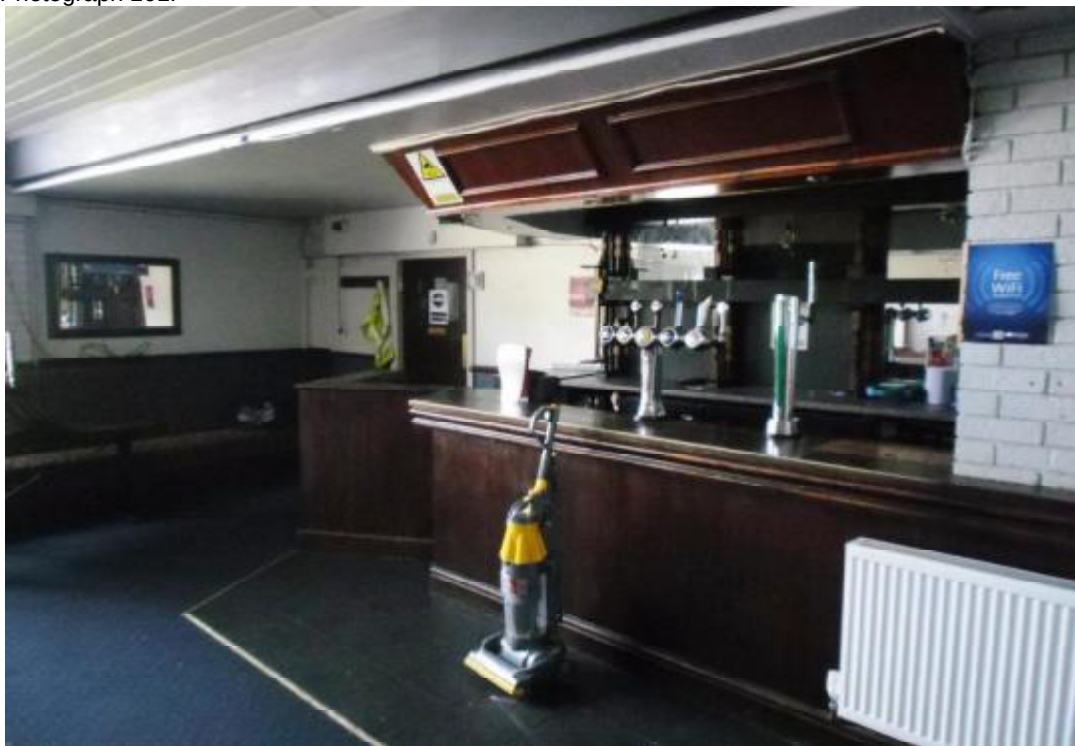
Photograph 101: View of bar.

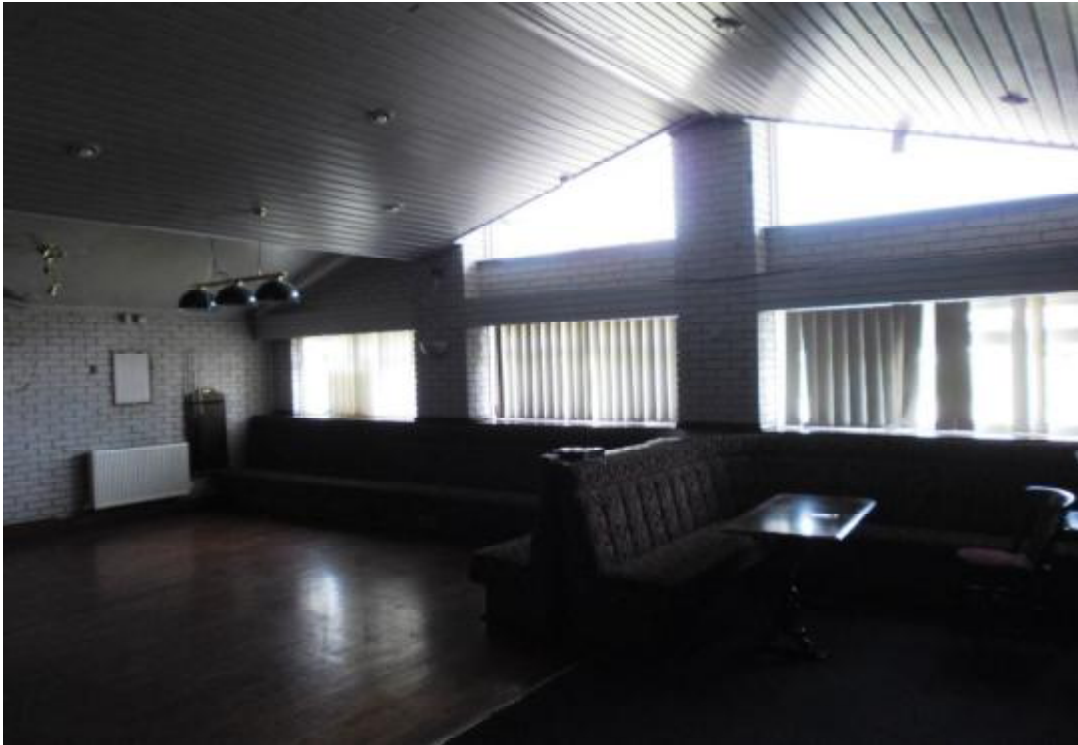
Photograph 104: General view of trading area.

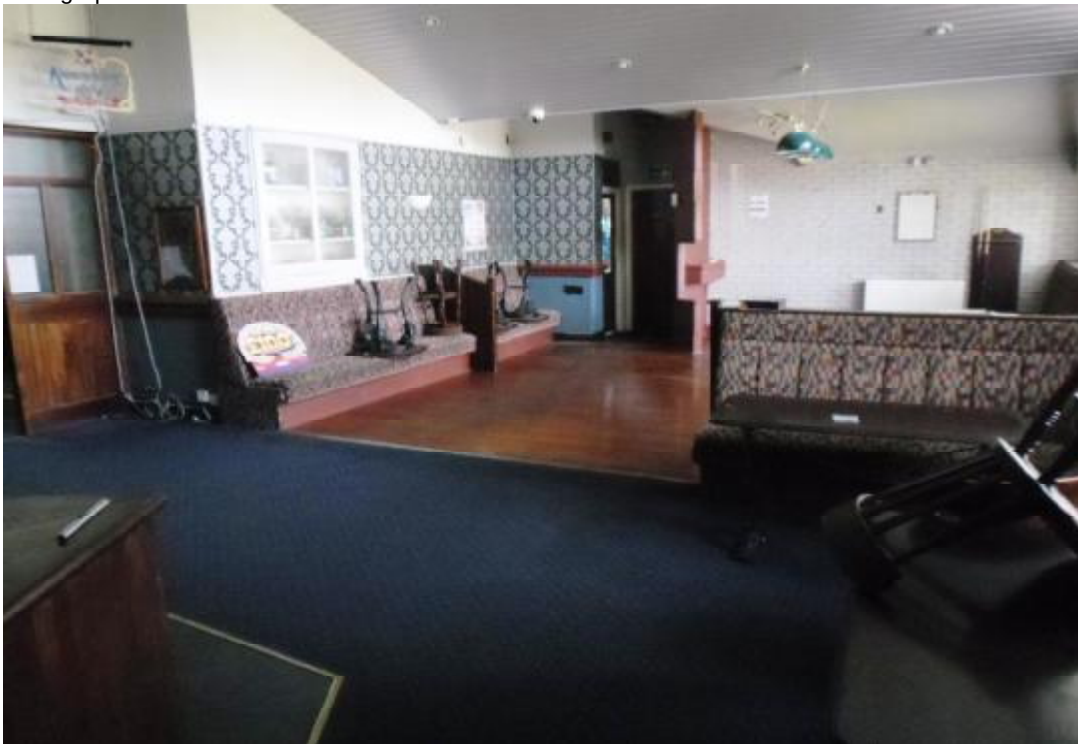
Photograph 105: General view of trading area.
