## Photographic Schedule of Condition

Goulbourne  
Borras Park Road  
Wrexham  
Clywd, LL12 7TF

Star Pubs & Bars

Tel: 01604 664366  
Fax: 01604 664367  
Date: 4 May 2016  
Ref: 0101487-BC-0000

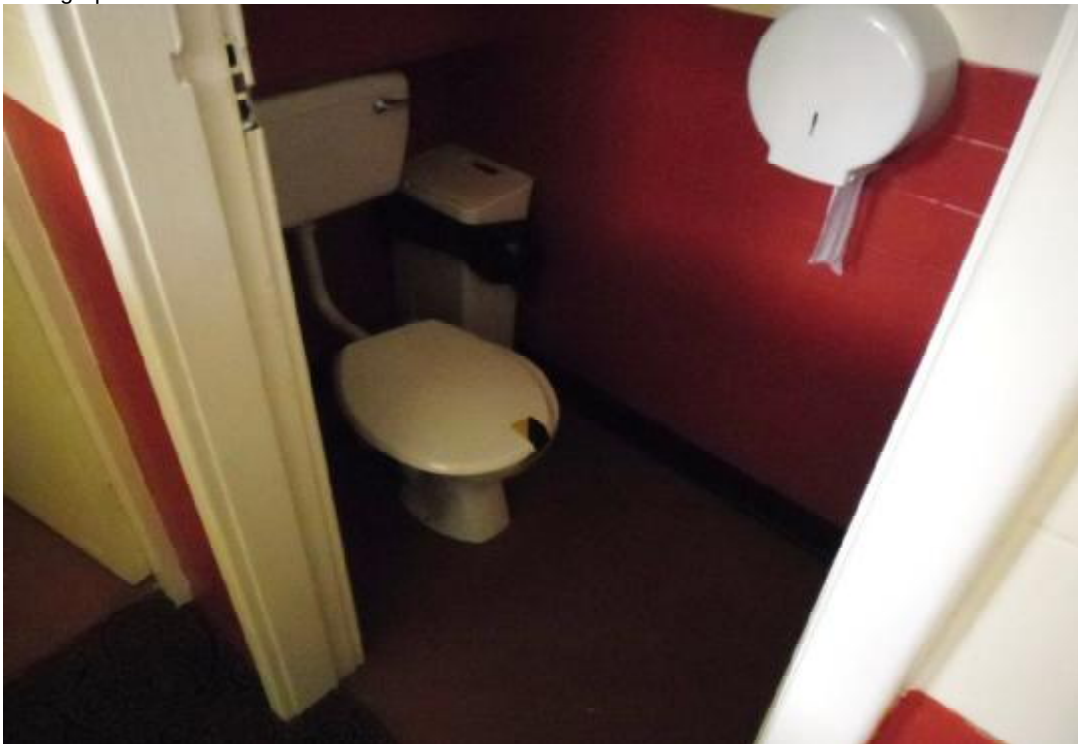
Photograph 117: General view of floor covering to female WC.

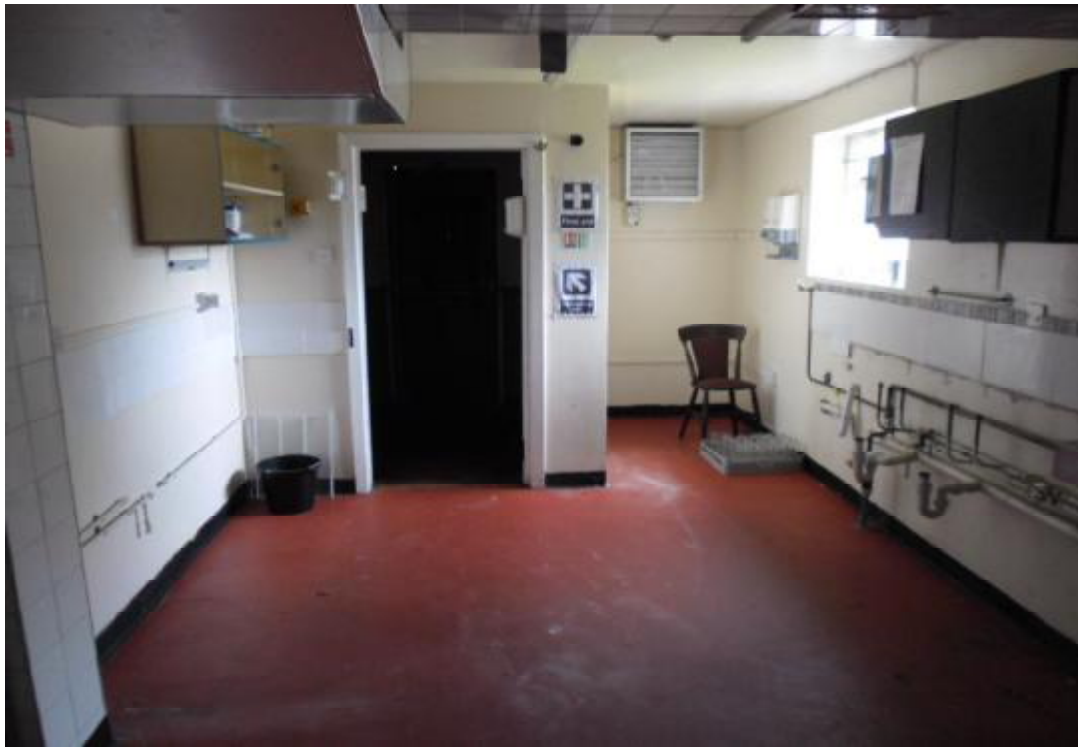
Photograph 120: General view of kitchen.

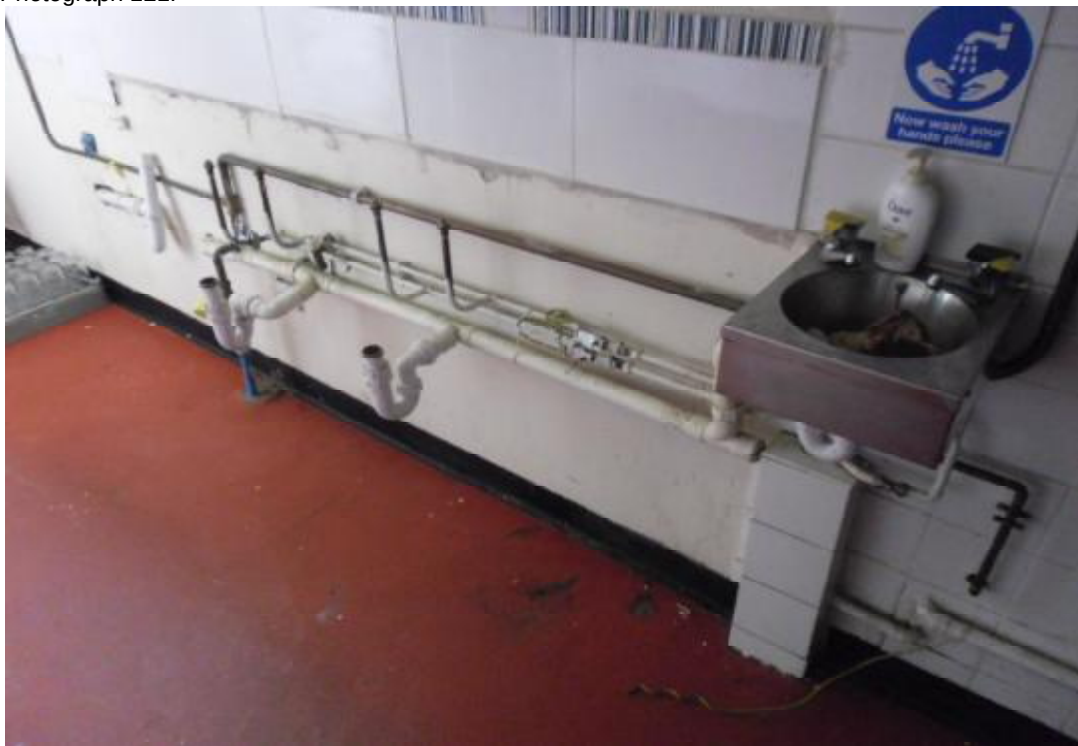
Photograph 121: Alternative view of kitchen.

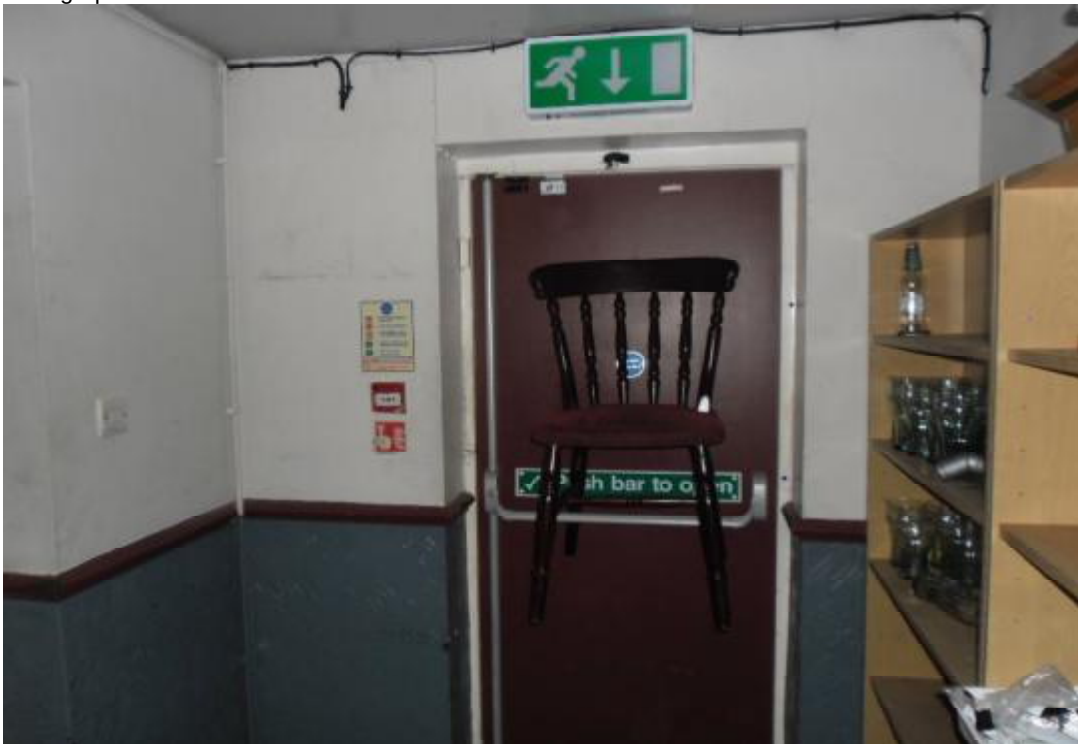
Photograph 123: View of floor covering to entrance lobby to kitchen area acting as storage room.

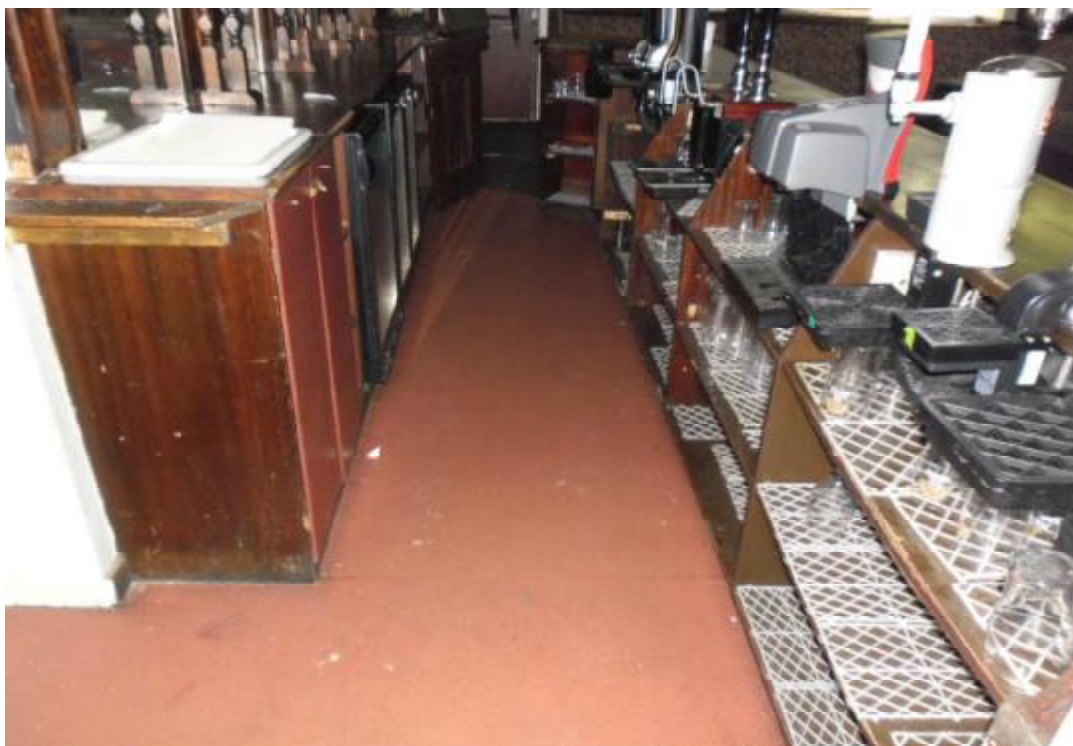
Photograph 126: General view of area behind bar.

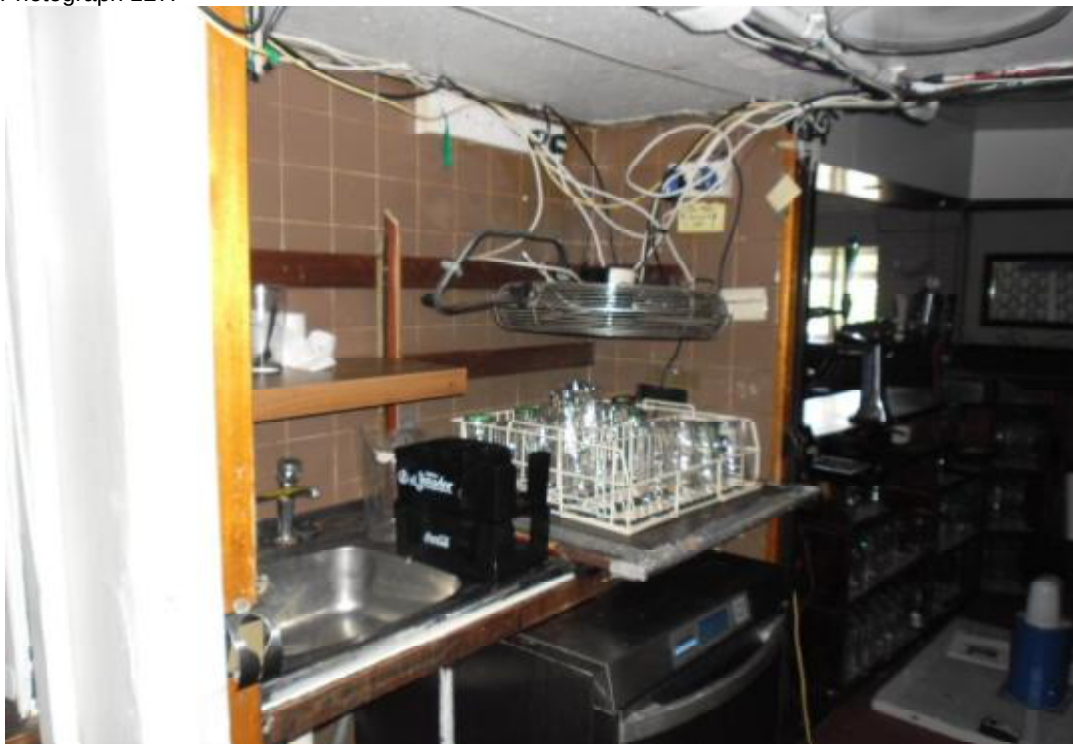
Photograph 127: Alternative view of area behind bar.

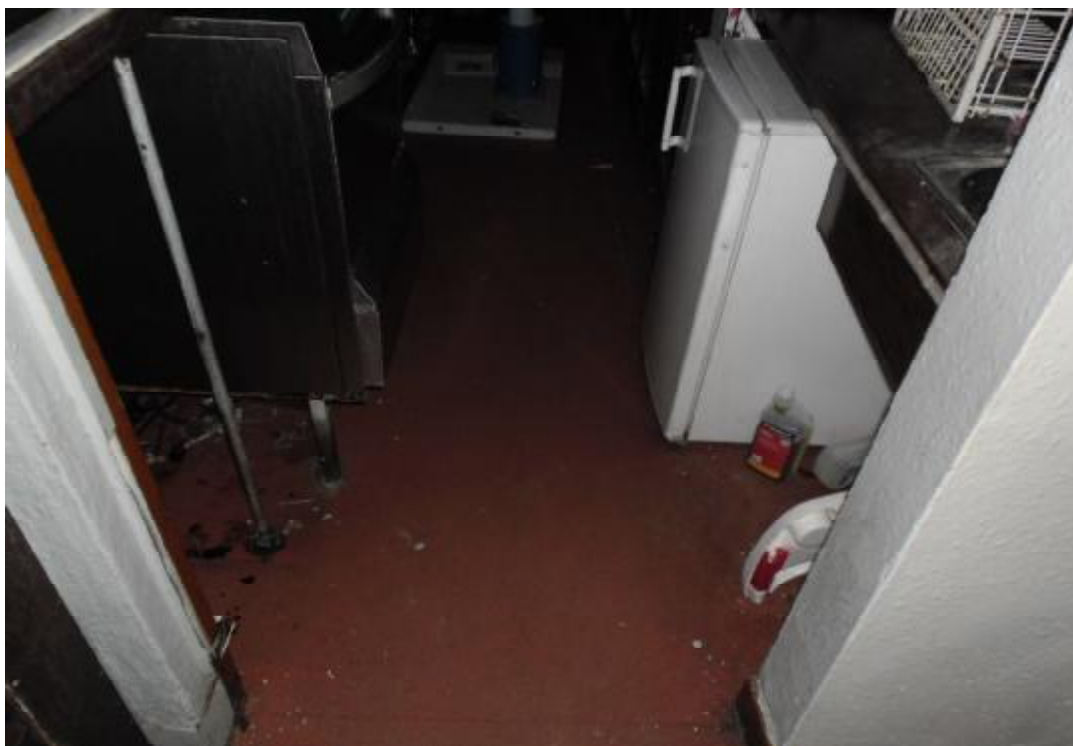
Photograph 128: General view of area behind bar with metal sink.

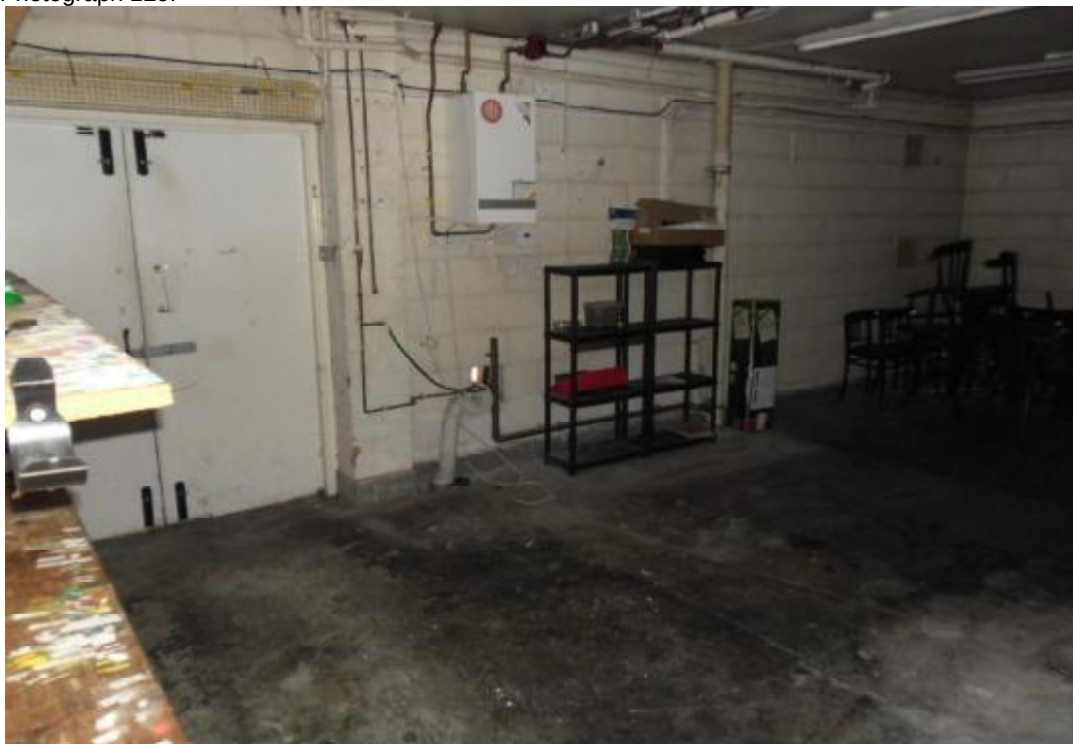
Photograph 129: General view of floor covering to area behind bar.

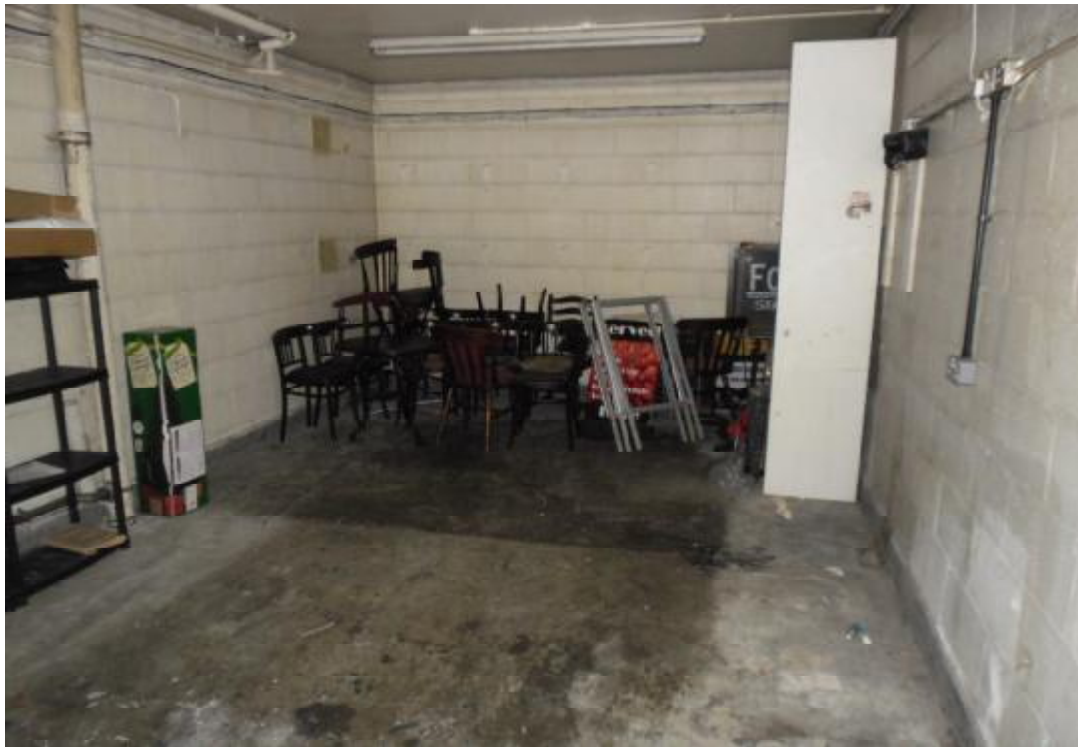
Photograph 130: General view of storage room.

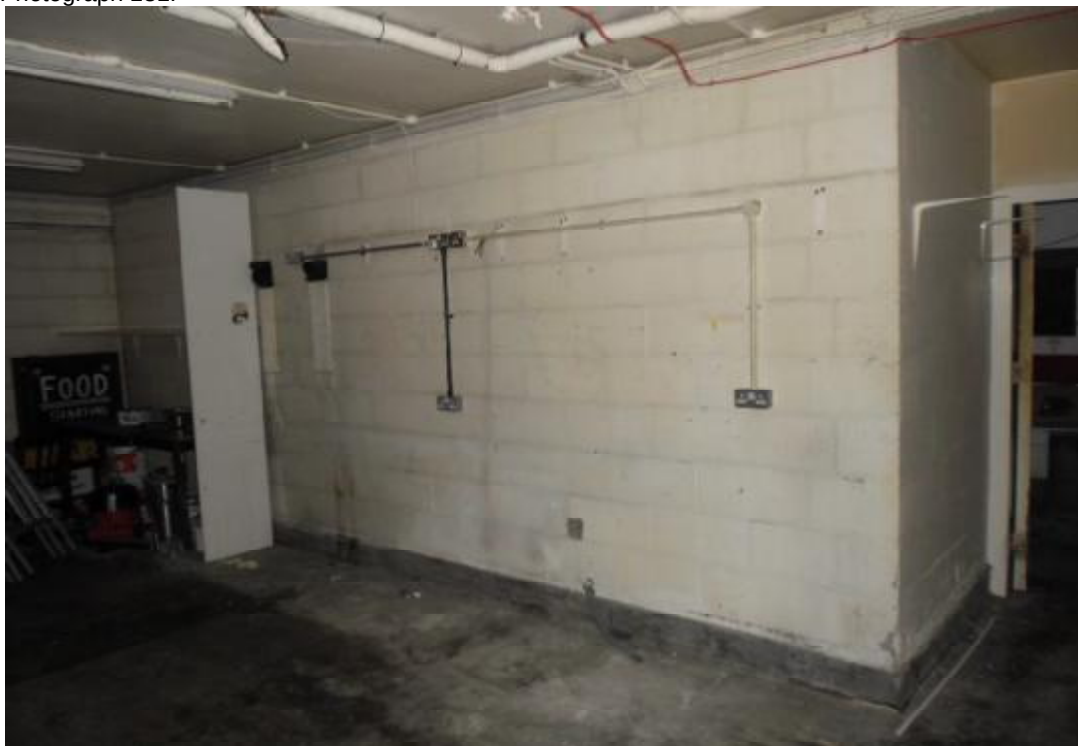
Photograph 131: Alternative view of storage room.

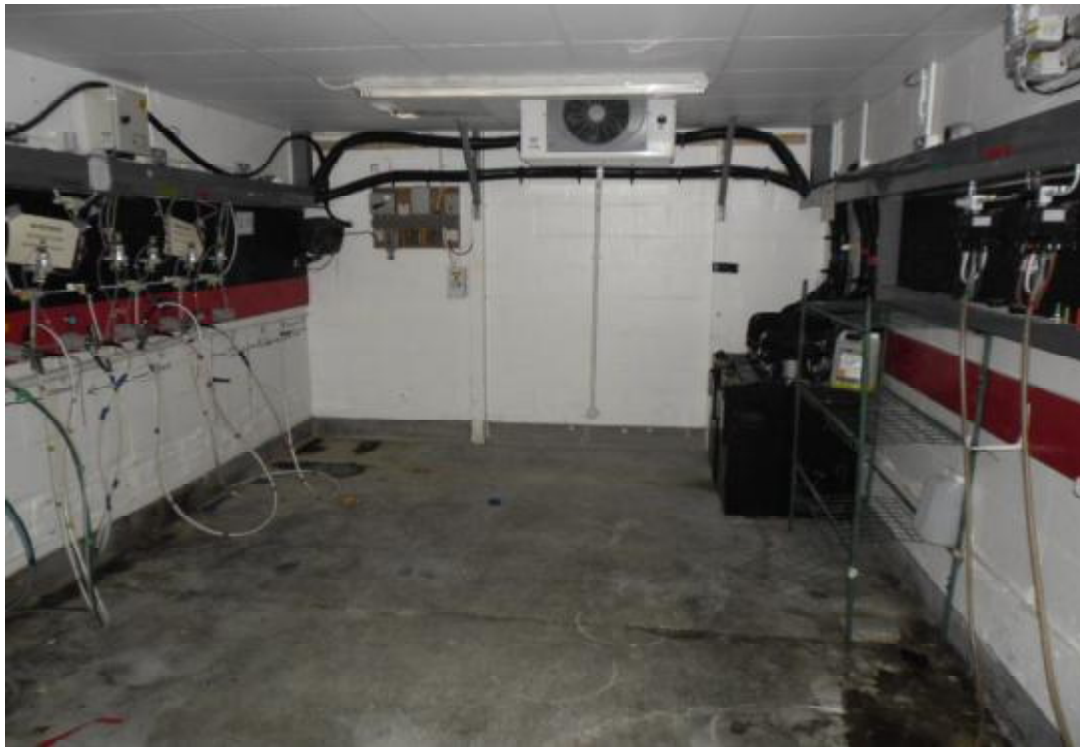
Photograph 136: View of internal storage room.

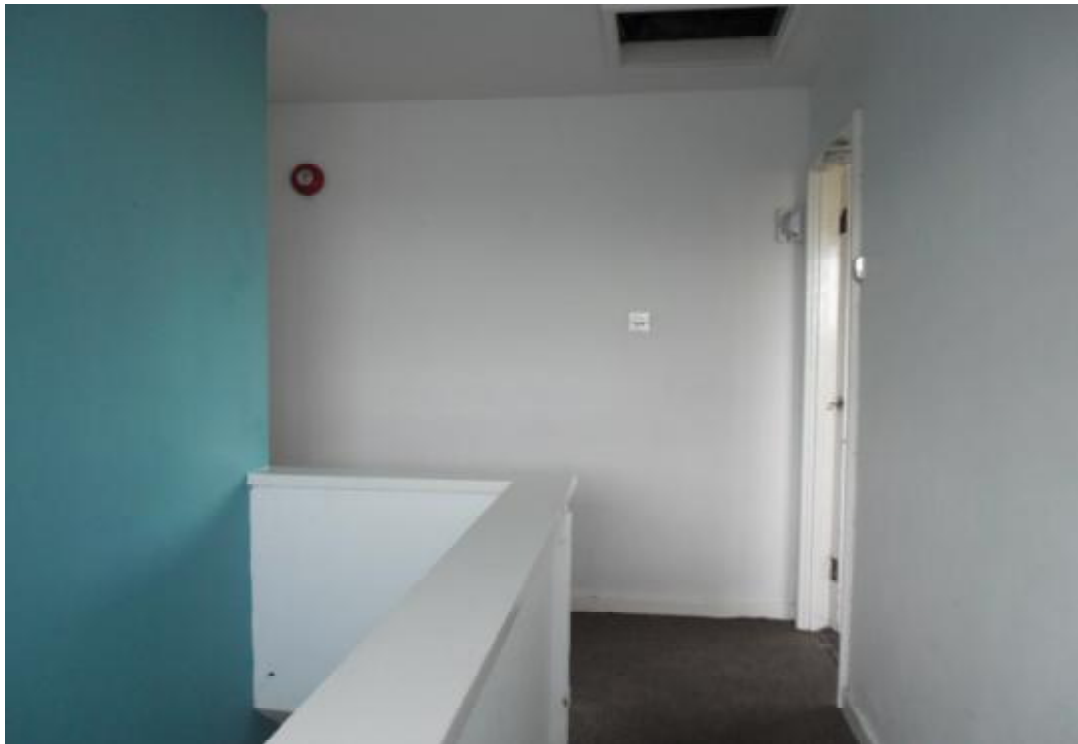
Photograph 140: General view of staircase to first floor.

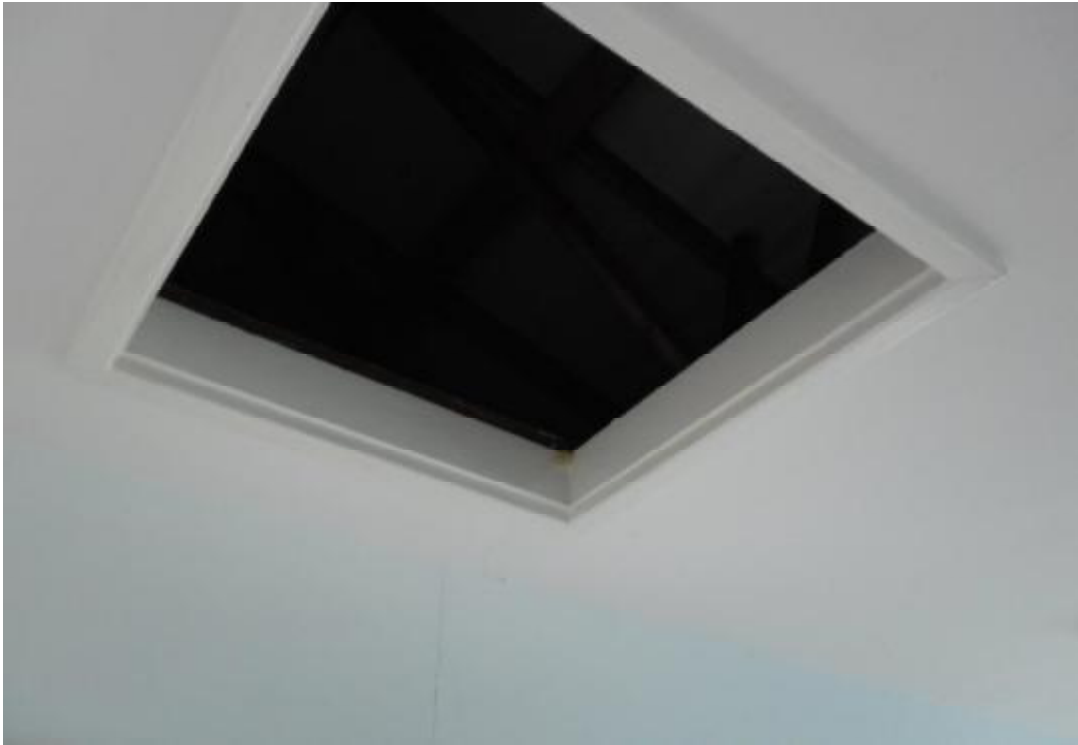
Photograph 142: Alternative view of staircase landing.

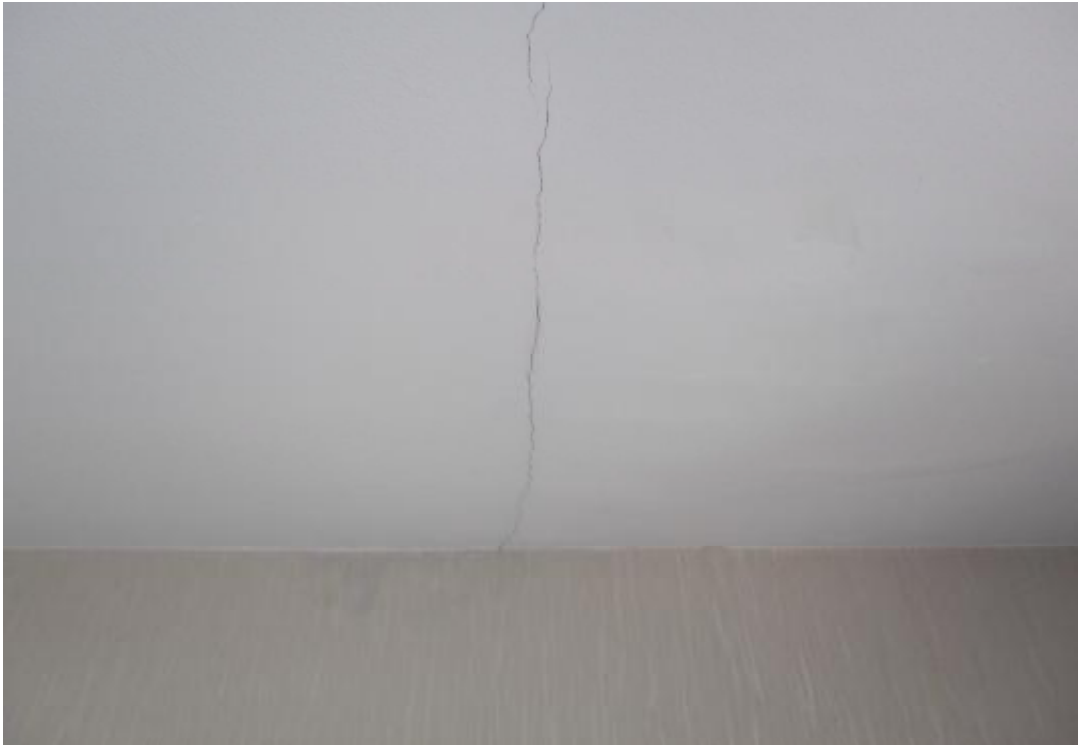
Photograph 146: View of hairline crack to ceiling covering above window aperture.

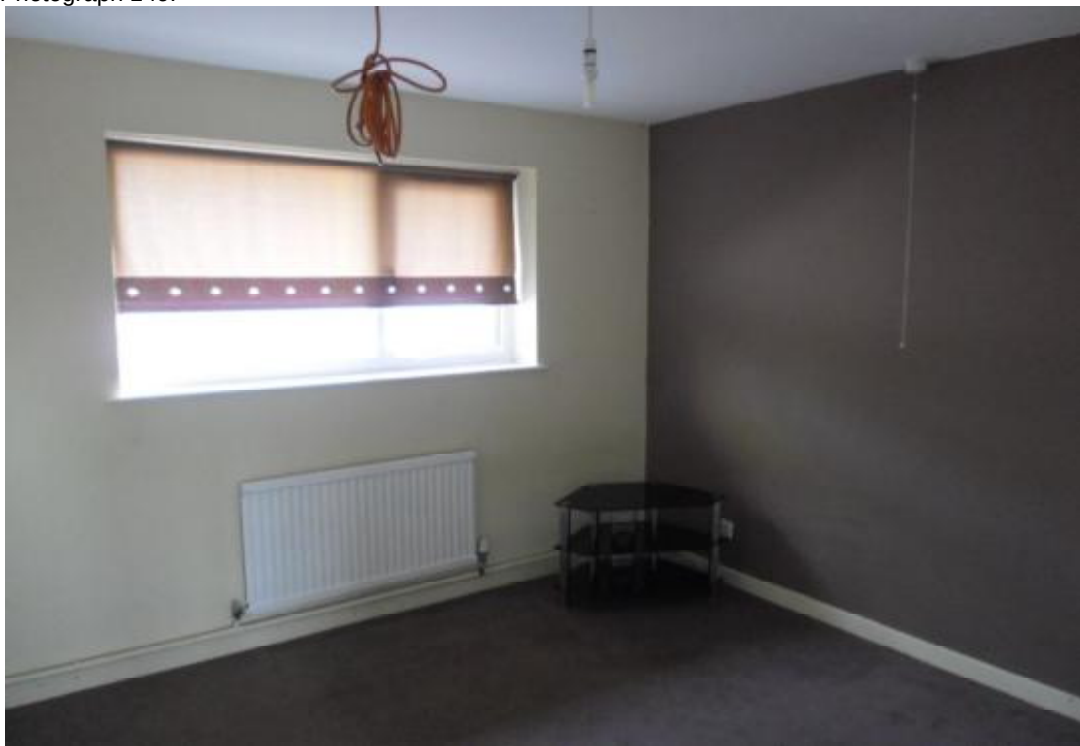
Photograph 149: General view of bedroom 1.

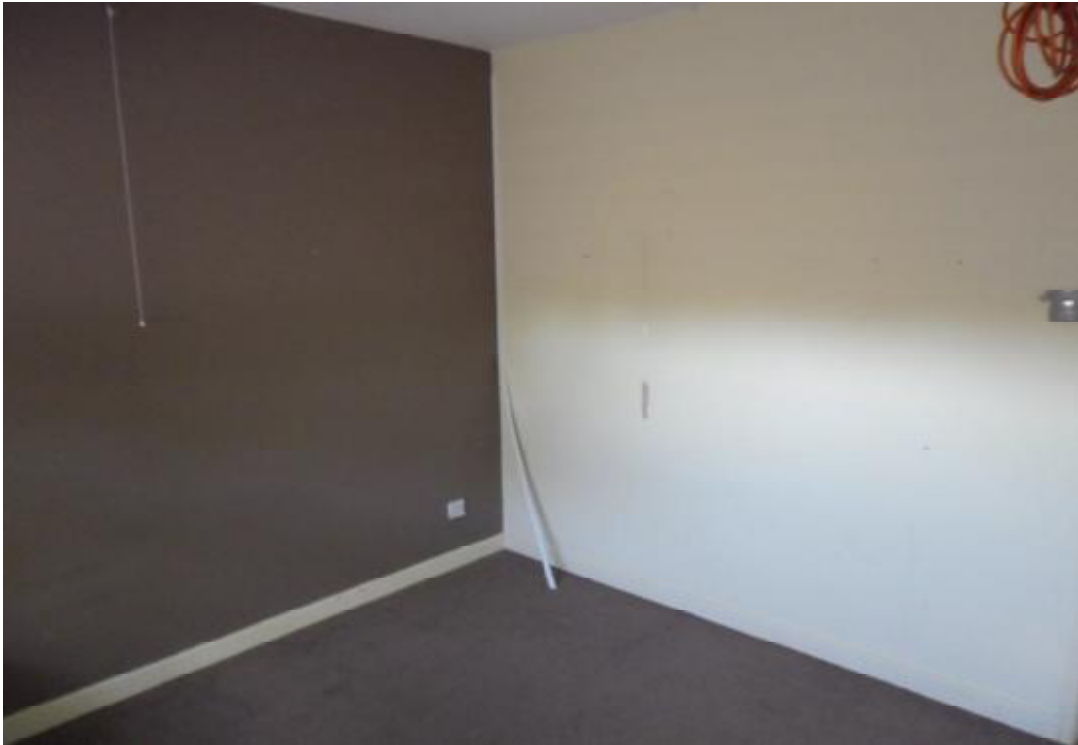
Photograph 150: General view of bedroom 1.

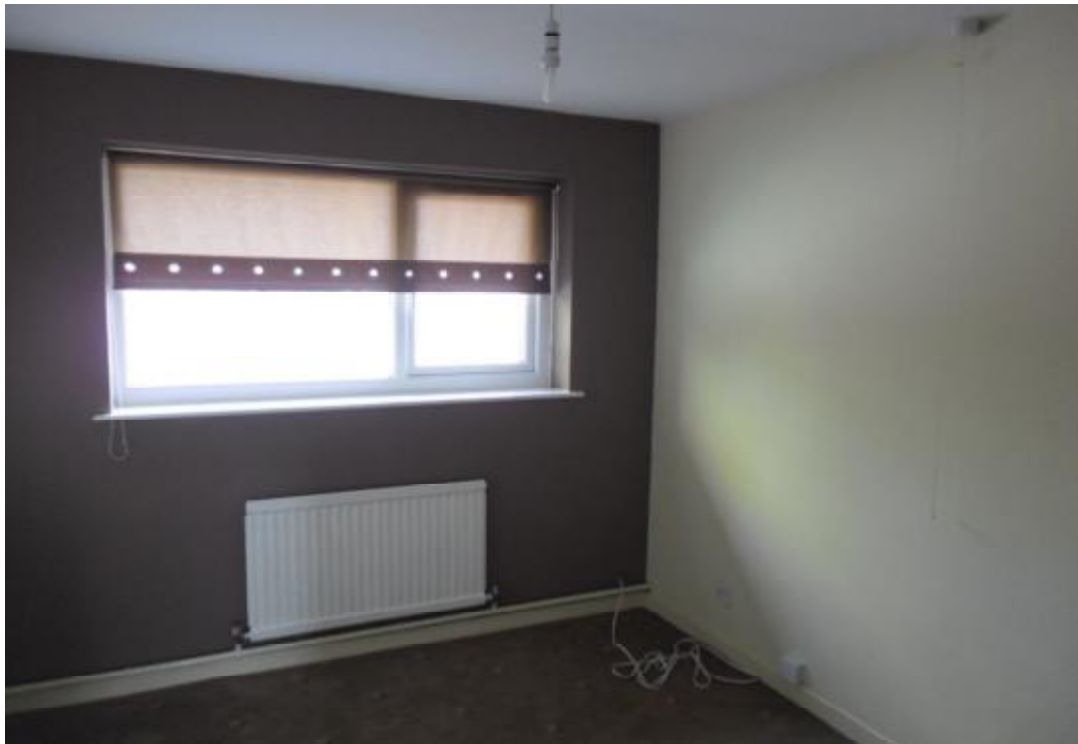
Photograph 152: View of redundant fixing holes to internal wall to bedroom 1.

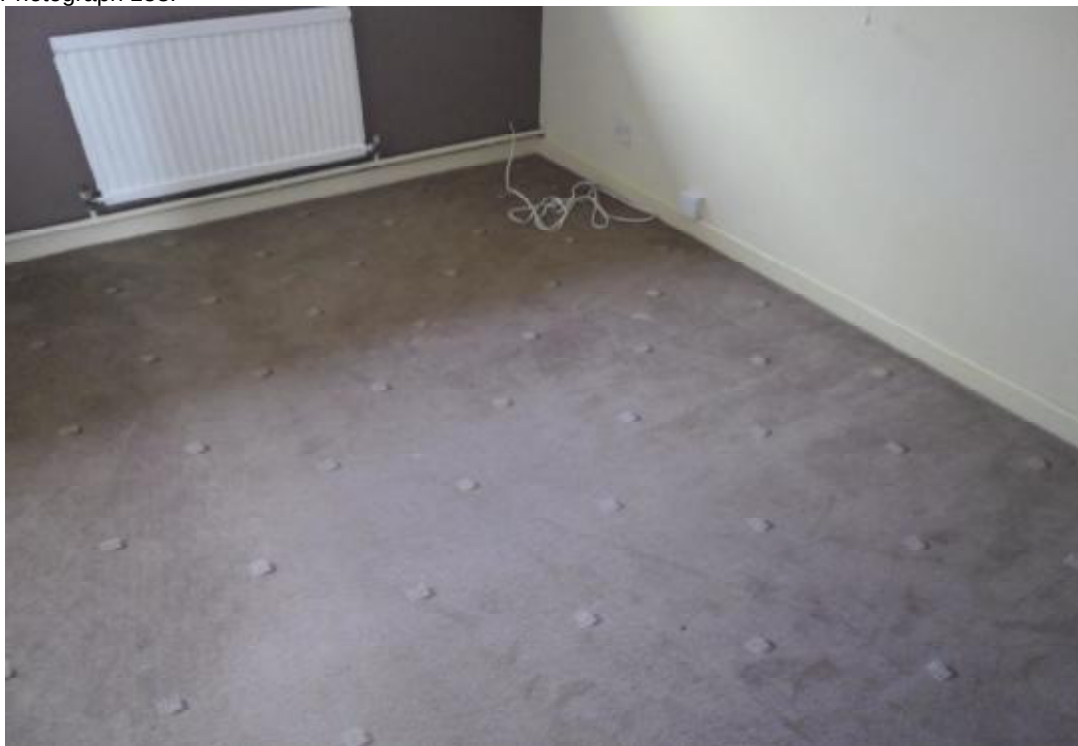
Photograph 153: General view of bedroom 2.

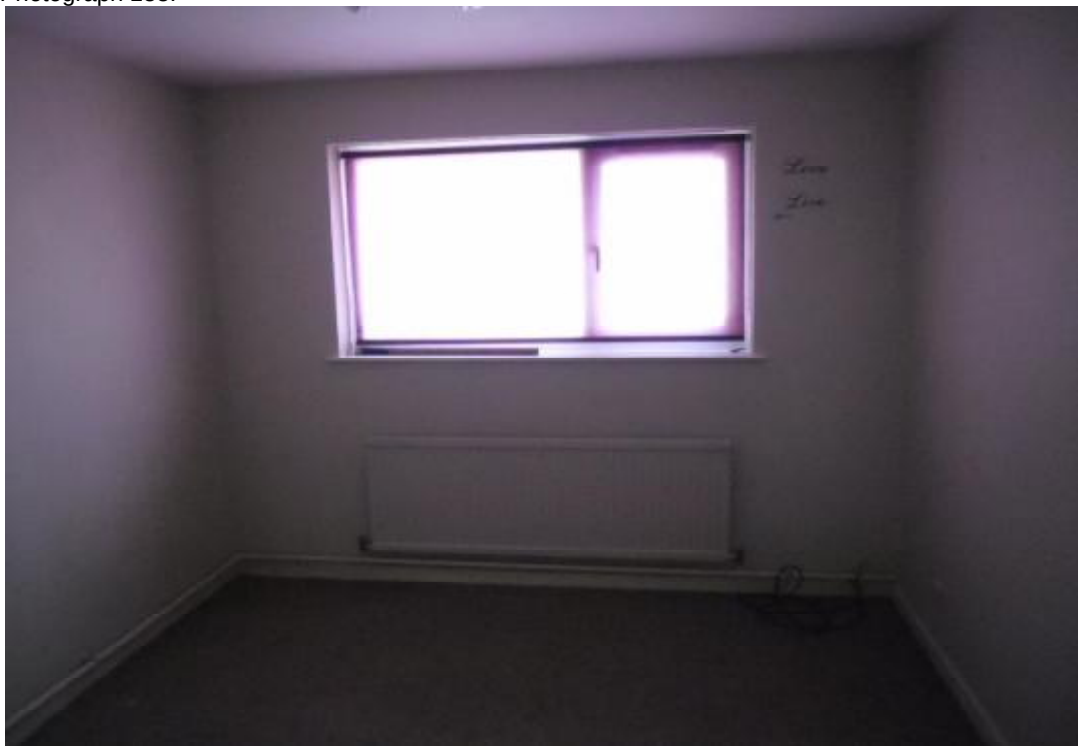
Photograph 155: General view of bedroom 2.

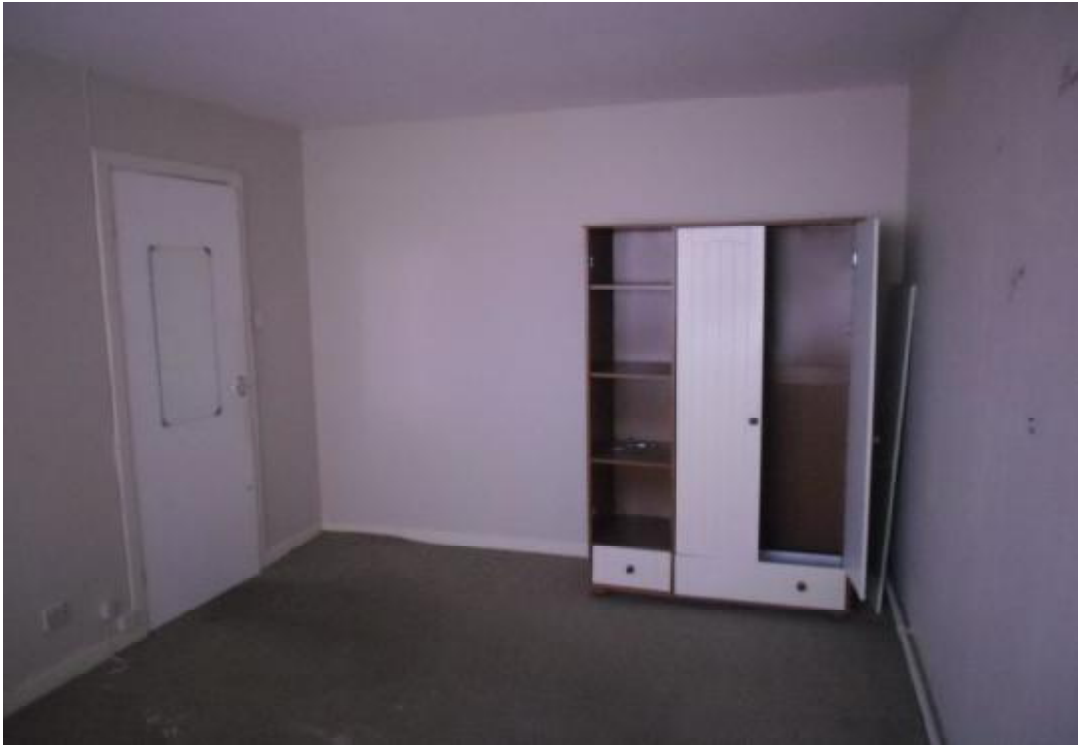
Photograph 156: General view of bedroom 3.

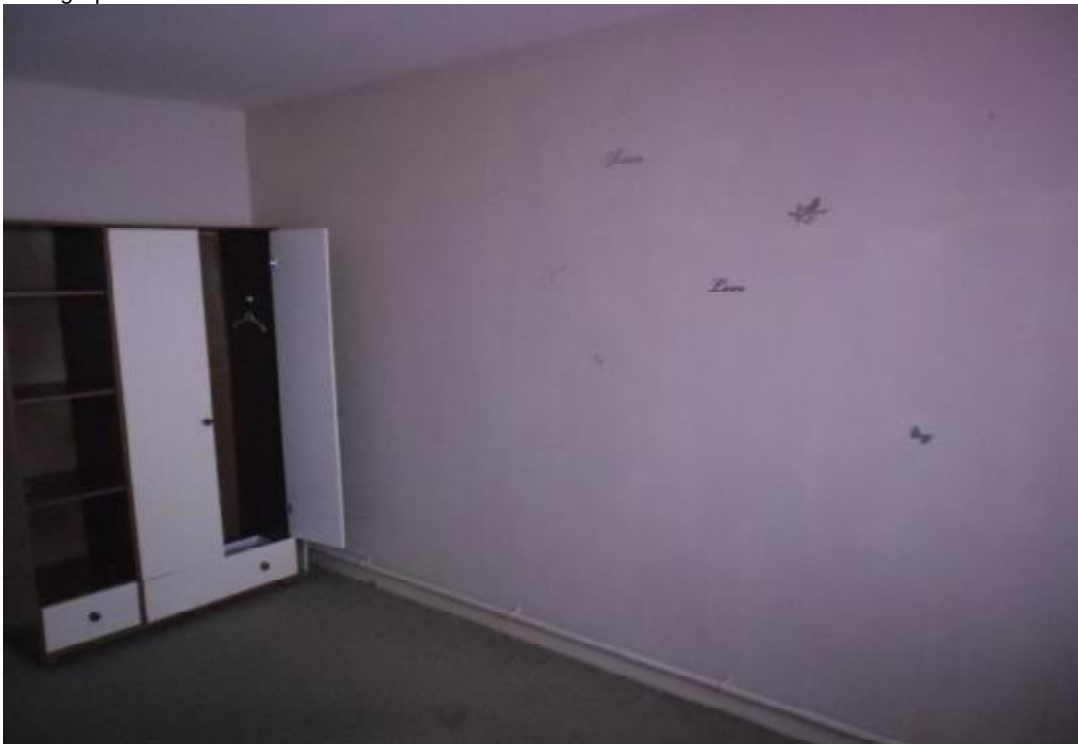
Photograph 157: Alternative view of bedroom 3.

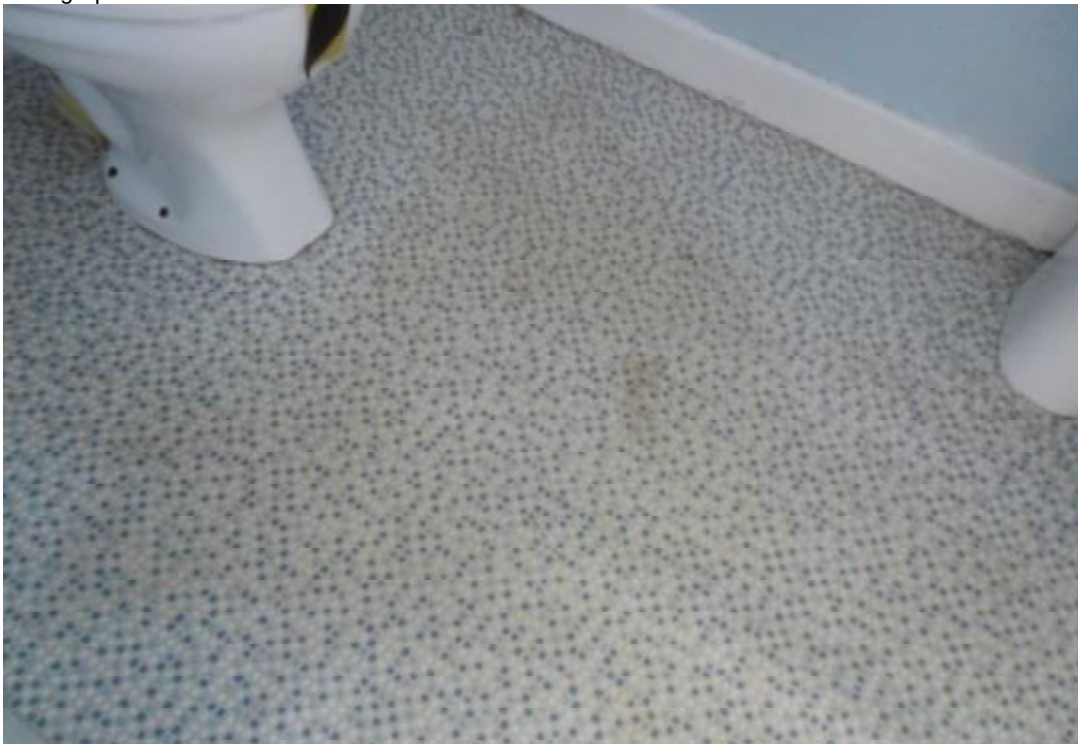
Photograph 165: General view of WC.

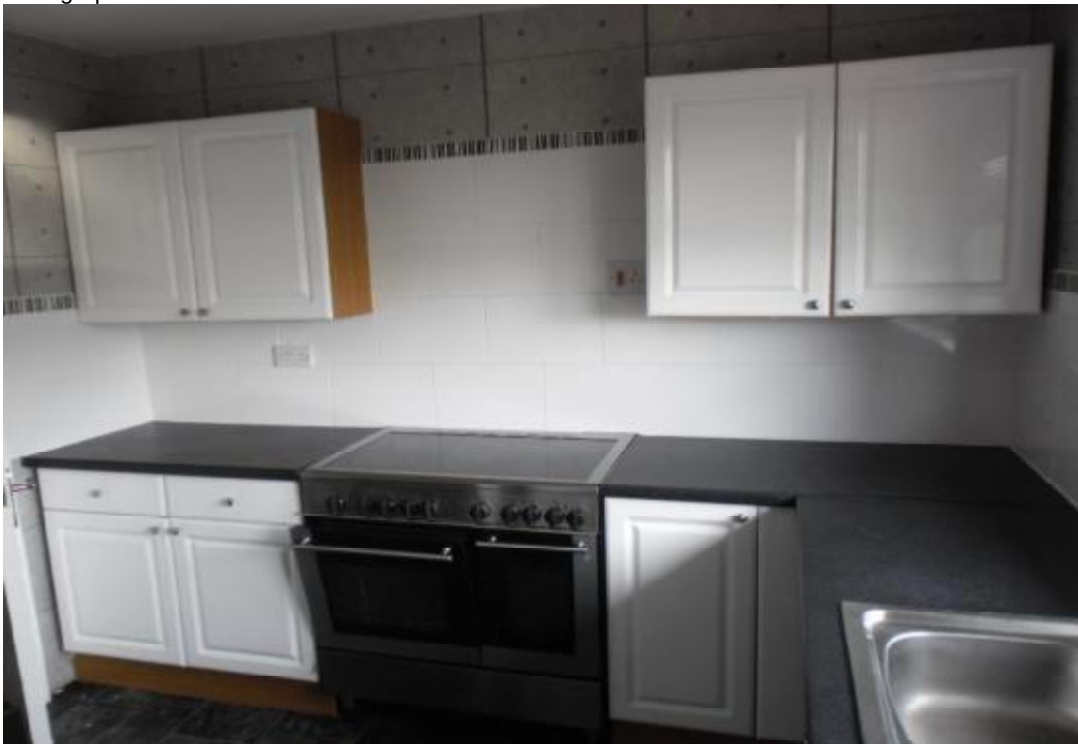
Photograph 167: General view of kitchen.

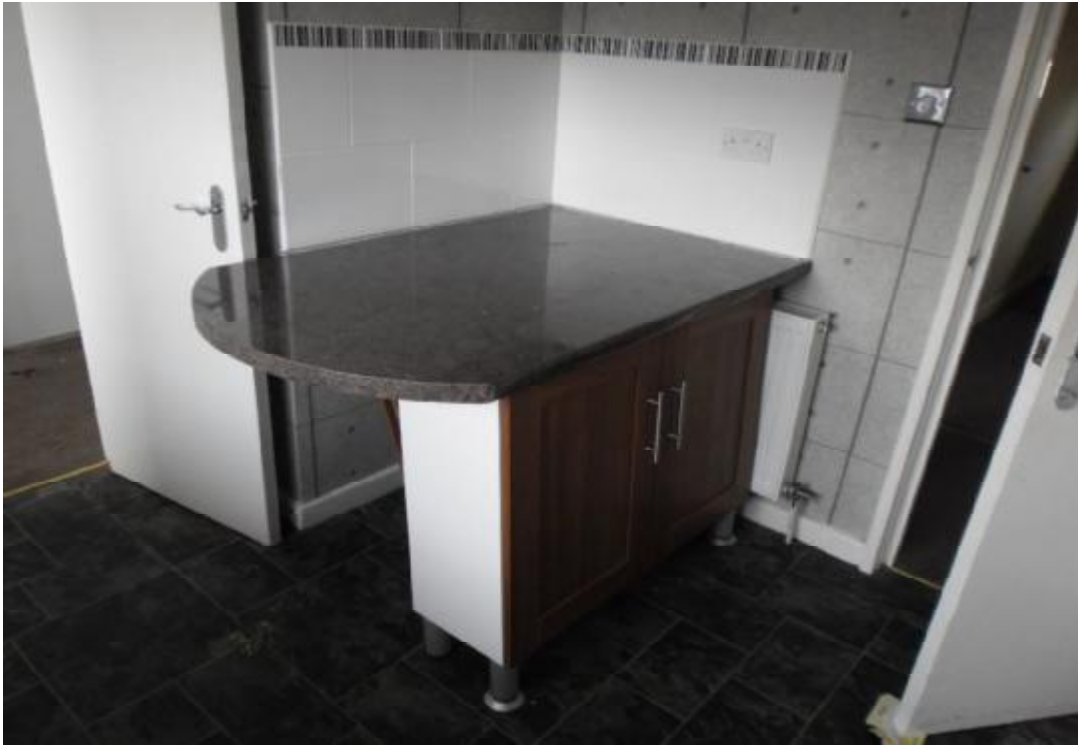
Photograph 168: General view of kitchen.

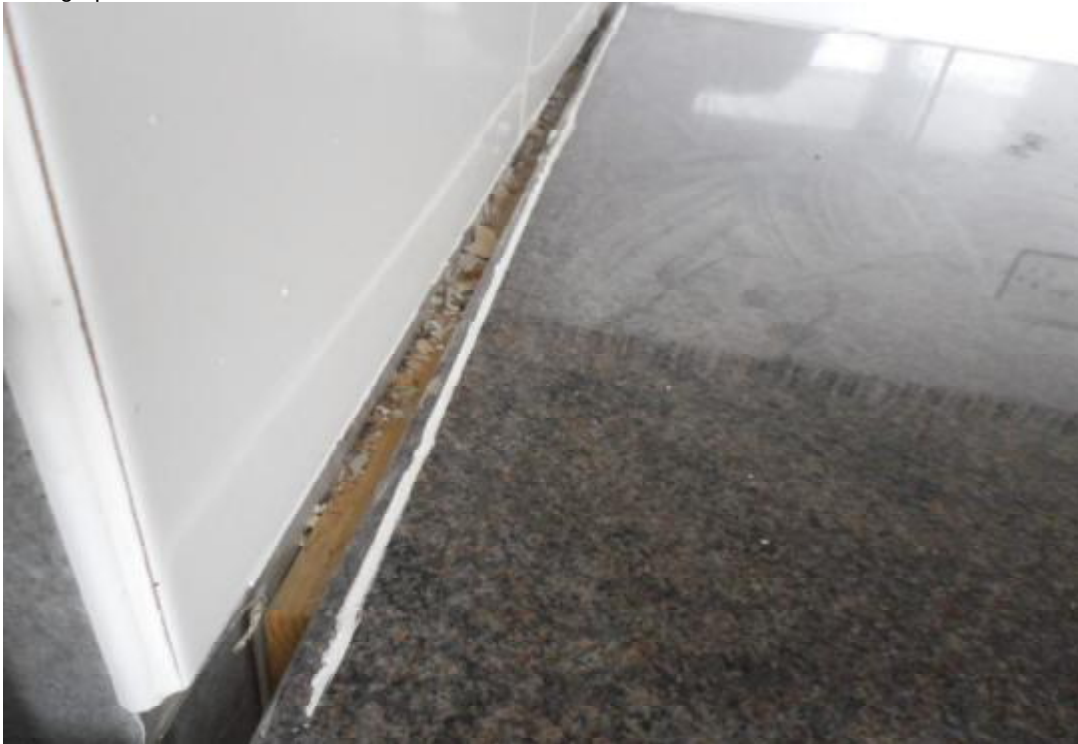
Photograph 169: General view of kitchen.

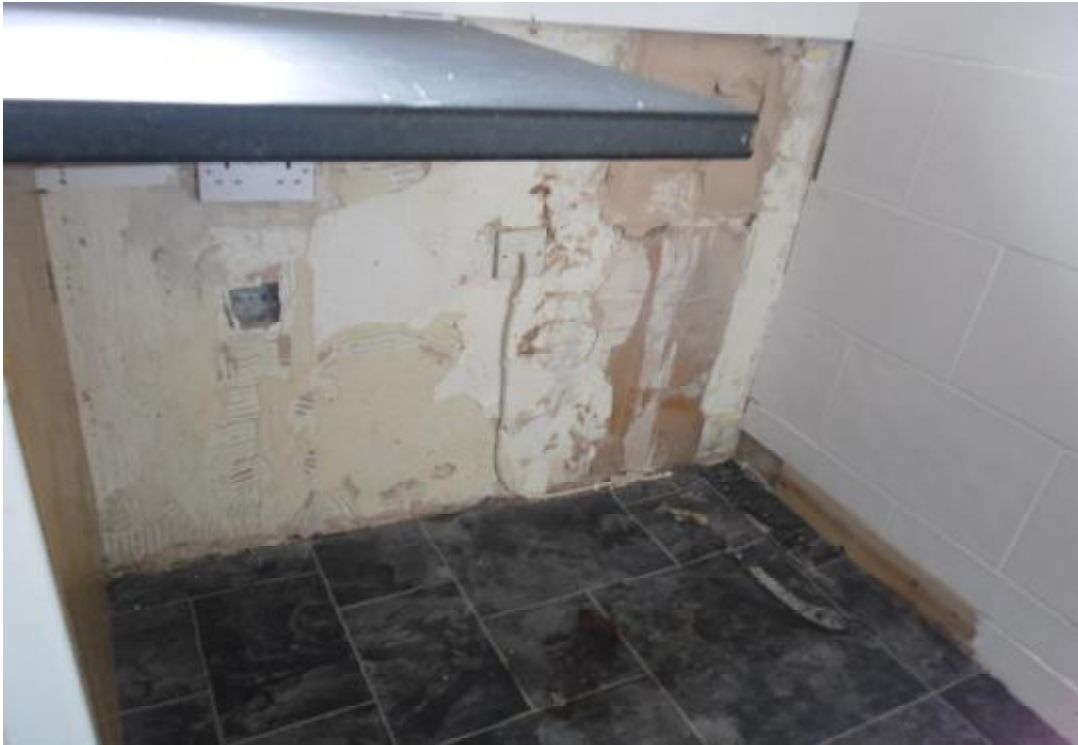
Photograph 170: View of dislodged worktop to kitchen area.

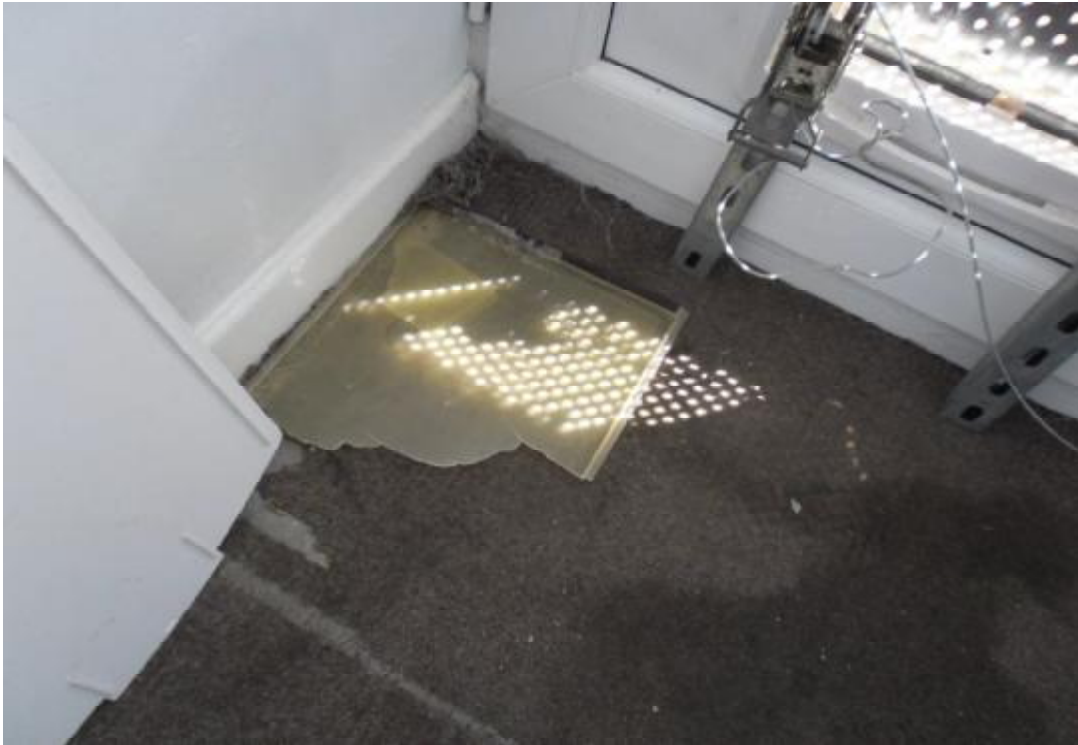
Photograph 176: View of damaged floor covering to the right-hand side of the rear access door.

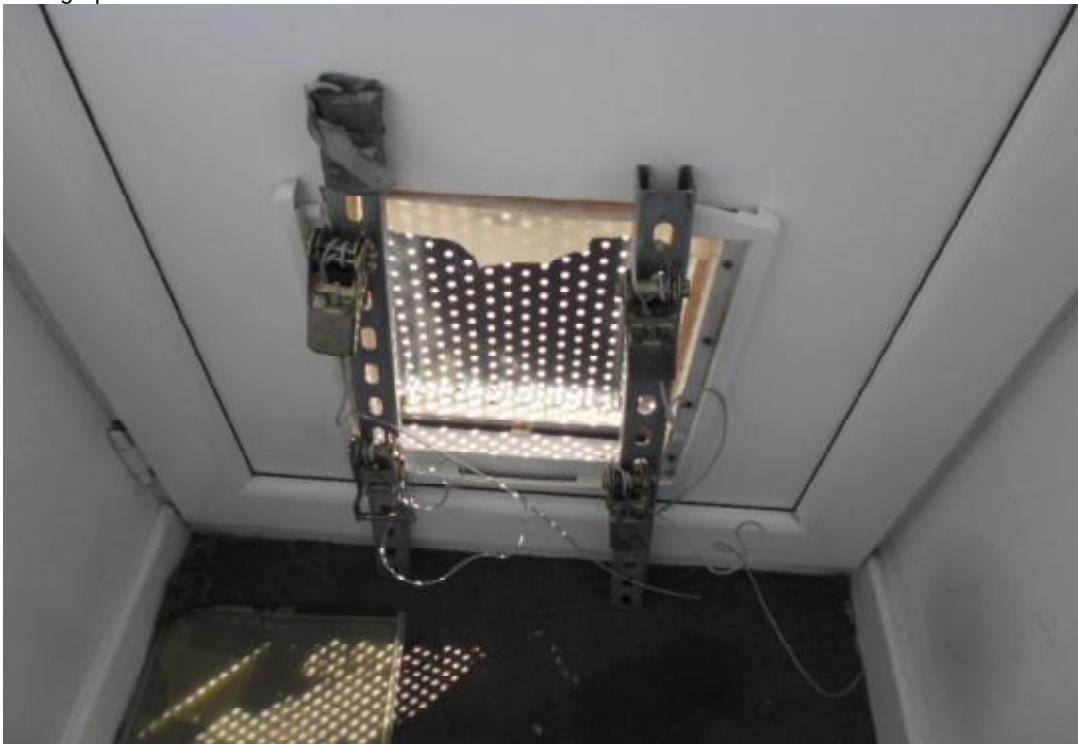
Photograph 177: View of damaged pet entrance access hatch to rear entrance door. Also note damage to carpet floor covering.
